Technical Service Information

MAZDA G4A-EL BIND UP IN REVERSE

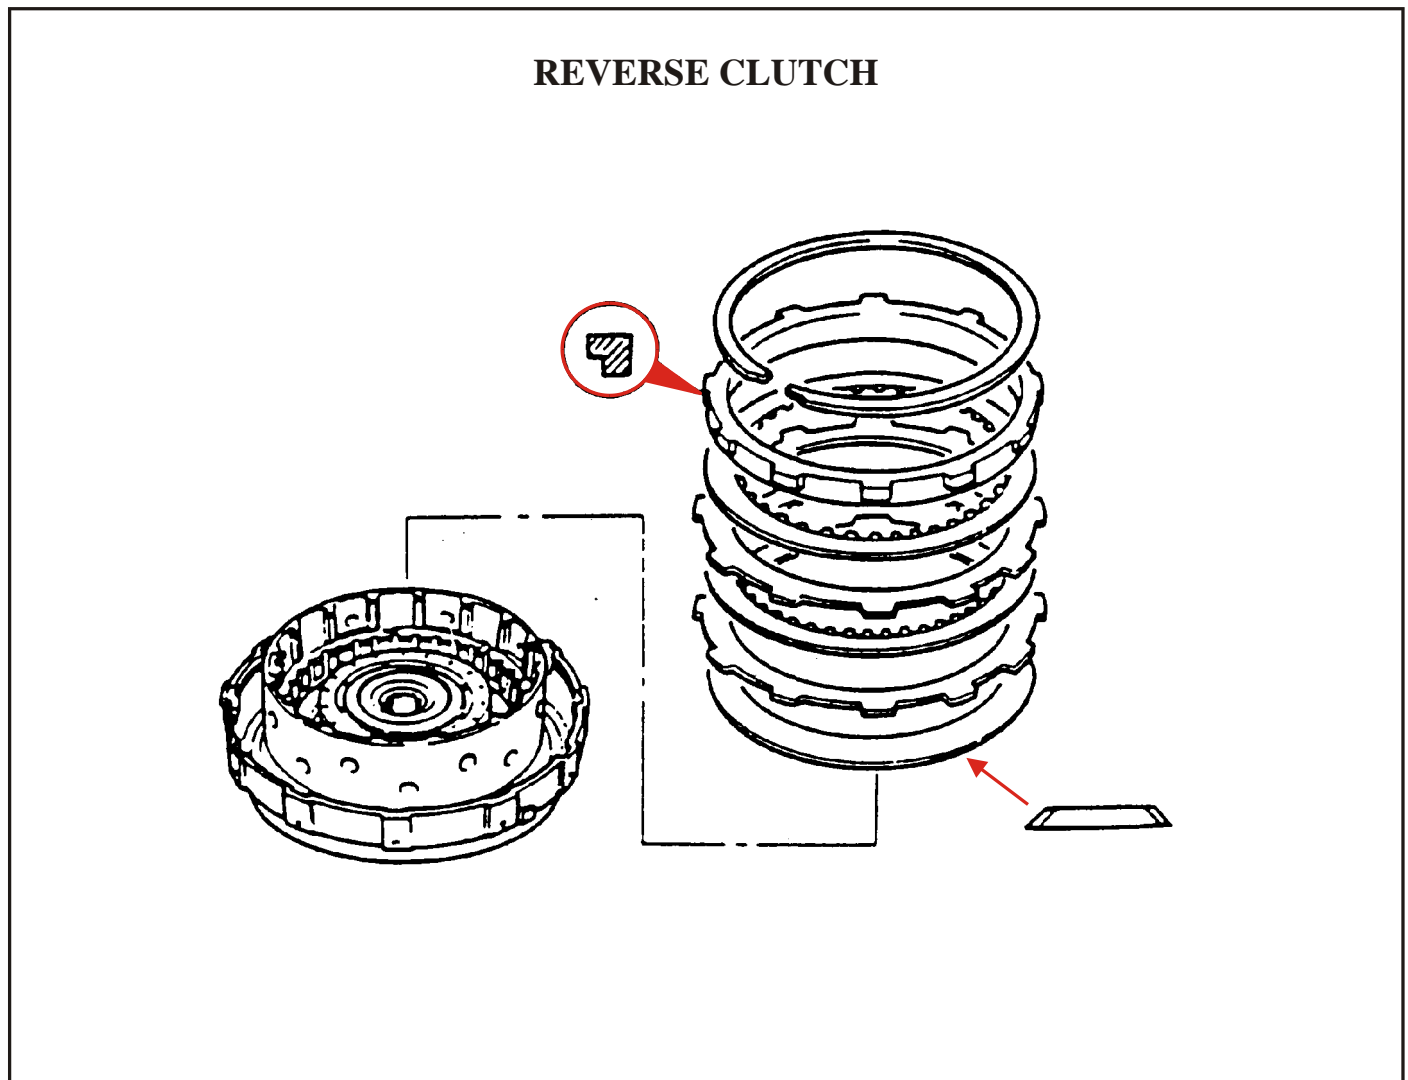
Figure 1

COMPLAINT: Bind up in Reverse.

CAUSE: Dished Plates installed incorrectly.

CORRECTION: Install dished plates as shown below.

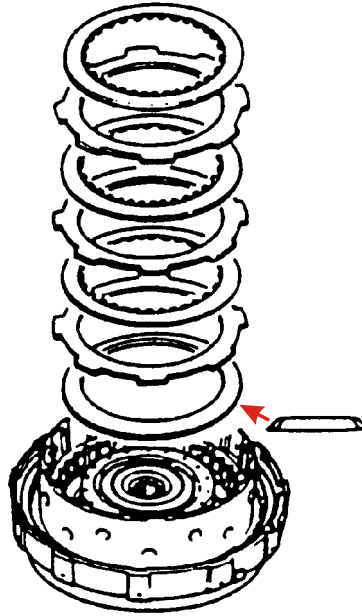
Figure 2

FORWARD CLUTCH

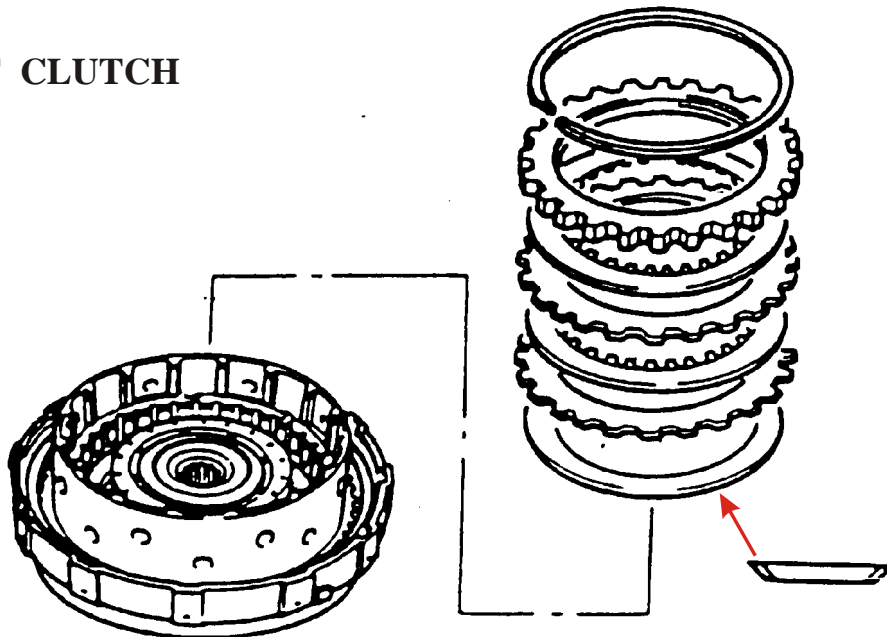
Figure 3

COAST CLUTCH
