"FIXES ARE GREAT IN '98"

INTRODUCTION

AUTOMATIC TRANSMISSION SERVICE GROUP
9200 S. DADELAND BLVD.
SUITE 720
MIAMI, FL 33156
(305) 670-4161

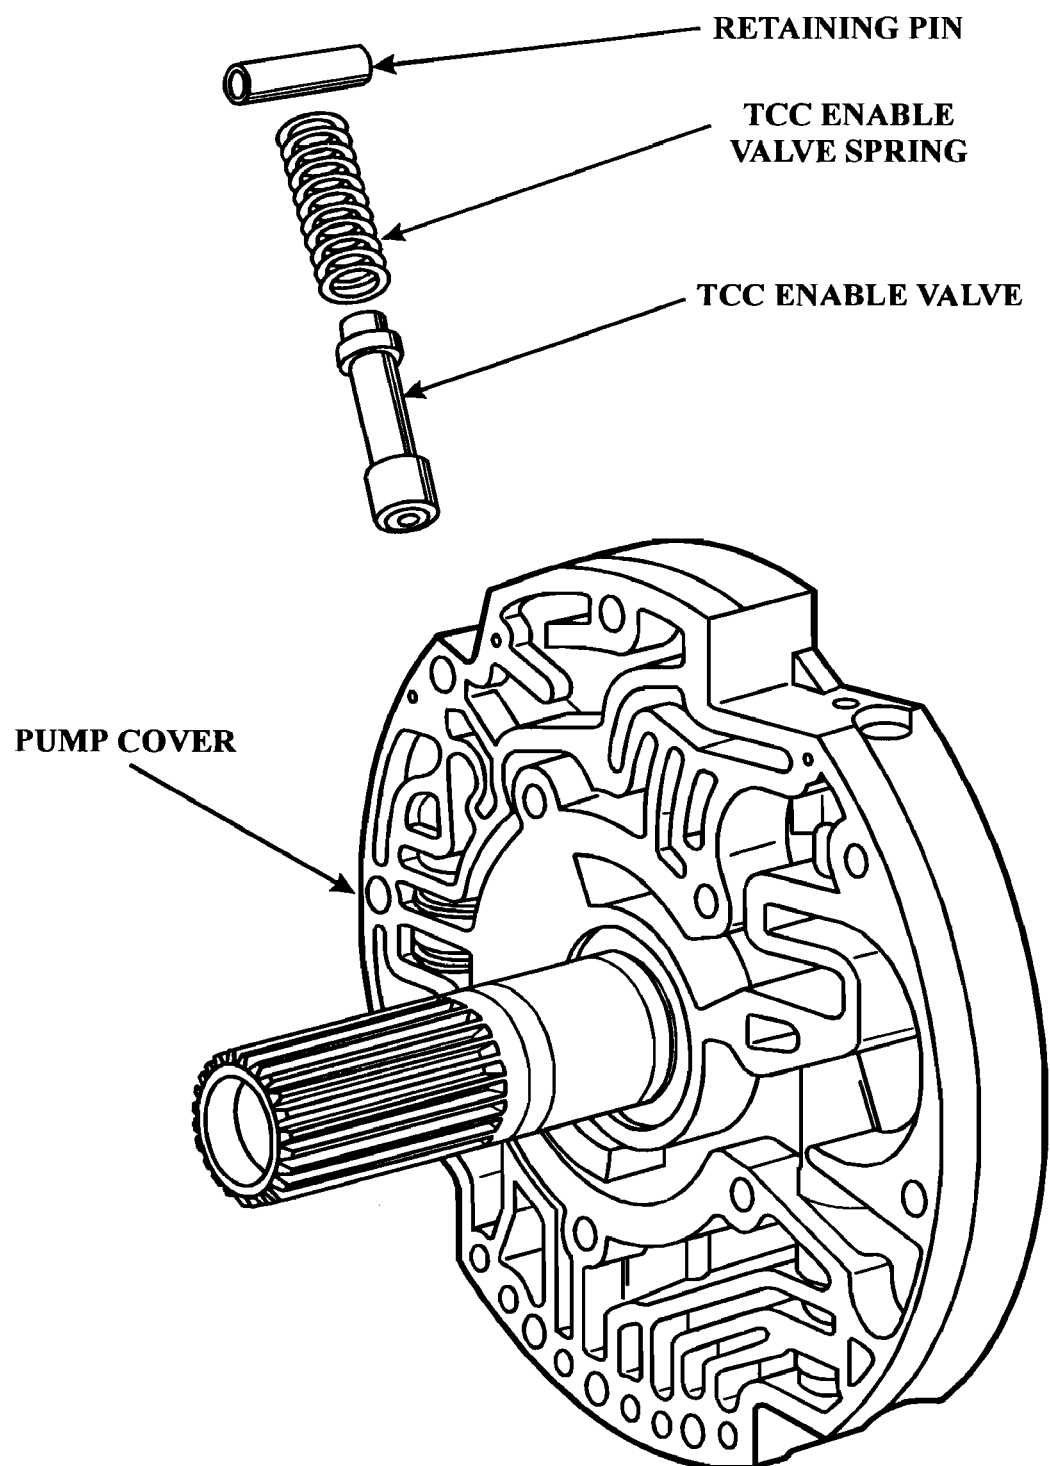
Figure 1

COMPLAINT: After rebuild, the vehicle displays a no converter clutch condition, stores trouble code 68 when the vehicle is driven in the Overdrive gear selector position, and stores trouble code 39 when the vehicle is driven in the "D3" gear selector position.

CAUSE: There are many electrical and mechanical reasons for these codes to be stored. After all of the electrical has been eliminated, the cause may be the TCC Enable Valve, in the pump cover assembly is in backwards.

CORRECTION: Remove the pump assembly and install the TCC Enable Valve in the direction that is shown in Figure 1, and ensure free movement after installation.

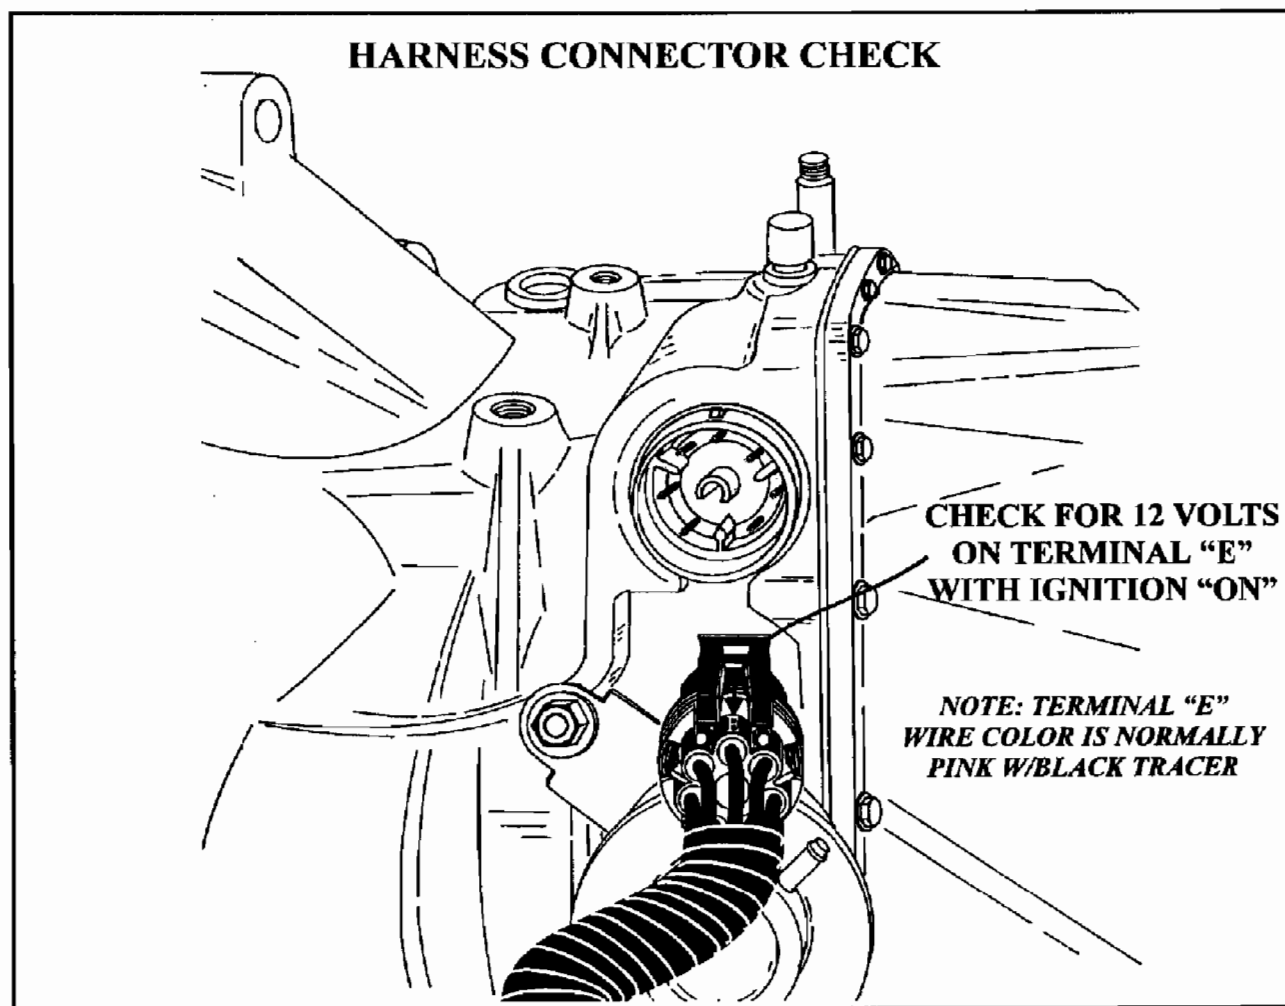
Figure 1

CAUSE: The cause may be, the "Fuse" that supply's the solenoids in the transmission and the Power Steering Pressure Switch with battery voltage may have blown. NOTE: Some years have the transmission solenoids, the EGR solenoid, Brake switch, Canister purge solenoid, Power Steering Pressure Switch and Air conditioning Relay all on the same fuse. A short or wiring problem on any and all of the above may cause the fuse to blow.

CORRECTION: Locate the "E" terminal on the harness connector, shown in Figure 1, and check for battery voltage with the ignition on. If there is NO voltage at terminal "E", refer to Figures 2&3 for fuse location and vehicle application and replace the fuse. NOTE: The fuse in question is highlighted for identification purposes.

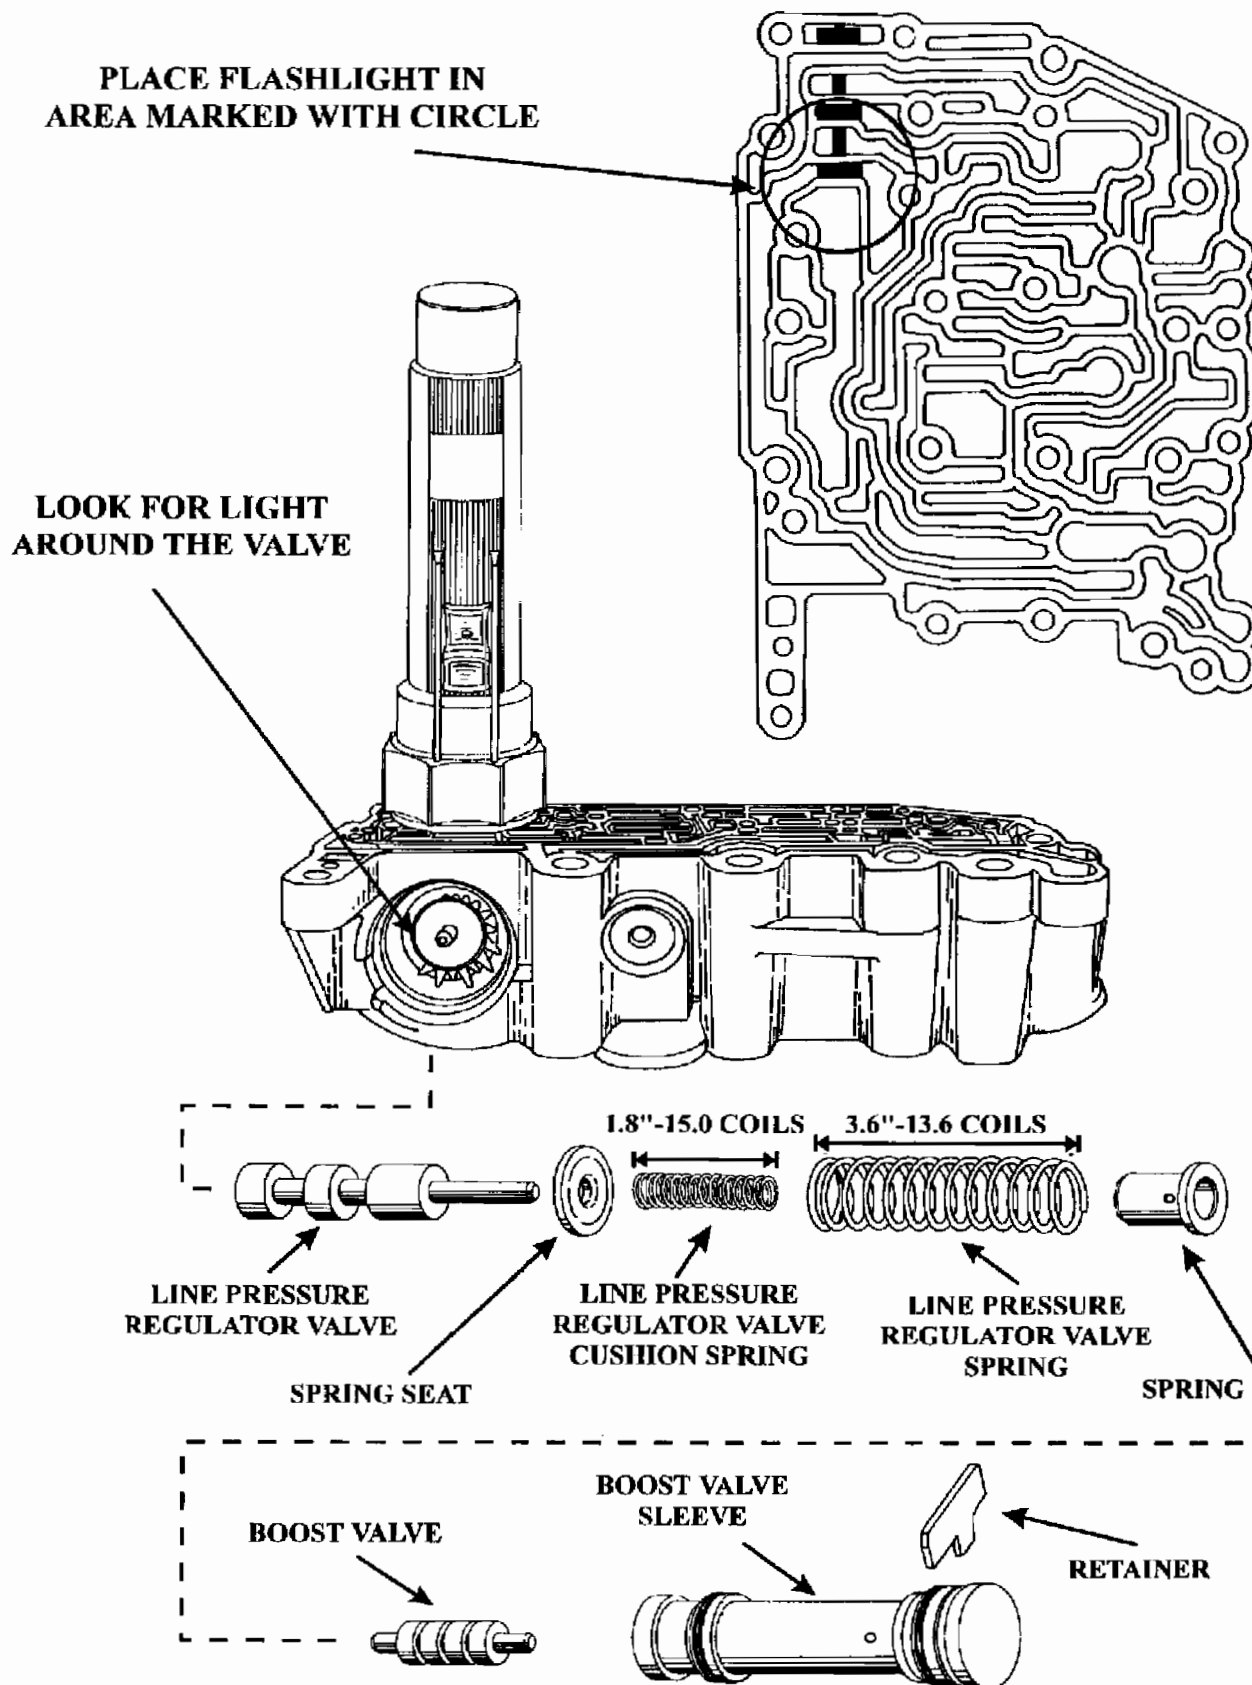
Figure 3

COMPLAINT: 1993 Saturn's, equipped with MP6 or MP7 automatic transaxles, may exhibit "Delayed" and/or "Harsh" engagement's into Reverse, after the vehicle is at operating temperature. Also, there may be repeat failures of the external filter seal, causing fluid loss.

CAUSE: The cause may be,

- A broken "Line Pressure Regulator Valve Cushion Spring."
- "Side to Side" Pressure Regulator Valve bore wear.

CORRECTION: Warm vehicle up to operating temperature. Remove temperature sensor and install a 0-300 psi. pressure gage, as shown in Figure 1. Remove 7.5 amp. Line Pressure Actuator fuse shown in Figure 2. Place selector in Reverse at an *Idle* and ensure that line pressure is not less than 175 psi. If the pressure gage indicates low pressure, remove the valve body and dis-assemble the Pressure regulator valve line up as shown in Figure 3. Locate the Line Pressure Regulator Valve Cushion Spring and inspect it for breakage. If the spring is not broken, reinstall the pressure regulator valve and place a flashlight over the valve body, shown in Figure 3, and look for light peering out between the valve and its bore. If light is seen or the Line Pressure Regulator Valve Cushion Spring is broken, replace the upper valve body with Saturn upper valve body kit, part no. 21005813.

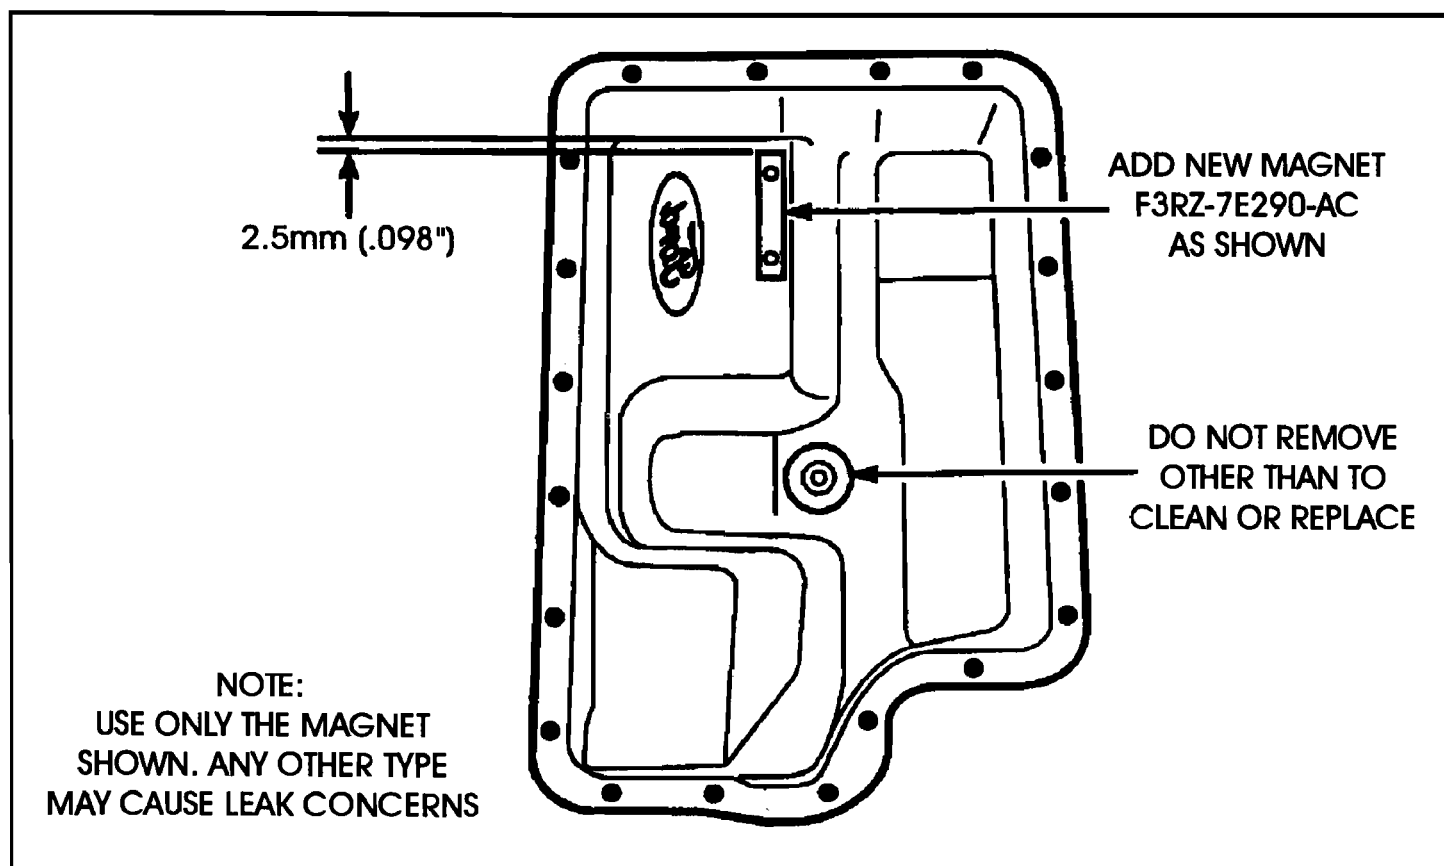
Figure 1

CAUSE: The cause may be, the bottom pan transmission filter falling out of its bore, resulting in air ingested into the pump and lower than normal line pressure, which creates lower than normal converter release pressure.

Transmission Pan Magnet F3RZ-7E290-AC

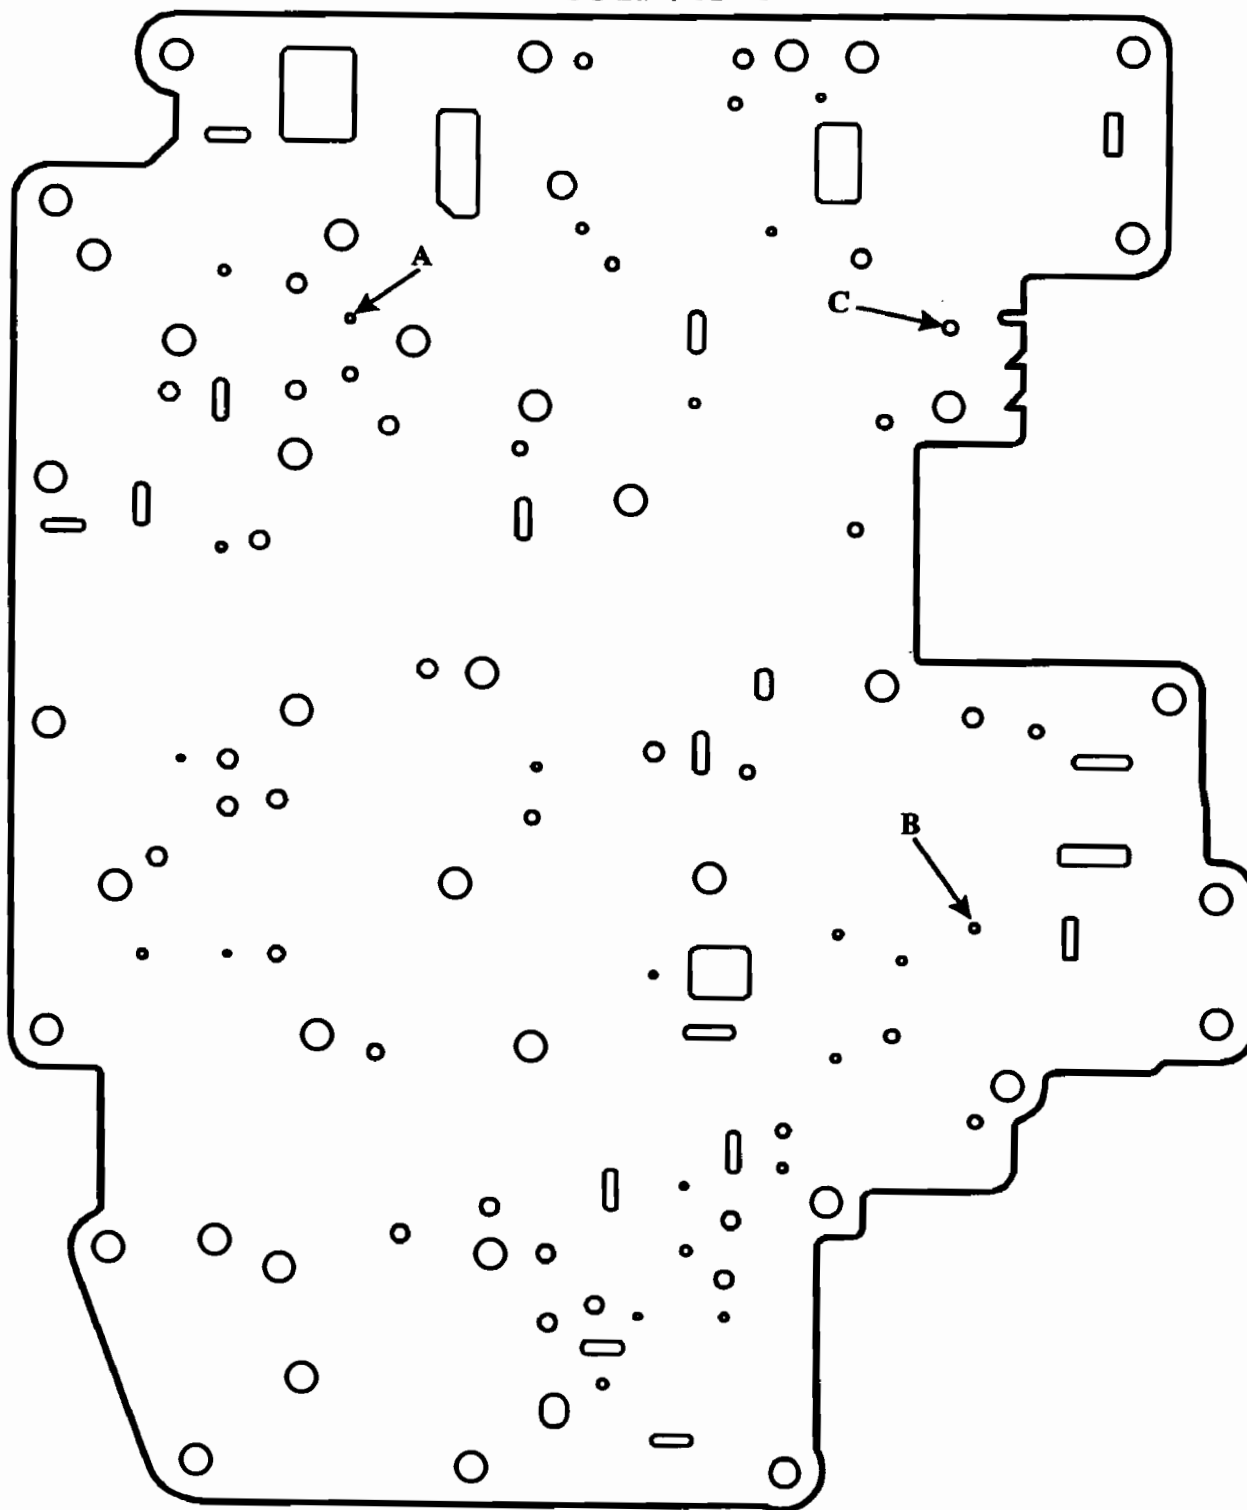
COMPLAINT: Before and/or after rebuild, the vehicle exhibits a converter clutch shudder condition, even with the proper Mercon® transmission fluid installed.

CAUSE: The cause may be, not enough oil to the converter clutch apply circuit.

Restrict the hole marked "C" in Figure 1, to approximately .030" using a cotter key, which ensures that apply oil can overcome this balance circuit.

1. DRILL HOLE MARKED "A" OUT TO .062".
2. DRILL HOLE MARKED "B" OUT TO .062".
3. INSTALL COTTER PIN IN HOLE MARKED "C"
TO REDUCE SIZE TO APPROXIMATELY .030".

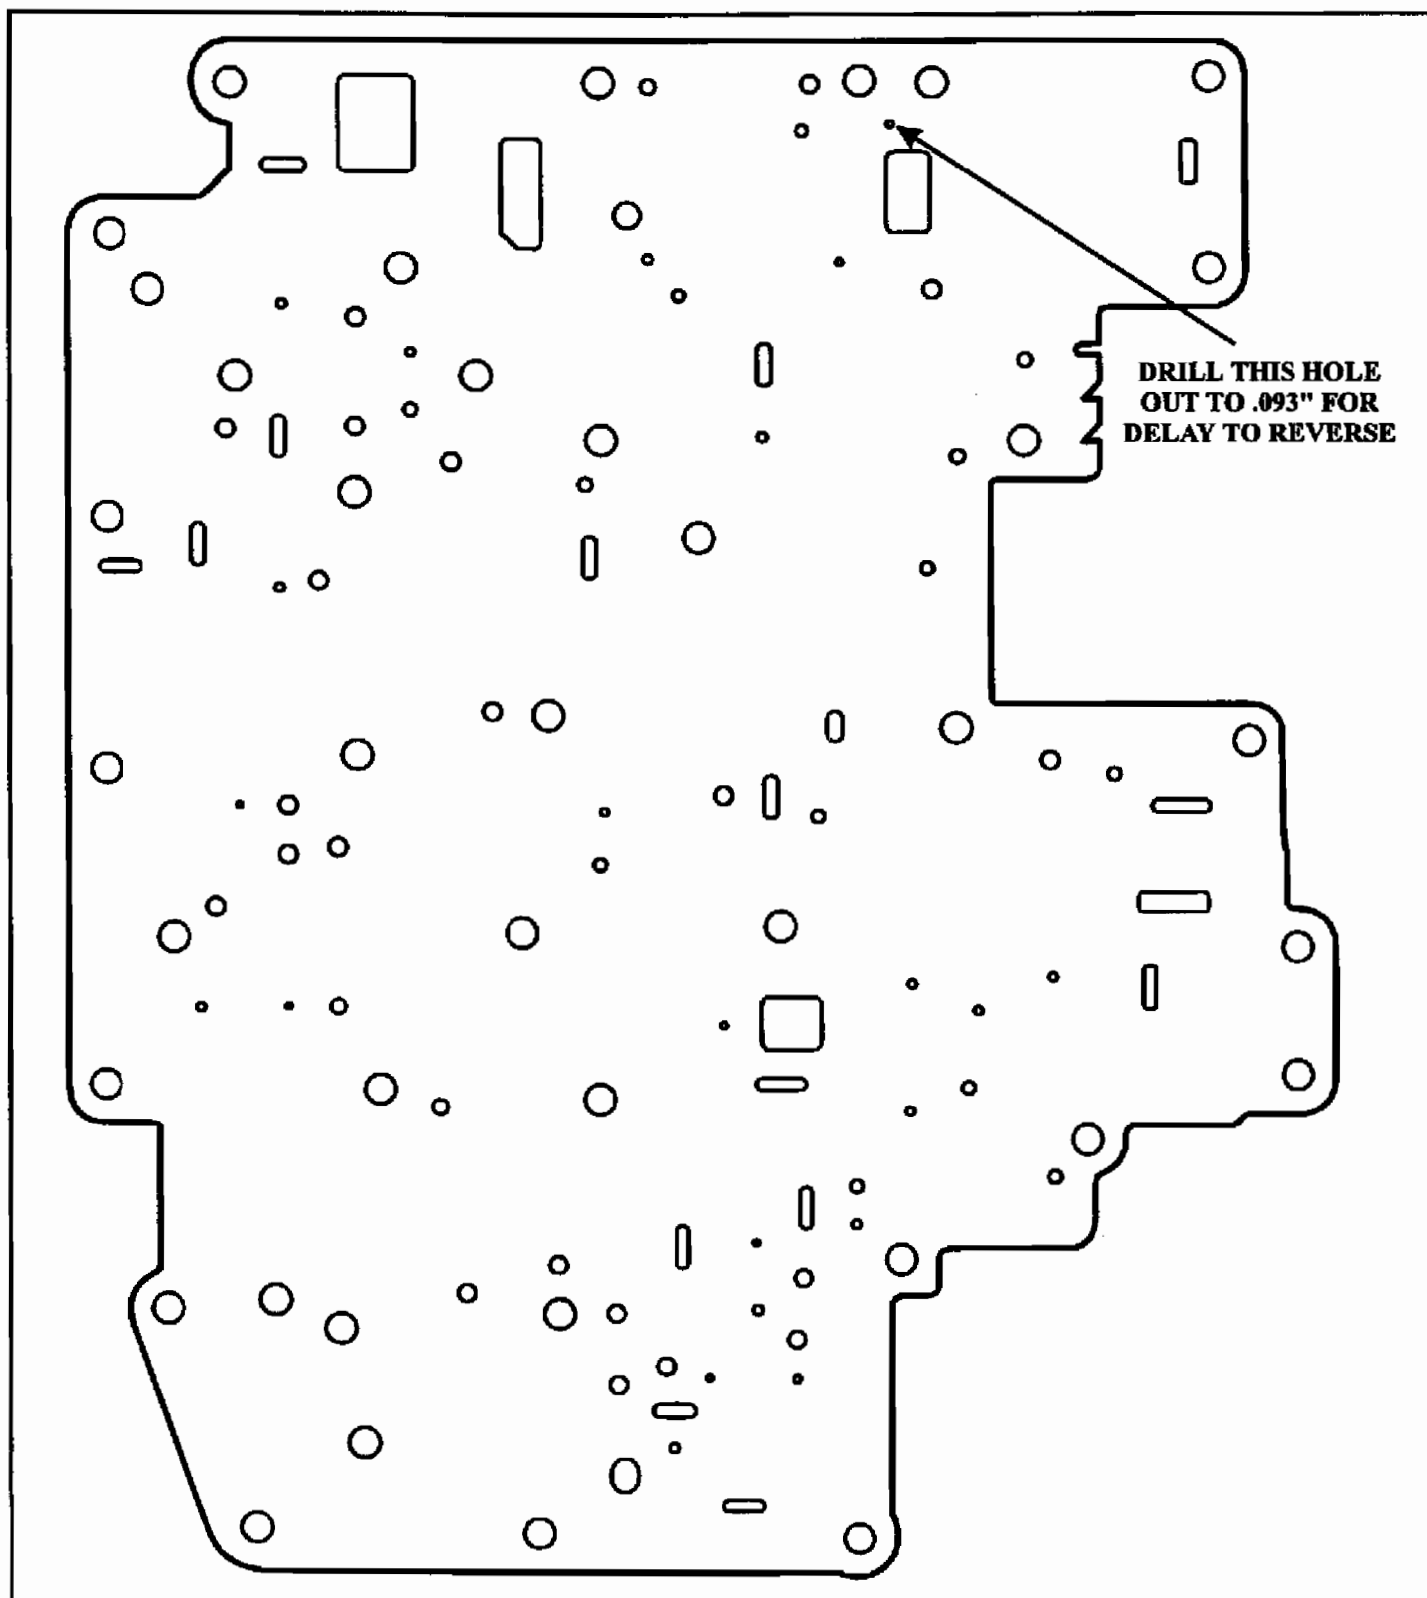
COMPLAINT: Some vehicles equipped with the AODE/4R70W transmission, may exhibit a delay to reverse condition, before and/or after rebuild.

CAUSE: The cause may be, not enough volume of oil to the reverse input clutches.

CORRECTION: Drill the hole in the spacer plate that is shown in Figure 1 out to .093" to increase the volume of oil to the reverse input clutches, and correct the delay to reverse.

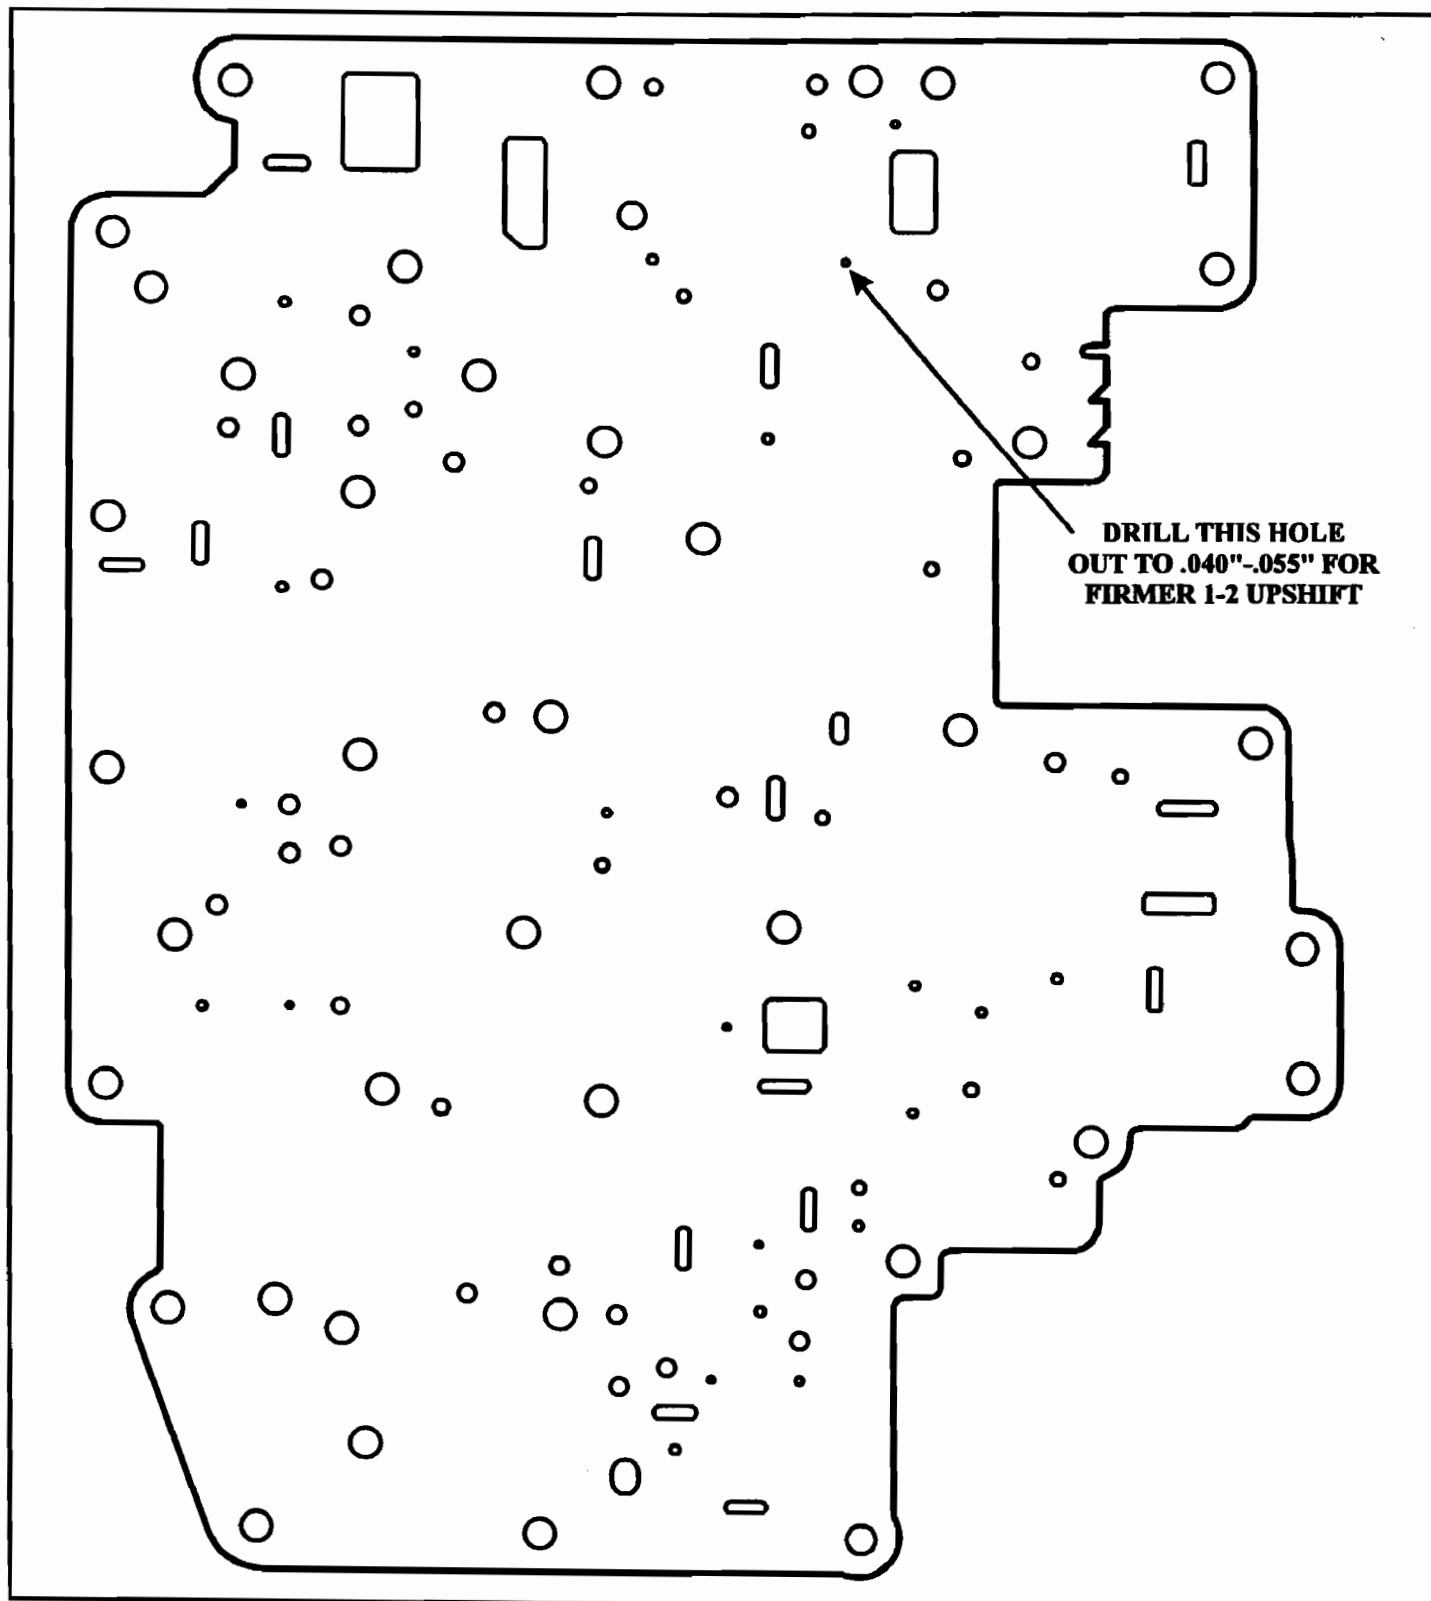
Figure 1

CAUSE: The cause may be, not enough volume of oil to the intermediate clutch pack.

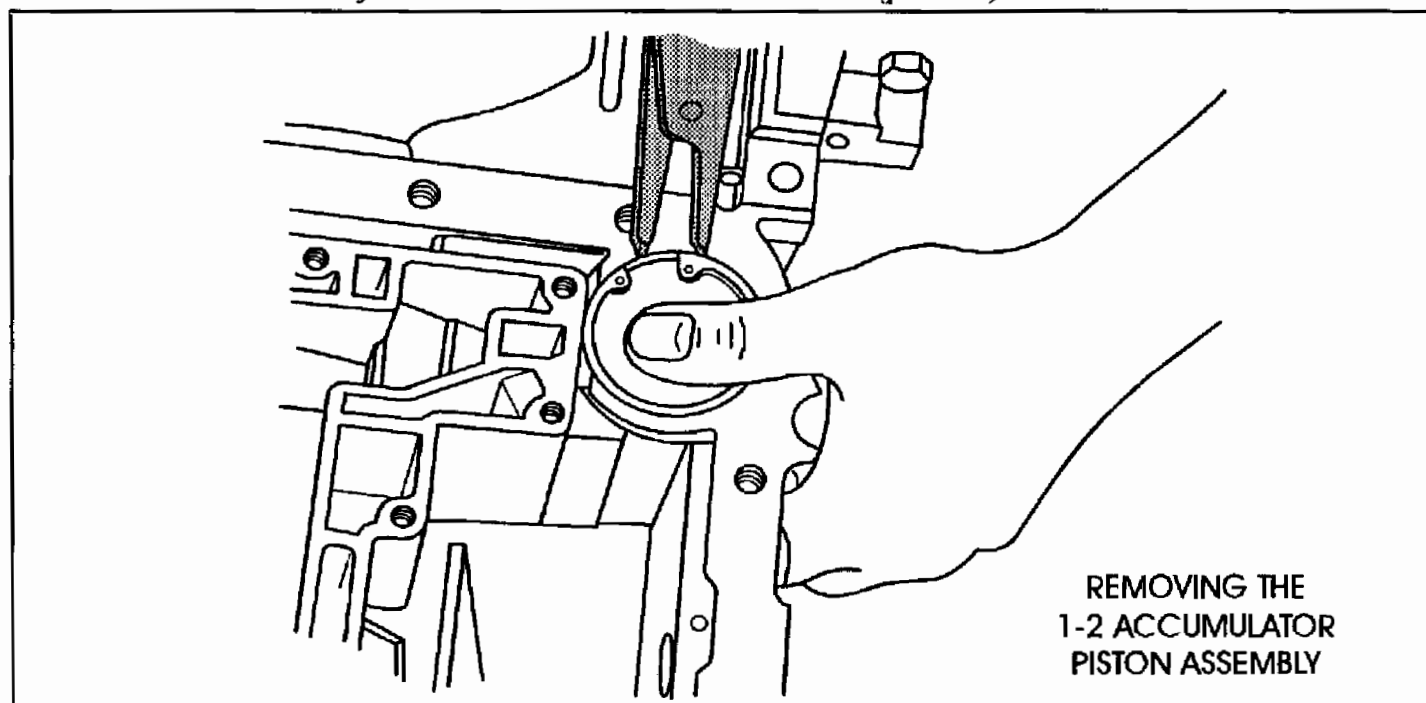
Figure 1

COMPLAINT: Before and/or after rebuild, the vehicle exhibits a slipping condition on the 1-2 upshift, and sometimes will not be displayed until some miles have been put on the vehicle.

CAUSE: The cause may be, premature 1-2 accumulator seal wear, which also creates the case accumulator bore to become scuffed, which leads to the loss in the 1-2 shift.

1-2 Accumulator Piston (New Design)	F7AZ-7F251-AA
1-2 Accumulator Spring, Bottom, (Purple)	F3LY-7F284-A
1-2 Accumulator Spring, Bottom, (Pink)	F4UZ-7F284-A
1-2 Accumulator Spring, Bottom, (Violet)	F7AZ-7F284-BA
1-2 Accumulator Spring, Top, (White)	F7AZ-7F284-AA
1-2 Accumulator Spring, Top, (Dk. Blue)	F7AZ-7F284-CA
1-2 Accumulator Spring, Top, (Lt. Blue)	F75Z-7F284-AA
1-2 Accumulator Spring, Top, (Brown)	F75Z-7F284-BA

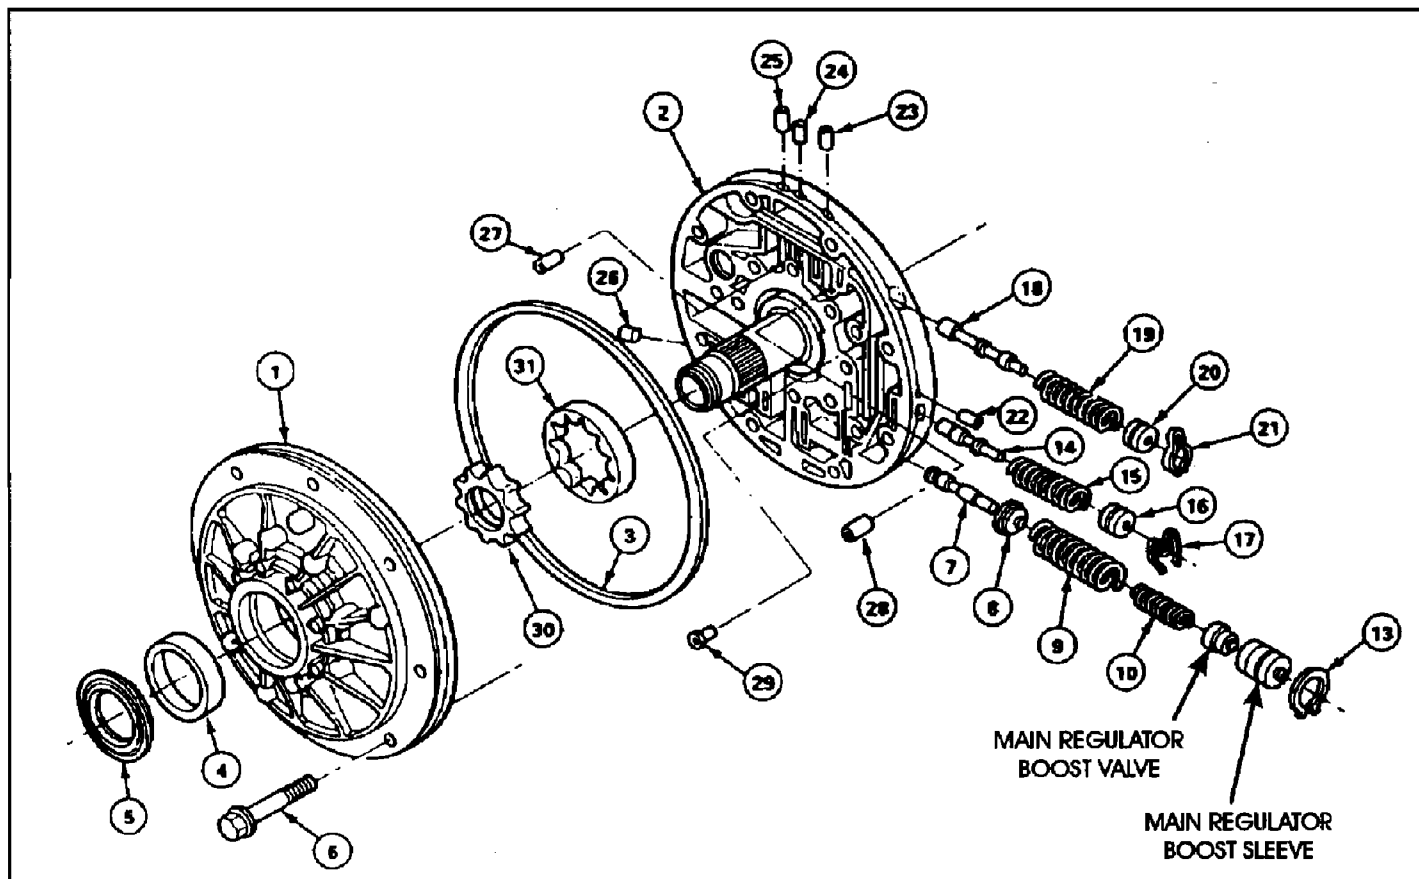
There is now available from Ford Motor Company, a pressure regulator boost valve and sleeve assembly for the E4OD transmissions. When servicing the E4OD transmission inspect the main regulator boost valve and sleeve assembly for any signs of wear, and replace as necessary with part number E9TZ-7D003-AA. Refer to Figure 1 for the location in oil pump cover, and to Figure 2 for proper assembly.
