Technical Service Information

THM 3T40 (125C) SLIP IN REVERSE/NO REVERSE

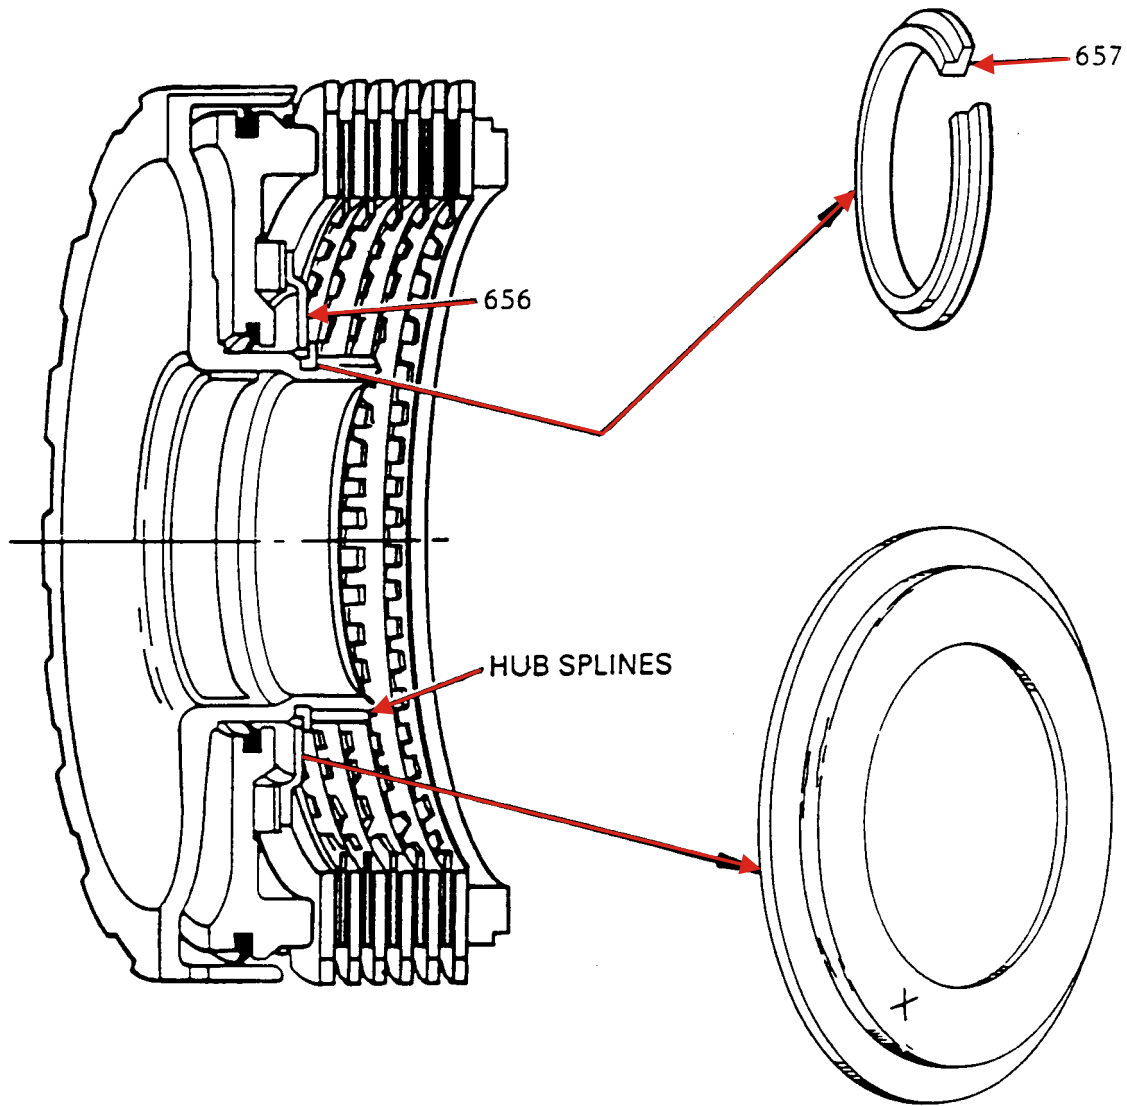
Figure 1

CAUSE: The cause may be, the Lo/Reverse snap ring installed improperly, or a mis-match of the Lo/Reverse clutch retainer. If the snap ring is installed backwards, the retainer may limit the travel of the Lo/Reverse clutch piston.

NOTE: LO/REVERSE CLUTCH SPRING RETAINER WITH THE "X" STAMPED ON IT MUST BE USED WITH THE STEPPED SNAP RING

CORRECTION: Insure that the Lo/Reverse snap ring is installed properly, with the step positioned toward the Lo/Reverse clutch retainer, as shown in Figure 1. The snap ring must rest inside the retainer bore to allow for proper piston travel. The only Lo/Reverse clutch spring retainer that is compatible with the "Stepped" snap ring has an "X" stamped on it as shown in Figure 1.
