MAZDA G4A-EL NO REVERSE OR DRIVES IN NEUTRAL

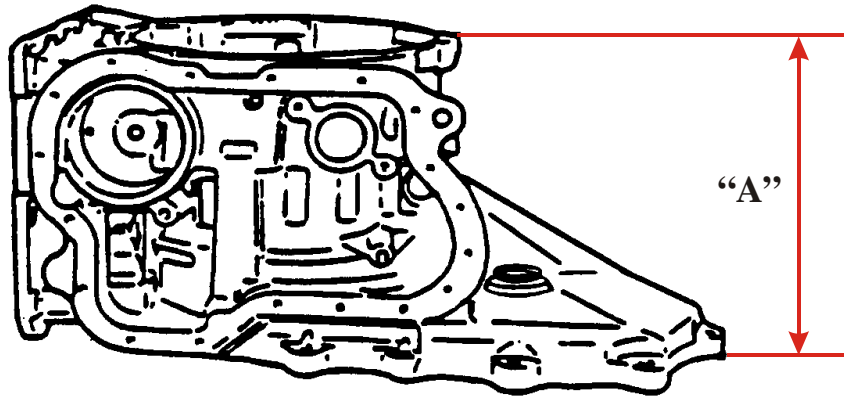
COMPLAINT: Vehicles equipped with G4A-EL transmissions may exhibit a no Reverse, Drives in Neutral, or a sensation of two ranges being applied at the same time or "Binding Up" on engagements or upshift's after replacing the "Valve Body" or rear "Case" half.

CAUSE: The cause may be a mismatched "Manual Valve" to "Case."

DIMENSION "A"= 8 INCHES ON 2.2 "NON-TURBO" MODELS

DIMENSION "A"= 8.250 INCHES ON 2.2 "TURBO" AND 3.0L MODELS

DIMENSION "A"=THE DISTANCE BETWEEN THE PUMP AND CASE MATING SURFACES

CORRECTION: Refer to Figure 1 to correctly identify and match 2.2 Turbo, 3.0L, and 2.2 Non-Turbo "Manual Valve" and rear "Case" dimensions. Install the proper "Manual Valve" for your application.
