Technical Service Information

ACURA/HONDA DIFFERENTIAL CROSS SHAFT FAILURE

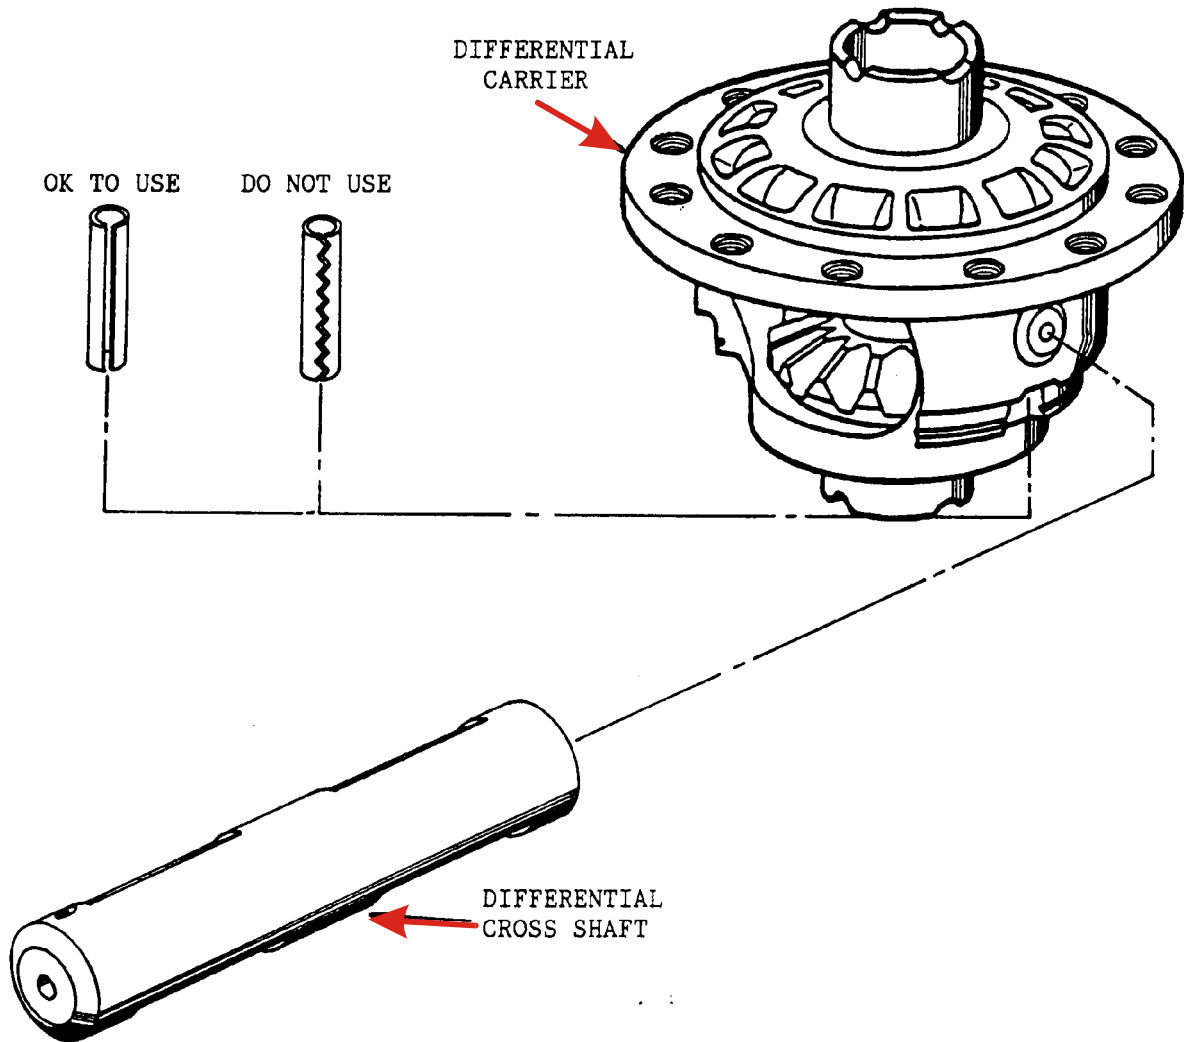
COMPLAINT: Failure of the differential cross shaft that resembles a lubrication failure, in the area of the cross shaft where pinion gears rotate.

CAUSE: The cause may be the material from which the cross shaft was made.

CORRECTION: There is now available from Honda, two new design differential cross shafts made of Titanium, that will eliminate the above complaint and should be installed during routine overhaul (See Figure 1). The rolled pin that retains the cross shaft in the differential carrier should also be replaced with a different design. The original rolled pin, with the split that resembles a "Zipper" (Figure 1), should NEVER be used. ALWAYS replace it with a regular split type rolled pin of the proper dimension.

Refer to the chart in Figure 1 for the dimensions and part numbers for the new design differential cross shafts.
