Technical Service Information

FORD E40D NO UPSHIFT, COMPUTER COMMANDS OK

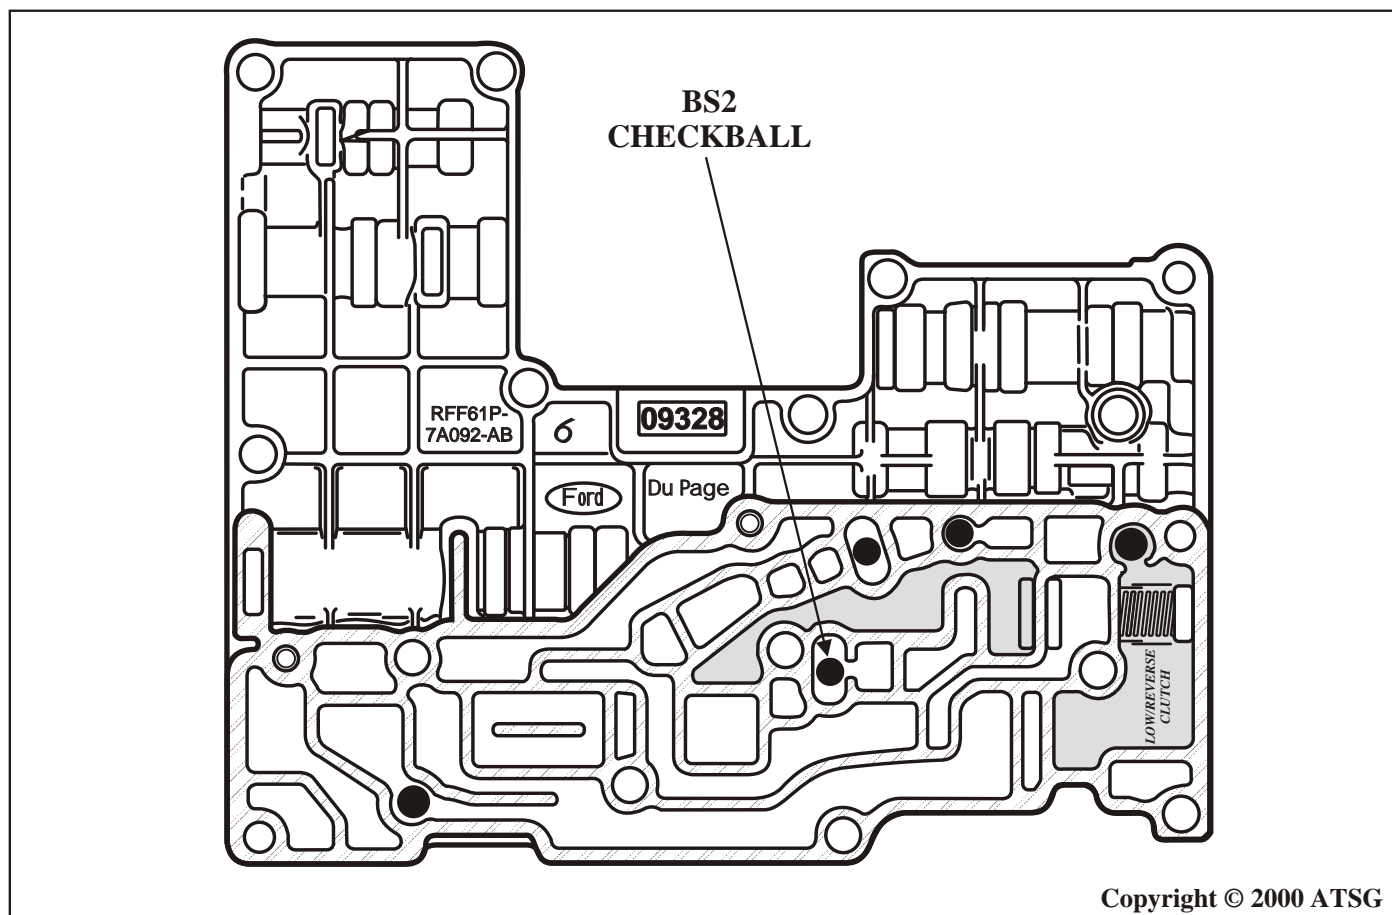
Figure 1

COMPLAINT: Some 1996 and later Ford Motor Company vehicles that are equipped with the E40D Transmission, before or after overhaul may exhibit a no upshift condition with the shift selector in Drive.

CAUSE: After determining that the PCM is commanding the transmission to make the upshifts, the cause may be that the BS2 Checkball, located in the Main Valve Body is missing. See Figure 1.

CORRECTION: Install the ¼ in. Green Rubber Checkball in the location as shown in Figure 1.

Green ¼ in. Checkball.....F6TZ-7E195BB
