Technical Service Information

THM 4L60 (700-R4) SECOND GEAR STARTS

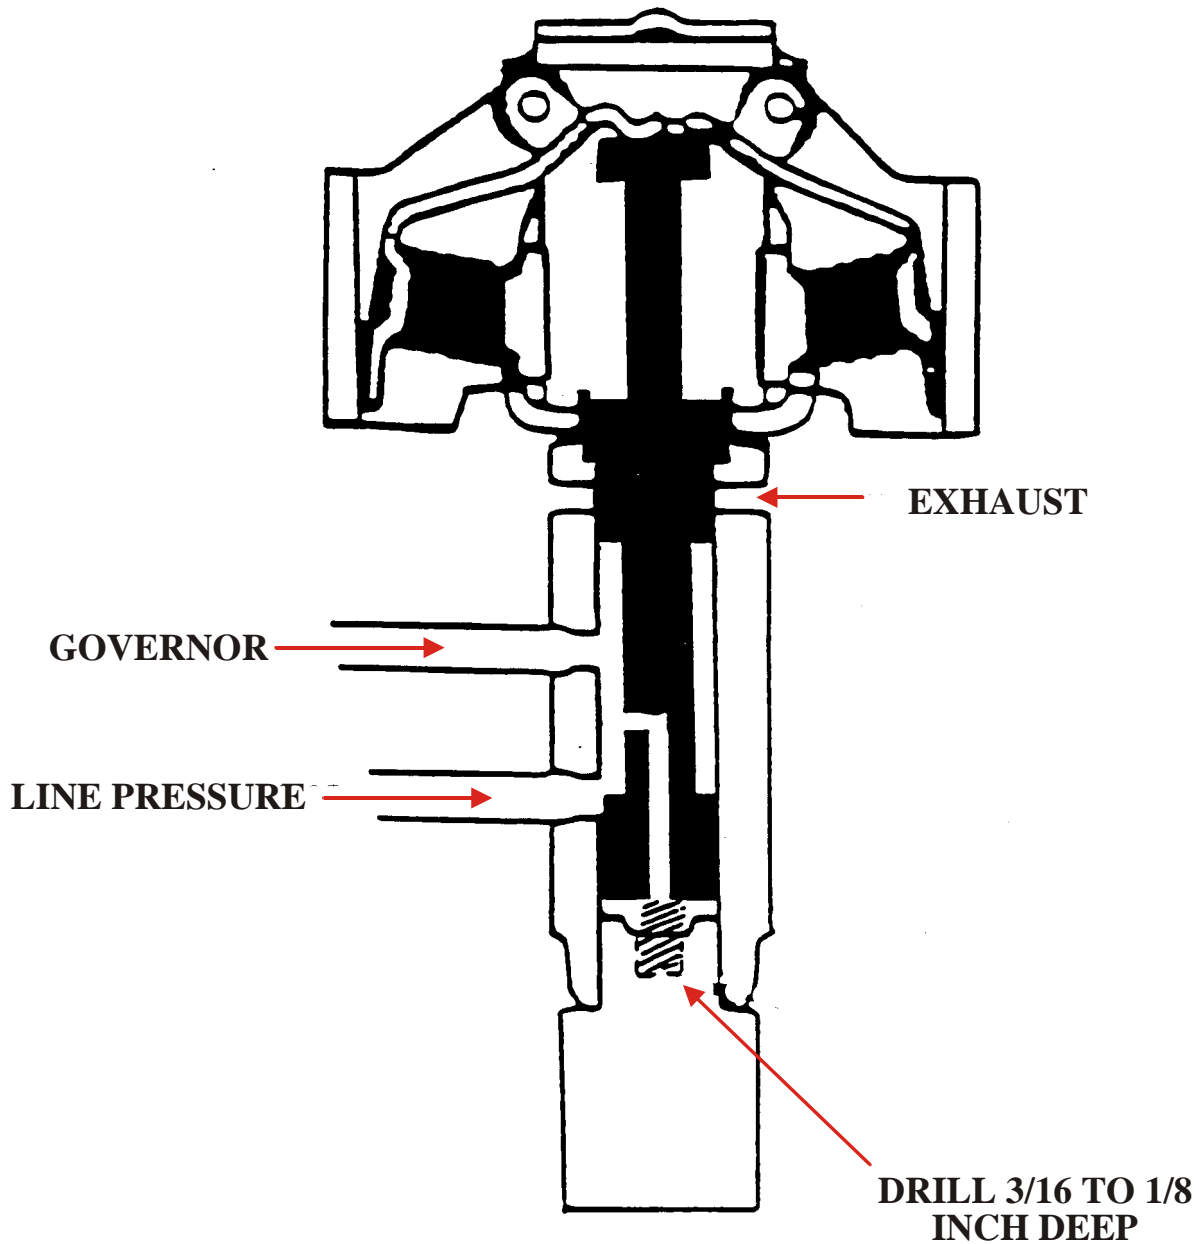
COMPLAINT: Second gear starts or a clunk when shifting from second back to first on a coast down to a stop.

CAUSE: The cause may be a slight cross leak in the case or valve body. If the valve body is suspect, exchange and try another. In most instances, changing case is more work than the problem deserves.

CORRECTION: A modification can be made that will compensate for minor cross leaks in the governor circuits.

- (1) Remove governor assembly
- (2) Remove governor gear
- (3) Using a 3/16 drill bit, drill a shallow hole on the end of the plastic gear that fits into the governor. About an 1/8 of an inch deep.
- (4) Insert a 200 governor spring into the hole and reinstall the gear so that the spring will be pushing on the governor valve.
- (5) Reinstall the governor and test drive.

You should notice the minimum throttle 1-2 shift is a little later, but the clunk is gone. By varying the weight of the spring, we can lower or raise the minimum 1-2 shift speed without adversely affecting the other shift points, and eliminating the coast down clunk.
