Technical Service Information

THM 4L80-E CONVERTER CLUTCH SHUDDER

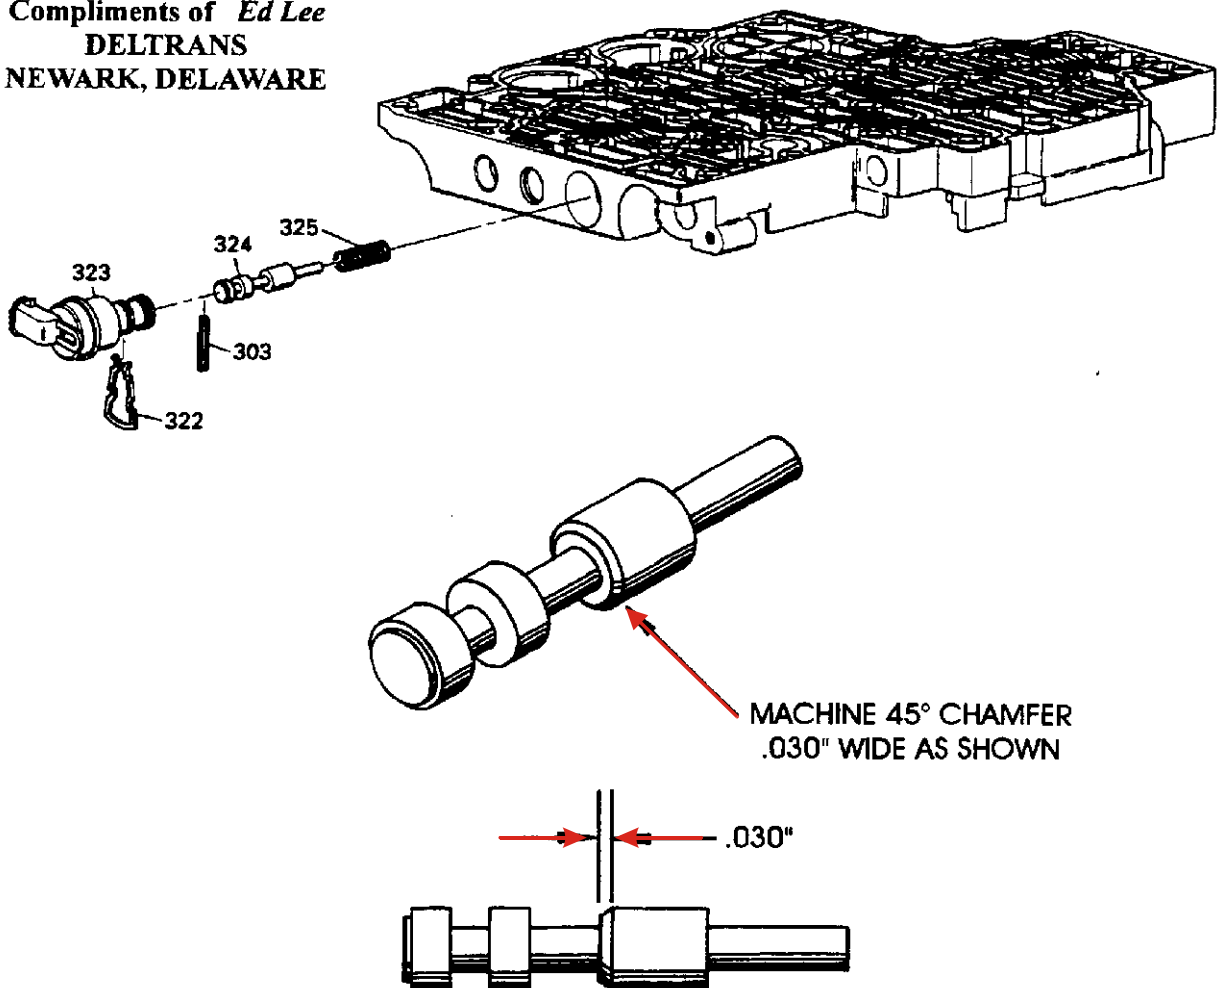
Figure 1

- COMPLAINT:** Before and/or after rebuild, the vehicle displays a Converter Clutch Shudder condition as the torque converter clutch is applying.
- CAUSE:** The cause may be, an inadequate amount of "Regulated Apply" oil to the converter.
- CORRECTION:** Machine a 45 degree chamfer that is .030" wide, on the TCC Regulator Apply Valve, on the land that is shown in Figure 1. This will allow more line pressure in to the TCC regulated apply circuit. Do not machine any wider than .030".
