Technical Service Information

THM 440-T4 DELAYED 2-3 SHIFT

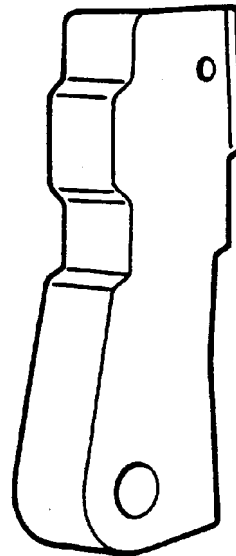
Figure 1

A long and/or delayed 2-3 shift on THM 440-T4 transaxle may be caused by a leaking 3rd clutch inner seal (Figure 1, Item 635A). A new, thicker seal is used in production and available for service replacement. The new seal can be recognized by a small group of hash marks on the inside diameter of the seal.

**INSPECT FOR
DENT OR ROUGH
METAL FINISH
IN THIS AREA**
