Technical Service Information

THM 4L60 (700-R4) BINDING OR TIE-UP IN REVERSE

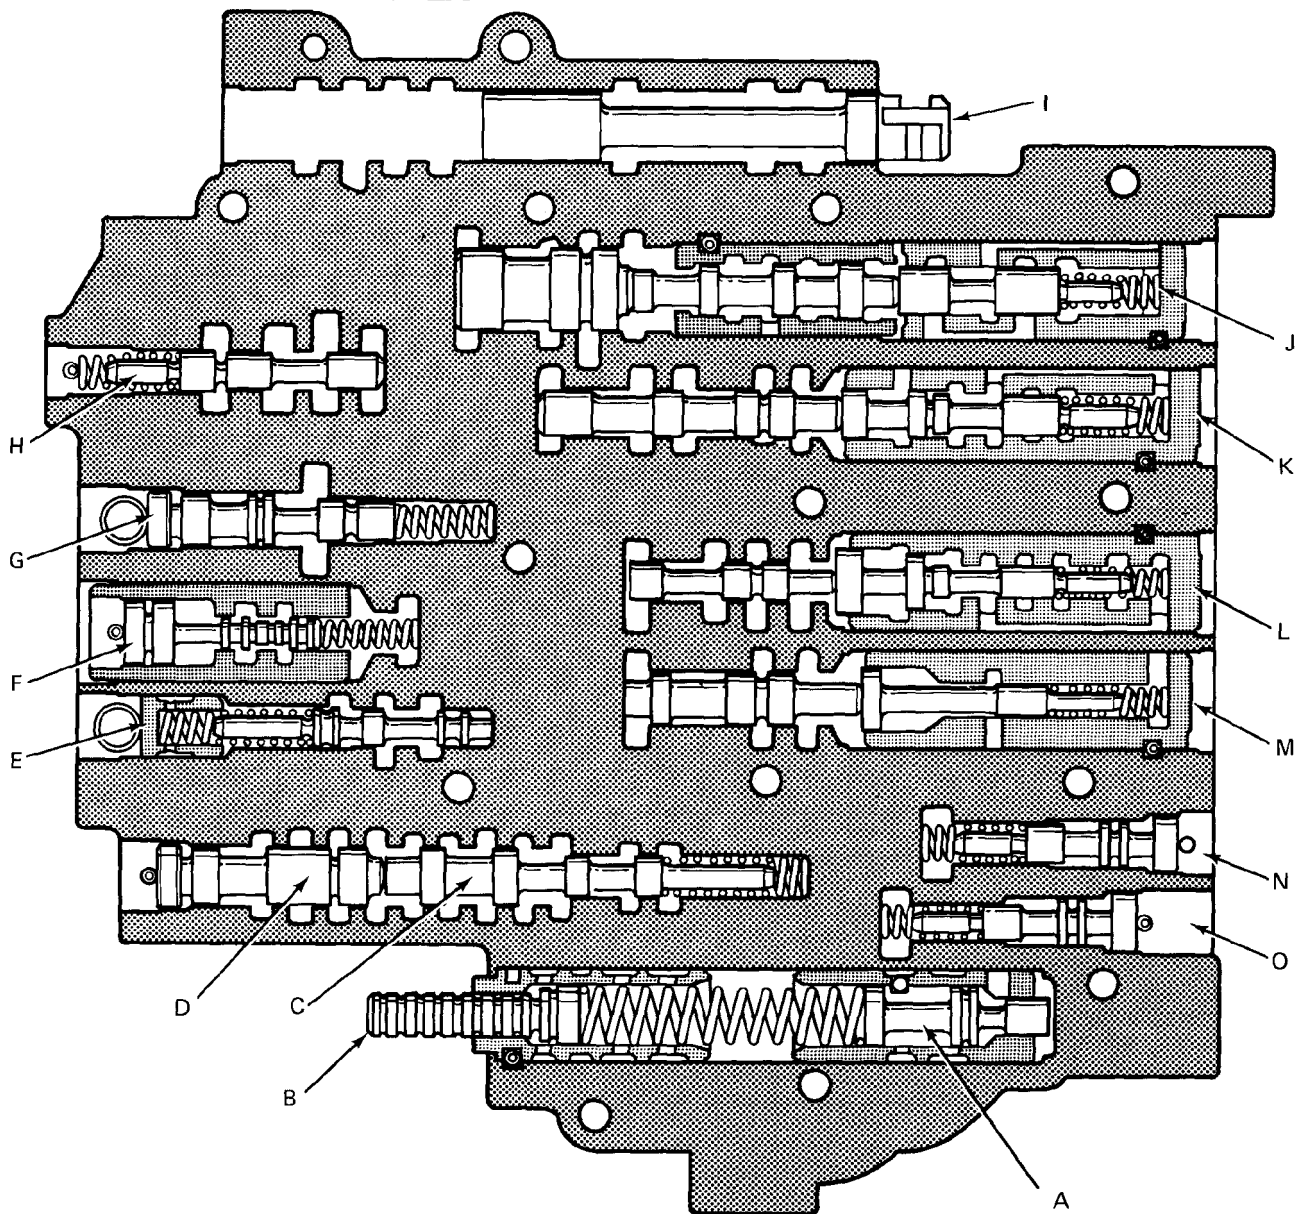
- COMPLAINT:** Any 1982 thru 1989 THM 700-R4 transmission that may exhibit a binding condition when reverse is selected.
- CAUSE:** The cause may be a stuck 4-3 sequence valve and/or a stuck 2-3 shift valve, both of which are located in the main valve body (See Figure 1).
- CORRECTION:** Inspect the 4-3 sequence valve and the 2-3 shift valve for sticking, and for debris present in the valve train. Clean and correct as necessary. Refer to Figure 1 for proper installation of valves and sleeves in valve body bores.

**ALUMINUM BUSHING PLUGS MAY BE
FOUND IN BORE "M" ON SOME
ECM MODELS**
