# Technical Service Information

## FORD ATX DELAYED OR NO 1-2 SHIFT

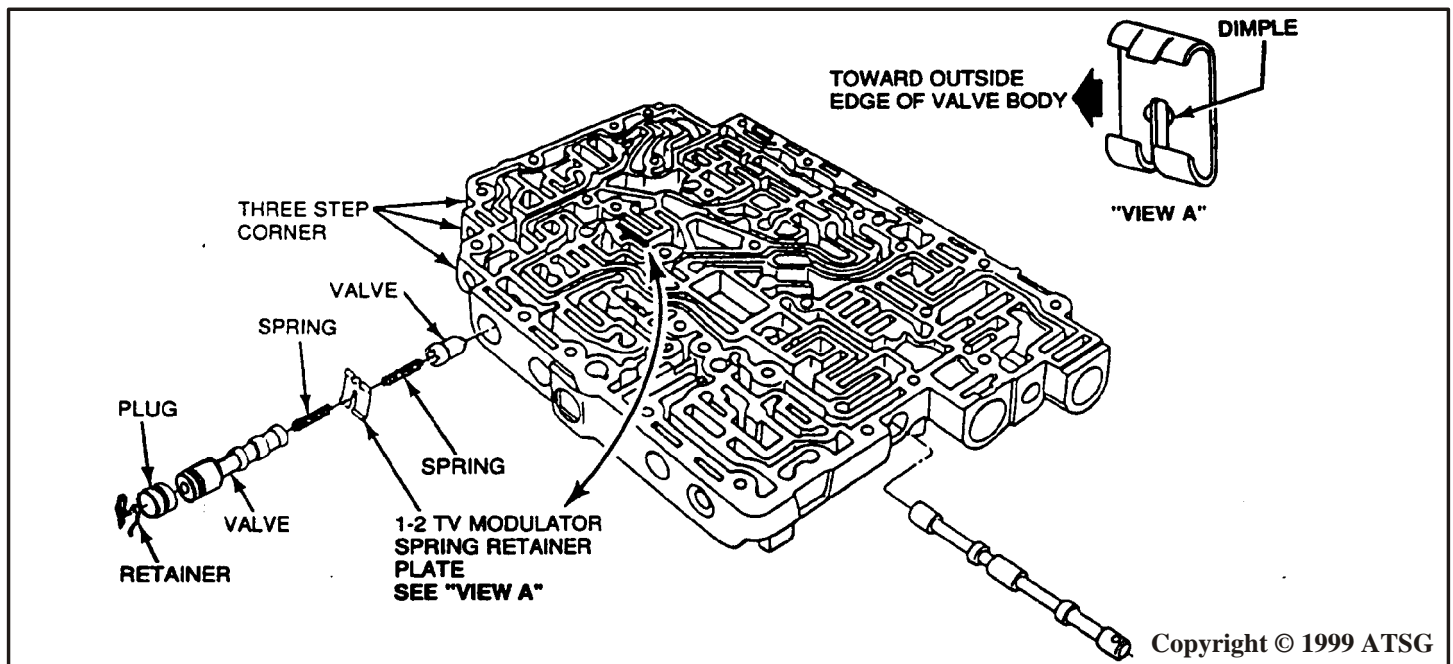
Figure 1

**COMPLAINT:** Some 1987-1990 Escort, Taurus, and some 1987-1993 Tempo vehicles may exhibit an intermittent or no 1-2 upshift, or a delayed (Higher Than Normal) 1-2 upshift. This condition usually occurs during the initial drive away after extended or overnight parking, and may correct itself and perform normally after warming up.

**CAUSE:** The cause may be the TV modulator spring turning around in the 1-2 shift bore in the valve body.

**CORRECTION:** Install a new design TV modulator spring retainer plate, OEM number F23Z-7F194-A, which has a "Dimple" on the retainer to prevent the spring from turning around in the bore. The dimple goes toward the outside edge of valve body, and the proper location are both shown in Figure 1. The dimple will now keep the spring centered in the valve body bore.
