Technical Service Information

THM 4L60 (700-R4) NO 4TH GEAR

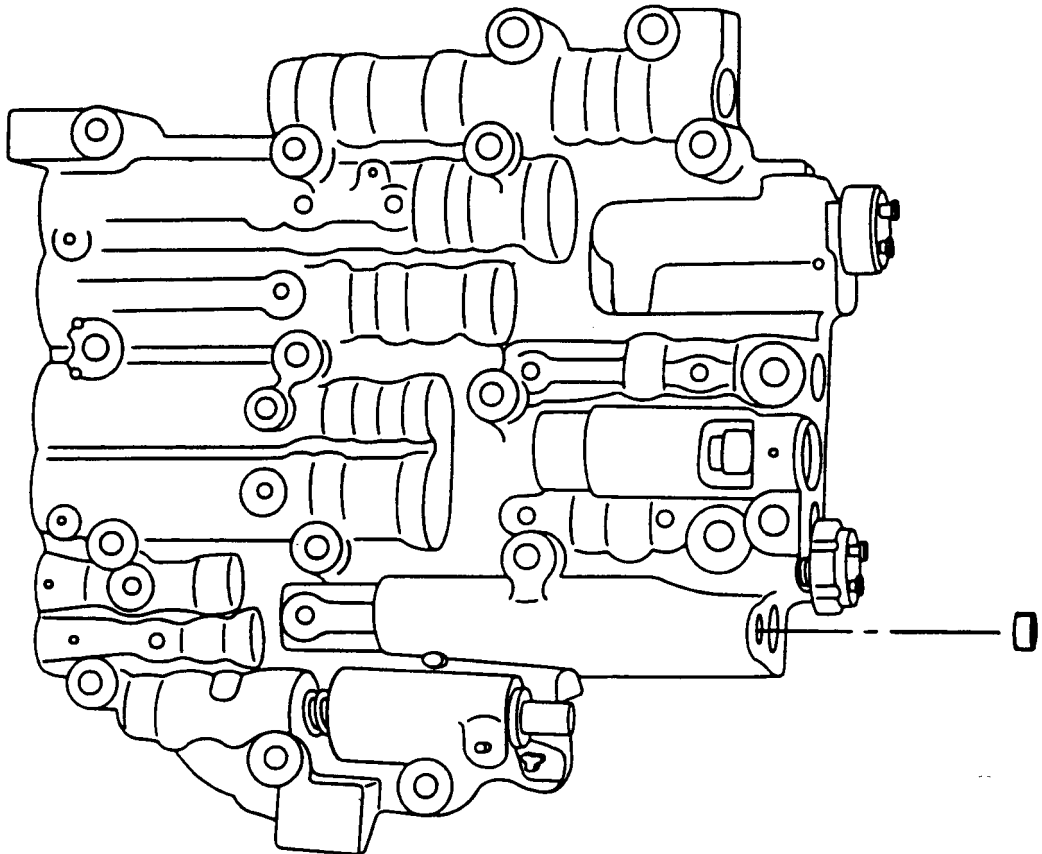
Figure 1

COMPLAINT: No 4th gear; 2nd and 4th pressure lower than line pressure.

CAUSE: The cause could be the cup plug missing from the servo feed passage in the valve body (See Figure 1). The cause may also be the bleed orifice cup plug missing from the case in the bottom of the 3-4 accumulator bore (See Figure 2).

CORRECTION: Install cup plug. OEM Part Number for bleed orifice cup plug is 8628864.
