# Technical Service Information

## THM 4L60 (700-R4) PREMATURE INPUT CLUTCH FAILURE

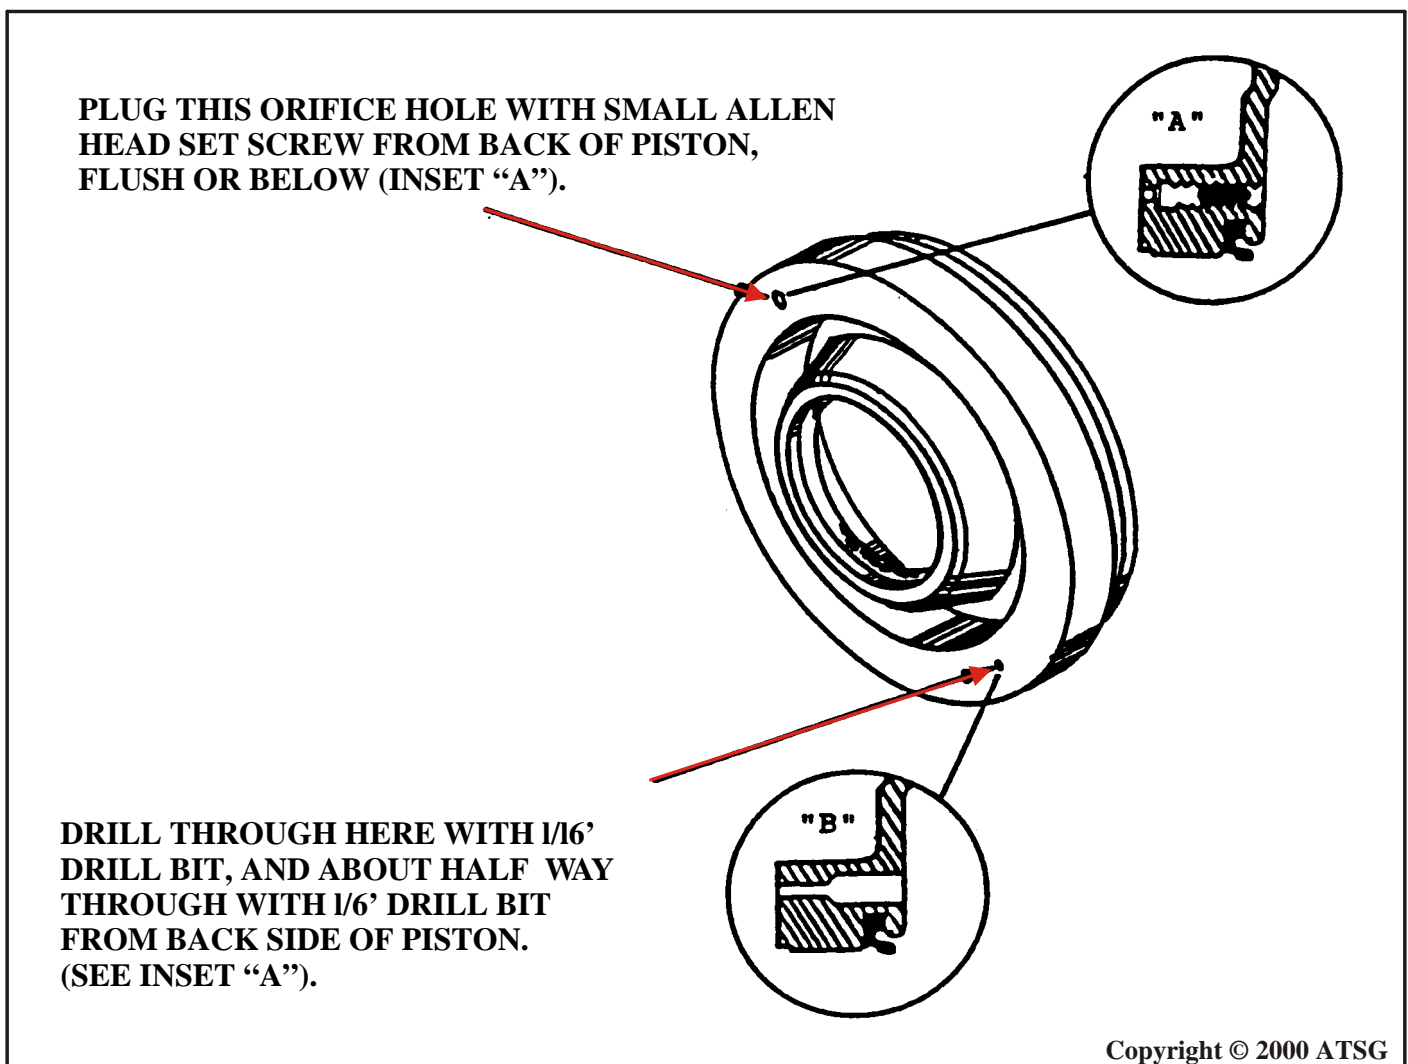
Figure 1

**COMPLAINT:** Premature reverse input clutch failure on 1987 or 1988 models only.

**CAUSE:** The cause may be the orifice hole in the new aluminum piston, drilled too large (Original was .116").

**CORRECTION** Plug the original hole from the back side of piston with an allen head set screw, flush or below. Retain the set screw with Lot-tite (See Figure 1, Inset "A").

180 degrees from original orifice hole you will find a hole started but not drilled through. Drill through here with a 1/16" drill bit, from the front side of the piston. Turn the piston over and from the back side of piston, drill about half way through with a 1/8" drill bit (See Figure1 Inset "B").
