CHRYSLER A500SE(42RE) NO UPSHIFT AFTER REBUILD

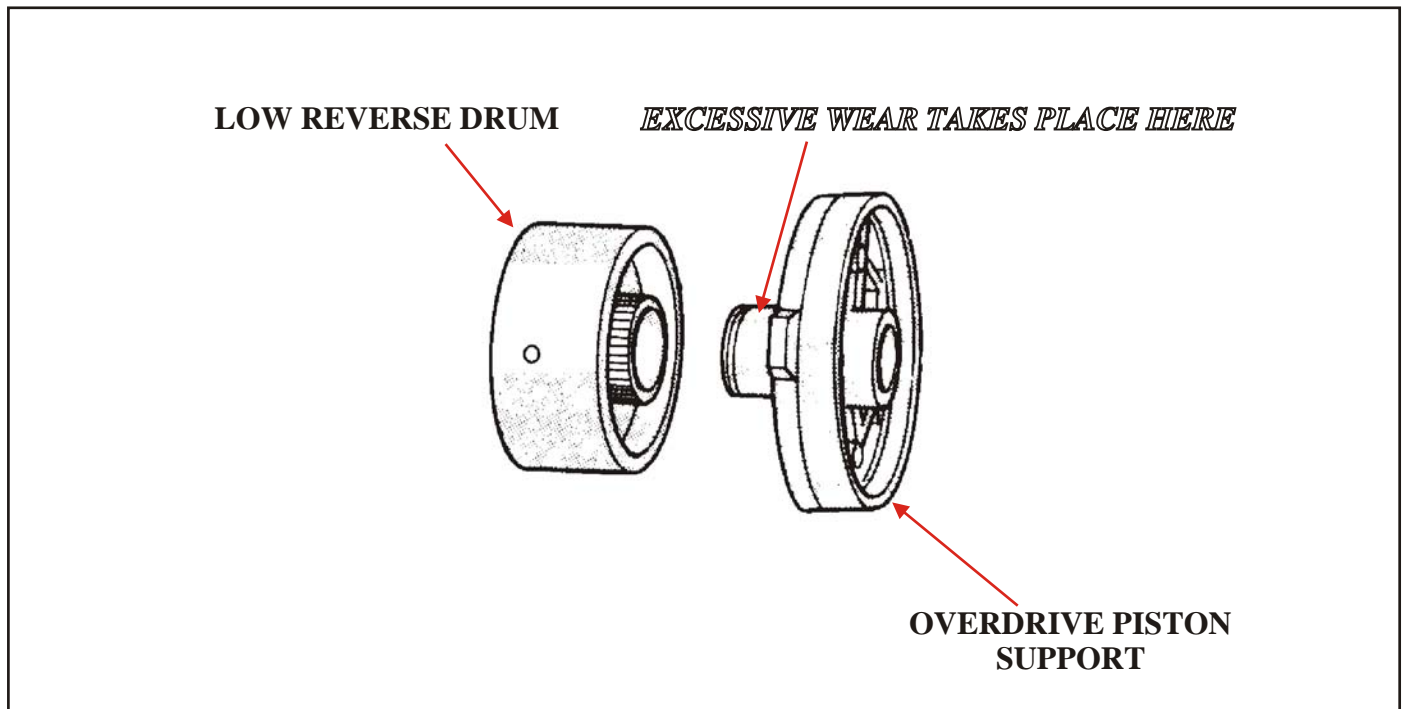
Figure 1

CAUSE: One cause may be that during overhaul, it is not uncommon to find the overdrive piston support worn excessively where the low reverse drum rides (See Figure 1). When the support was replaced, one was used from an A500/518 transmission. This allows all governor oil to be exhausted as the A500/518 support has feed and return governor holes for the governor tubes to fit into where as the 42RE does not use tubes since governor pressure is solenoid controlled off the valve body (See Figure 2). The support found on the 42RE does not have these holes which blocks any governor oil from escaping to an exhaust (See Figure 3).

CORRECTION: Replace the support with one from a 42RE transmission. In some cases, the overdrive extension housing can be removed from the transmission without removing the whole transmission from the vehicle. If this is available, remove the overdrive section and carefully drill an tap and plug the two holes in the support with pipe plugs as shown in Figure 4.

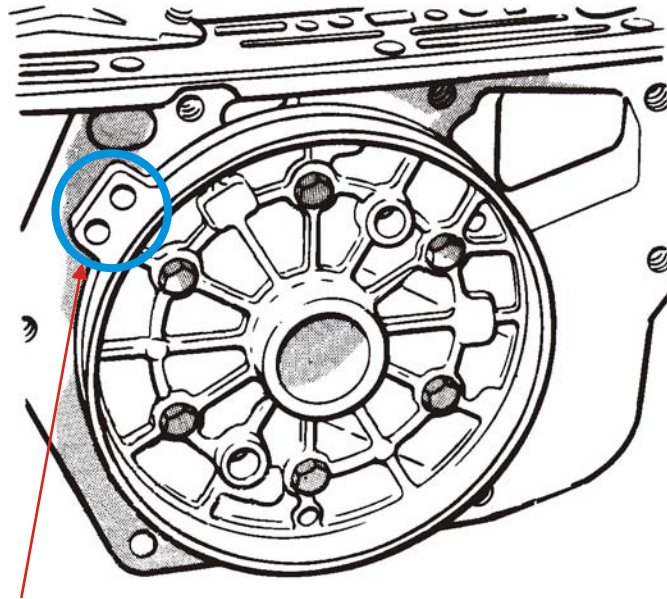
Figure 2

***GOVERNOR FEED AND RETURN
PIPE HOLES USED IN A500/518
MODEL TRANSMISSIONS ONLY***

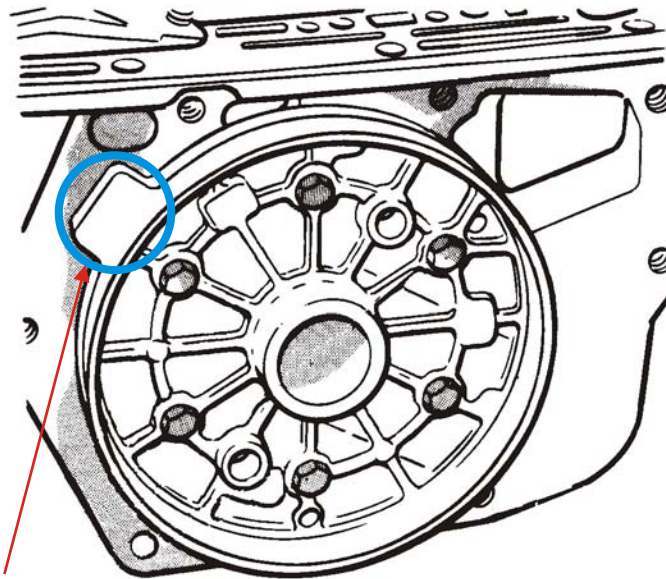
Figure 3

***NO HOLES IN SUPPORT WITH
THE 42RE & 46RE TRANSMISSIONS***
