Technical Service Information

THM 440-T4

NO DRIVE

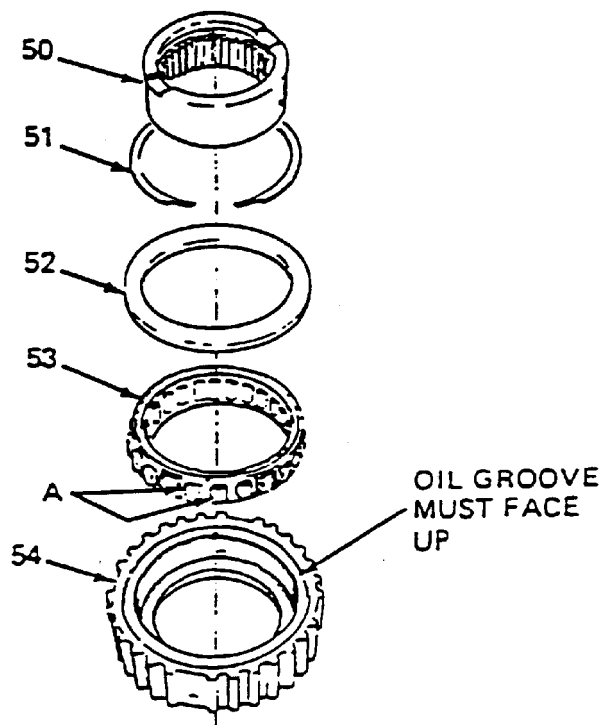
Figure 1

CAUSE: Input sprag failure. Figure 1. shows input sprag assembly.

CORRECTION: Install new sprag. Check inner and outer races for wear. If races are worn, replace as necessary. Figure 2 shows proper direction of rotation of sprag races.

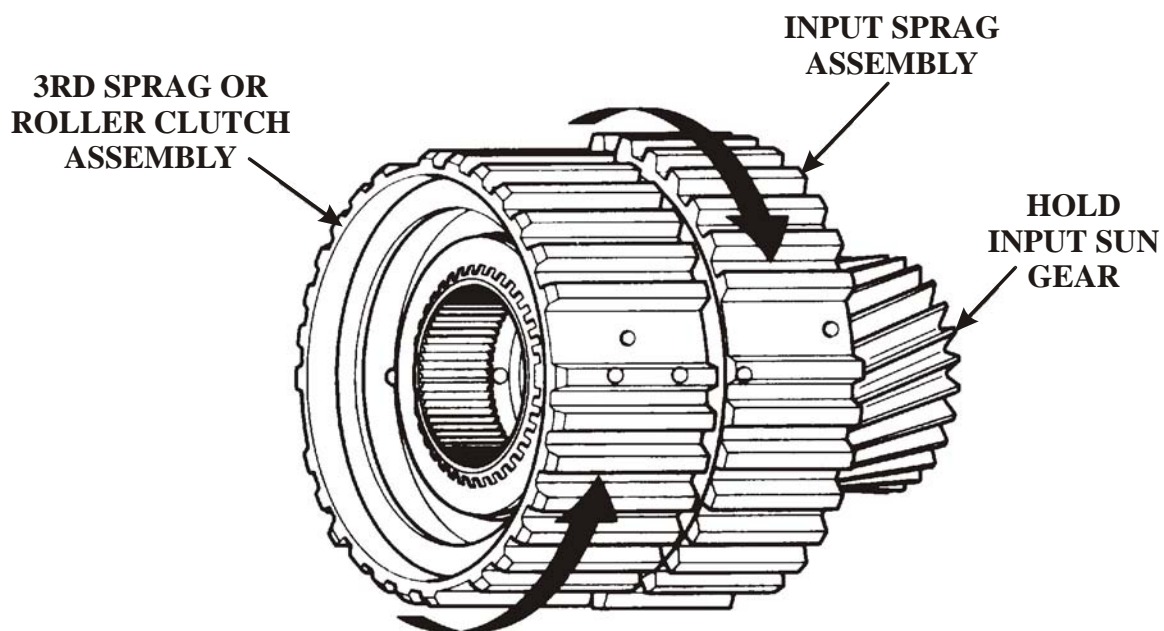
Figure 2

***THE SPRAG/ROLLER CLUTCH ASSEMBLIES MUST FREEWHEEL IN
DIRECTION OF ARROWS, AND HOLD IN OPPOSITE DIRECTION
WHILE HOLDING SUN GEAR AND SHAFT ASSEMBLY***
