FORD AOD REPEATED PLANETARY FAILURE

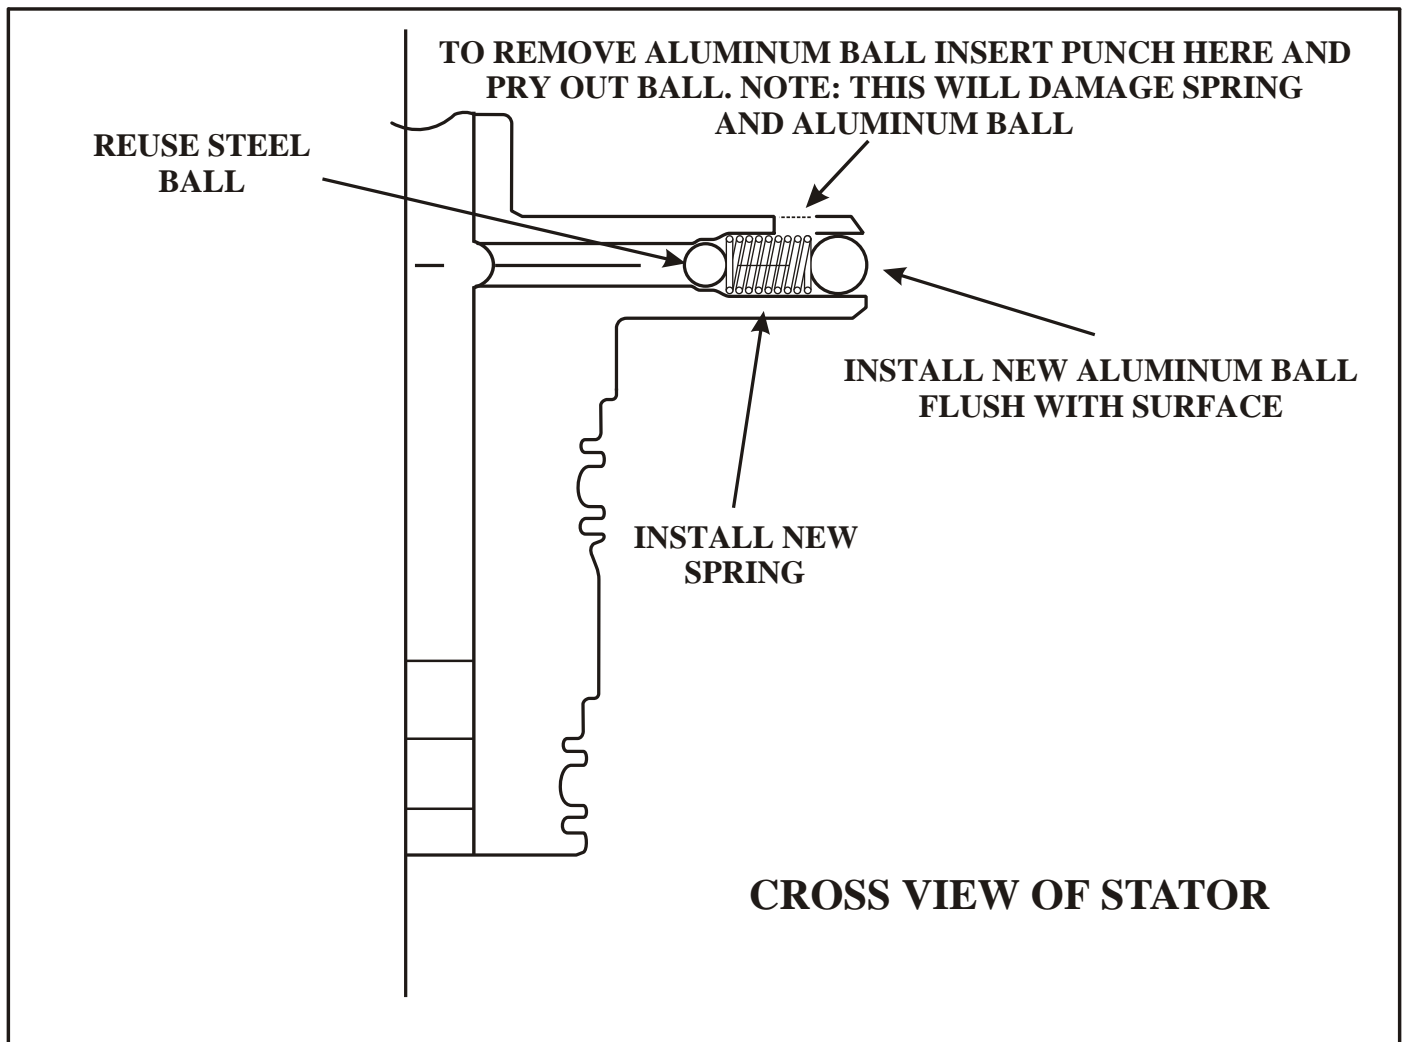
COMPLAINT: Repeated burning of the planetary carrier, reverse sun gear & drive shell, and the forward sun gear. At times this will occur in less than 100 miles after rebuild.

CAUSE: The cause may be the converter drain back cross hole passage in the pump stator support blocked with debris, or the checkball stuck (See Figure 1).

CORRECTION: Inspect and air check the converter drain back passage in the pump stator support, and clean as necessary. If removal of the checkball and spring assembly are necessary, refer to Figure 1 for removal Procedure.

Spring and Ball Kit E5AZ-7A205-A
