HONDA M24A

NO REVERSE

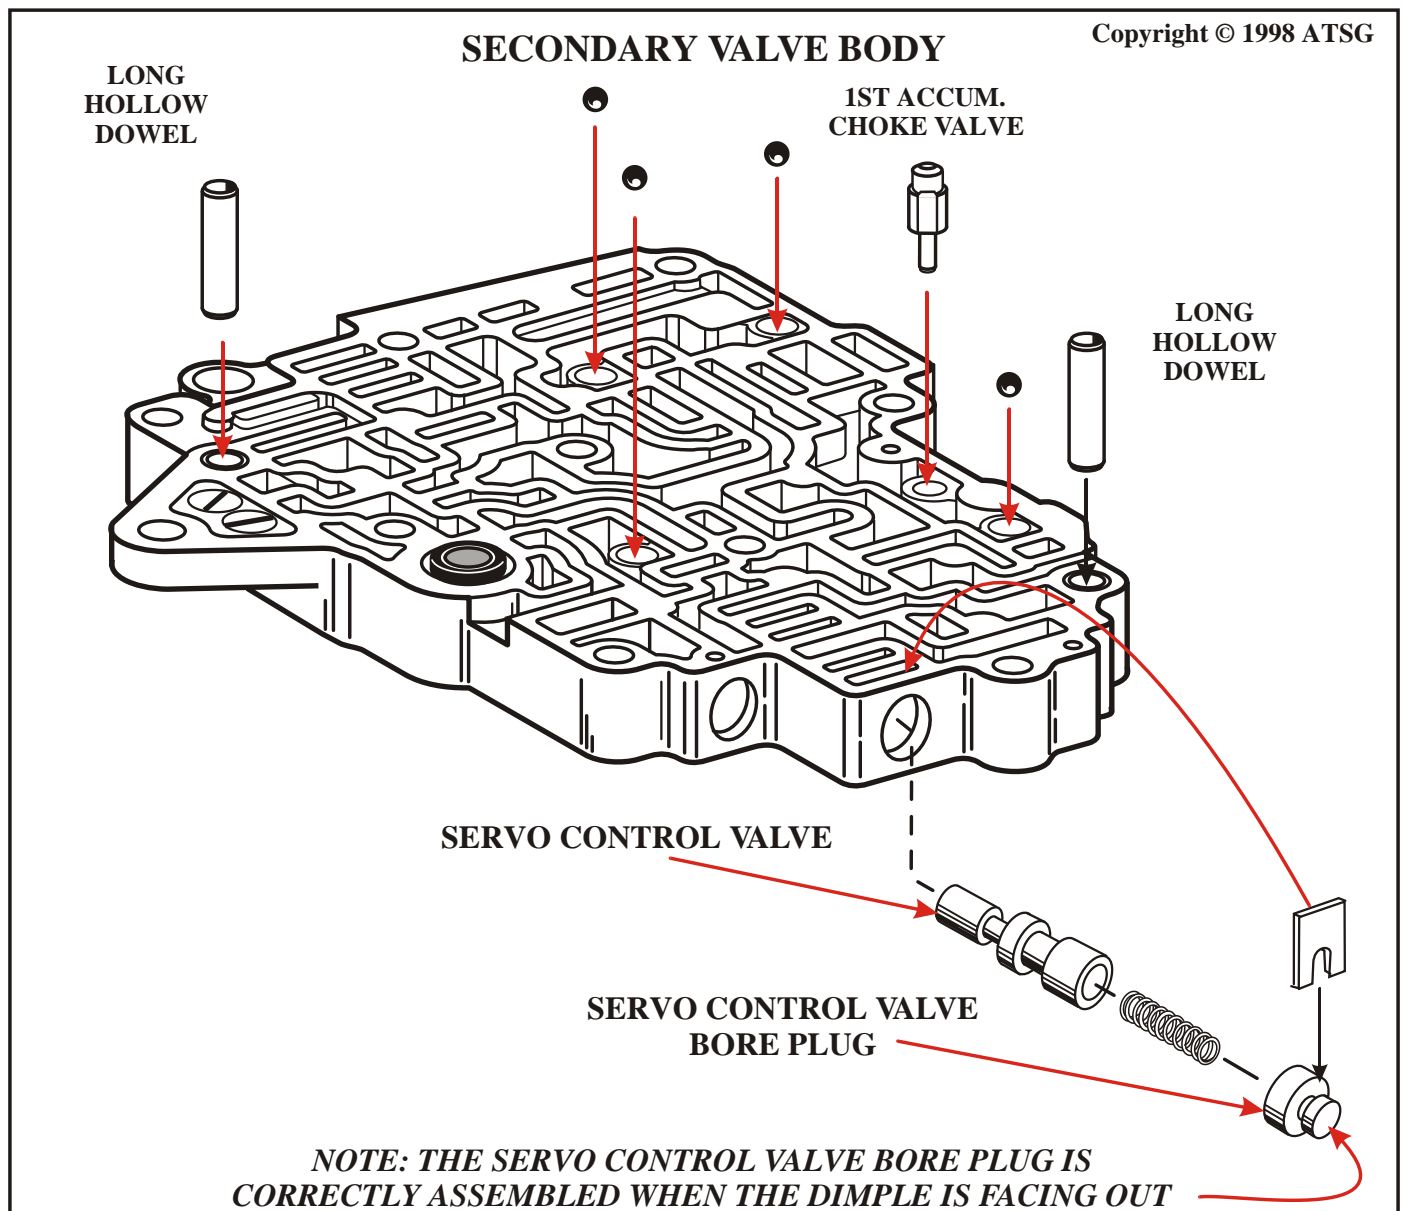
Figure 1

COMPLAINT: After overhaul, vehicles equipped with M24A transaxles may exhibit a no Reverse condition.

CAUSE: The cause may be, that the bore plug, which retains the servo control valve in its bore, was assembled backwards exhausting line pressure from the Manual Valve in Reverse.

CORRECTION: Locate the Servo Control Valve, which is in the Secondary Valve Body, and assemble the bore plug correctly as shown in Figure 1.
