Technical Service Information

FORD E4OD HARSH 3-4 SHIFT

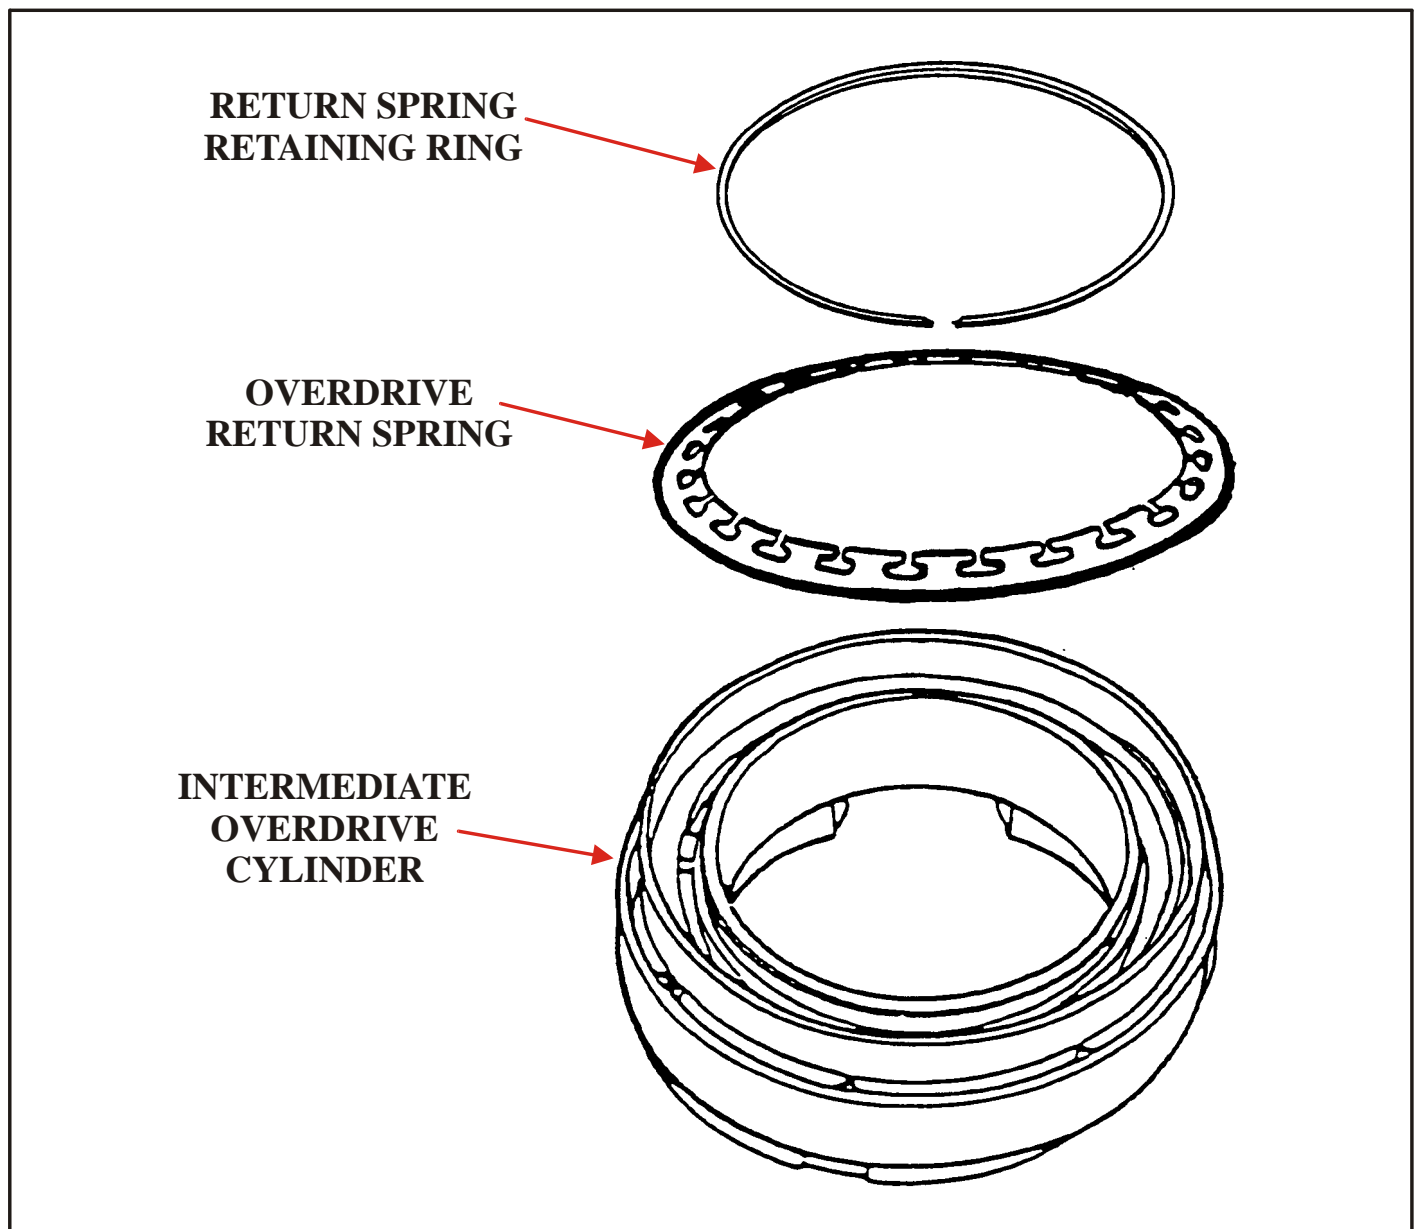
Figure 1

COMPLAINT: Harsh 3-4 shift, and/or upon transmission dis-assembly the O.D. Clutch retaining ring is dislodged from groove (See Figure 1).

CAUSE: Insufficient snap ring tension.

CORRECTION: Replace snap ring with updated (More Tension) snap ring available under OEM part number F0TZ-7A527-A.
