Technical Service Information

THM 4L80-E/4L80-EHD

TROUBLE CODE 68 IN OVERDRIVE

TROUBLE CODE 39 IN DRIVE 3

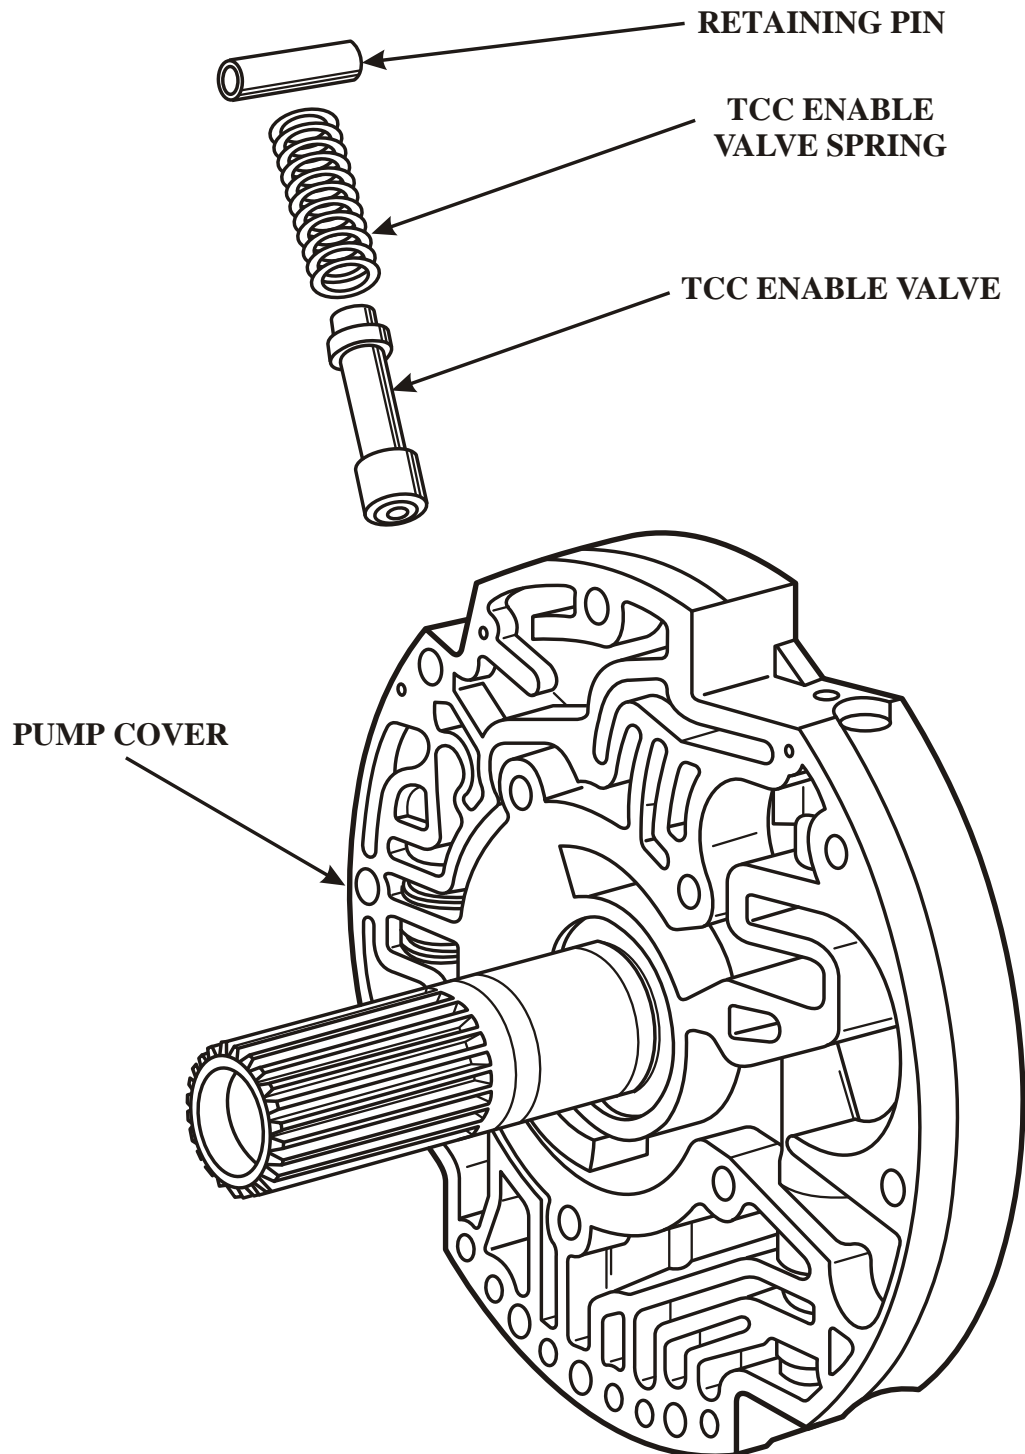
Figure 1

- COMPLAINT:** After rebuild, the vehicle displays a no converter clutch condition, stores trouble code 68 when the vehicle is driven in the Overdrive gear selector position, and stores trouble code 39 when the vehicle is driven in the "D3" gear selector position.
- CAUSE:** There are many electrical and mechanical reasons for these codes to be stored. After all of the electrical has been eliminated, the cause may be the TCC Enable Valve, in the pump cover assembly is in backwards.
- CORRECTION:** Remove the pump assembly and install the TCC Enable Valve in the direction that is shown in Figure 1, and ensure free movement after installation.
