Technical Service Information

FORD WINDSTAR

CODE P0743, TCC SOLENOID ELECTRICAL CIRCUIT FAULT

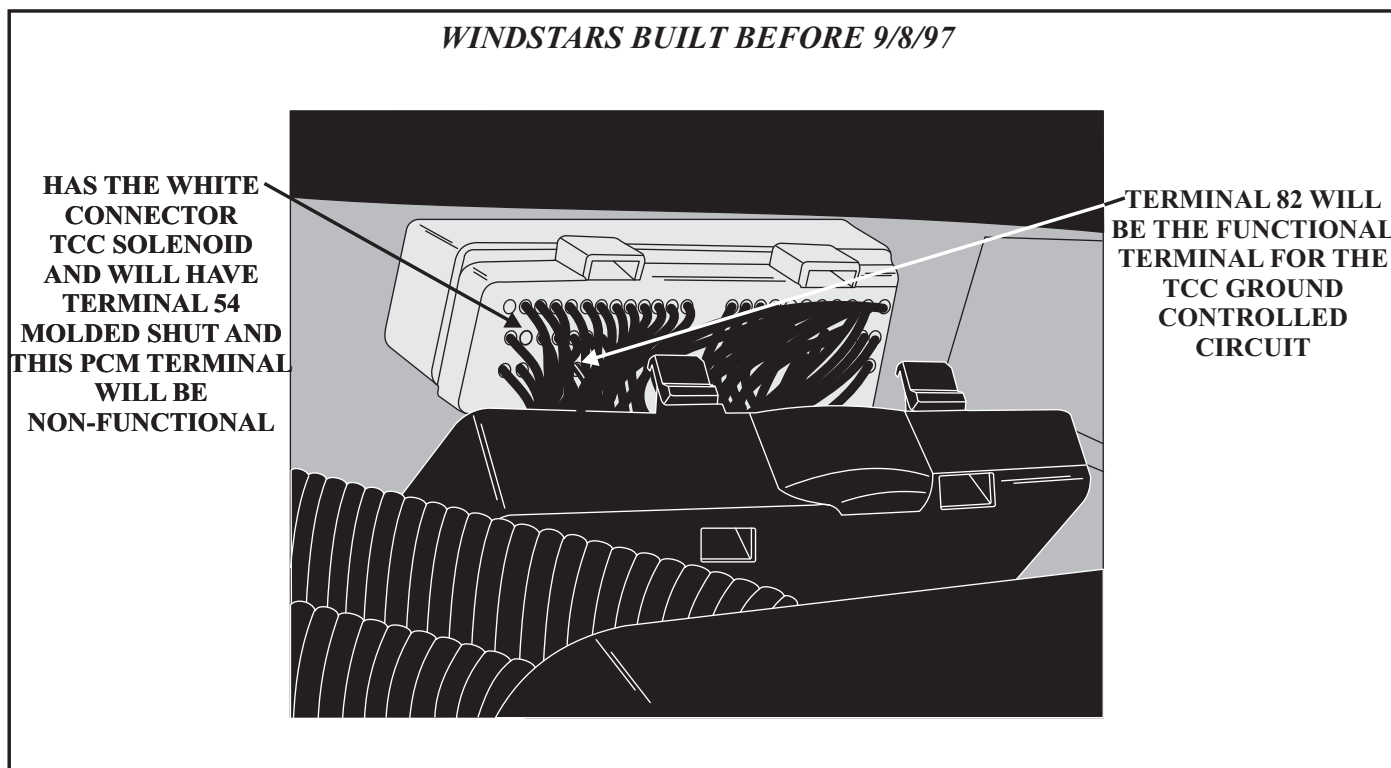
Figure 1

CAUSE: Since all items relating to this type of situation had already been eliminated as the cause of the problem, the technician decided to consult wiring diagrams for this vehicle. Since the factory wiring diagrams were split into two categories, vehicles built before 9/8/97 and vehicles built after 9/8/97, both were compared. The “before 9/8/97” indicated that the TCC ground controlled terminal was at pin 82, (Refer to Figure 1). The “after 9/8/97” diagram indicated this circuit should be at terminal 54, (Refer to Figure 2). The technician decided to check the signal that was being sent on this circuit by the PCM. The Red/Lt Blue wire was located at terminal 82 in the PCM connector. There was battery voltage on the circuit at all times, usually meaning that the PCM did not deliver the ground signal. *The PCM connector location at pin 54 was molded shut!*

The fix was to drill the terminal 54 location open and move the TCC ground controlled wire from the pin 82 location to terminal 54.

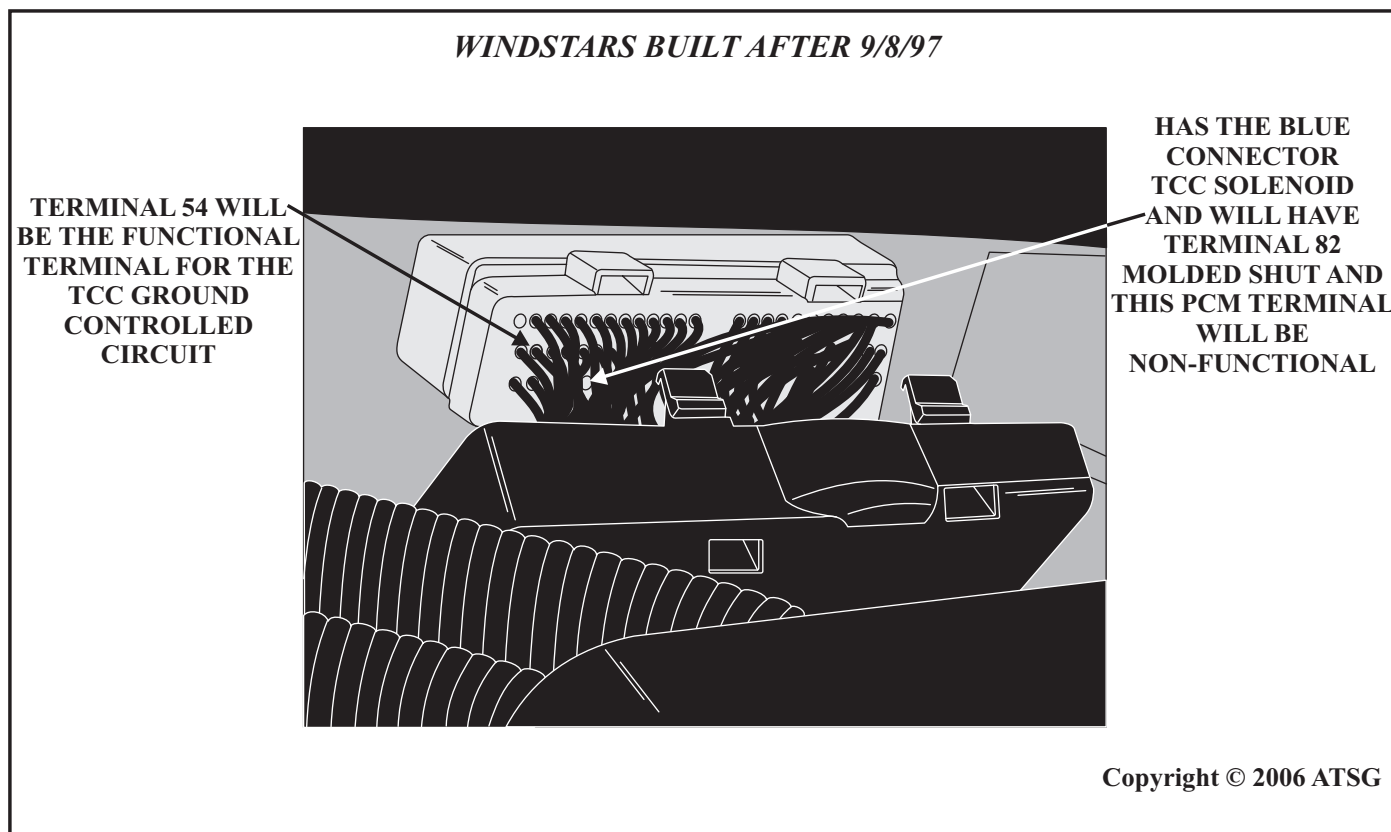
Figure 2

CORRECTION: This vehicle did have a “Z” as the 4th vin digit making it a 1998½ vehicle which means the active TCC solenoid ground circuit should be terminal 54, not 82.
