ACURA F4 HARSH FORWARD ENGAGEMENT

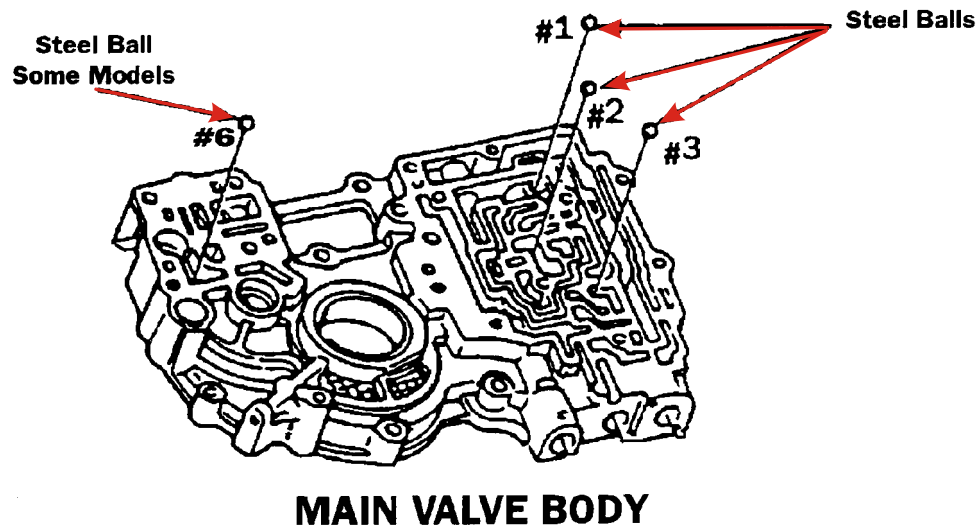
COMPLAINT: Very harsh engagement into drive from either reverse or from neutral after overhaul. Reverse application is fine.

CAUSE: Check ball # 1 (1st. Clutch Exhaust) may be out of place or missing. This will allow un orificed oil to enter the first clutch circuit when the transmission is placed into drive.

CORRECTION: Check the main valve body to be certain that all of the check balls are placed correctly. Figure 1 identifies the check balls and their locations.
