Technical Service Information

4L80-E

ENGINE STUMBLE/STALL ON ENGAGEMENT

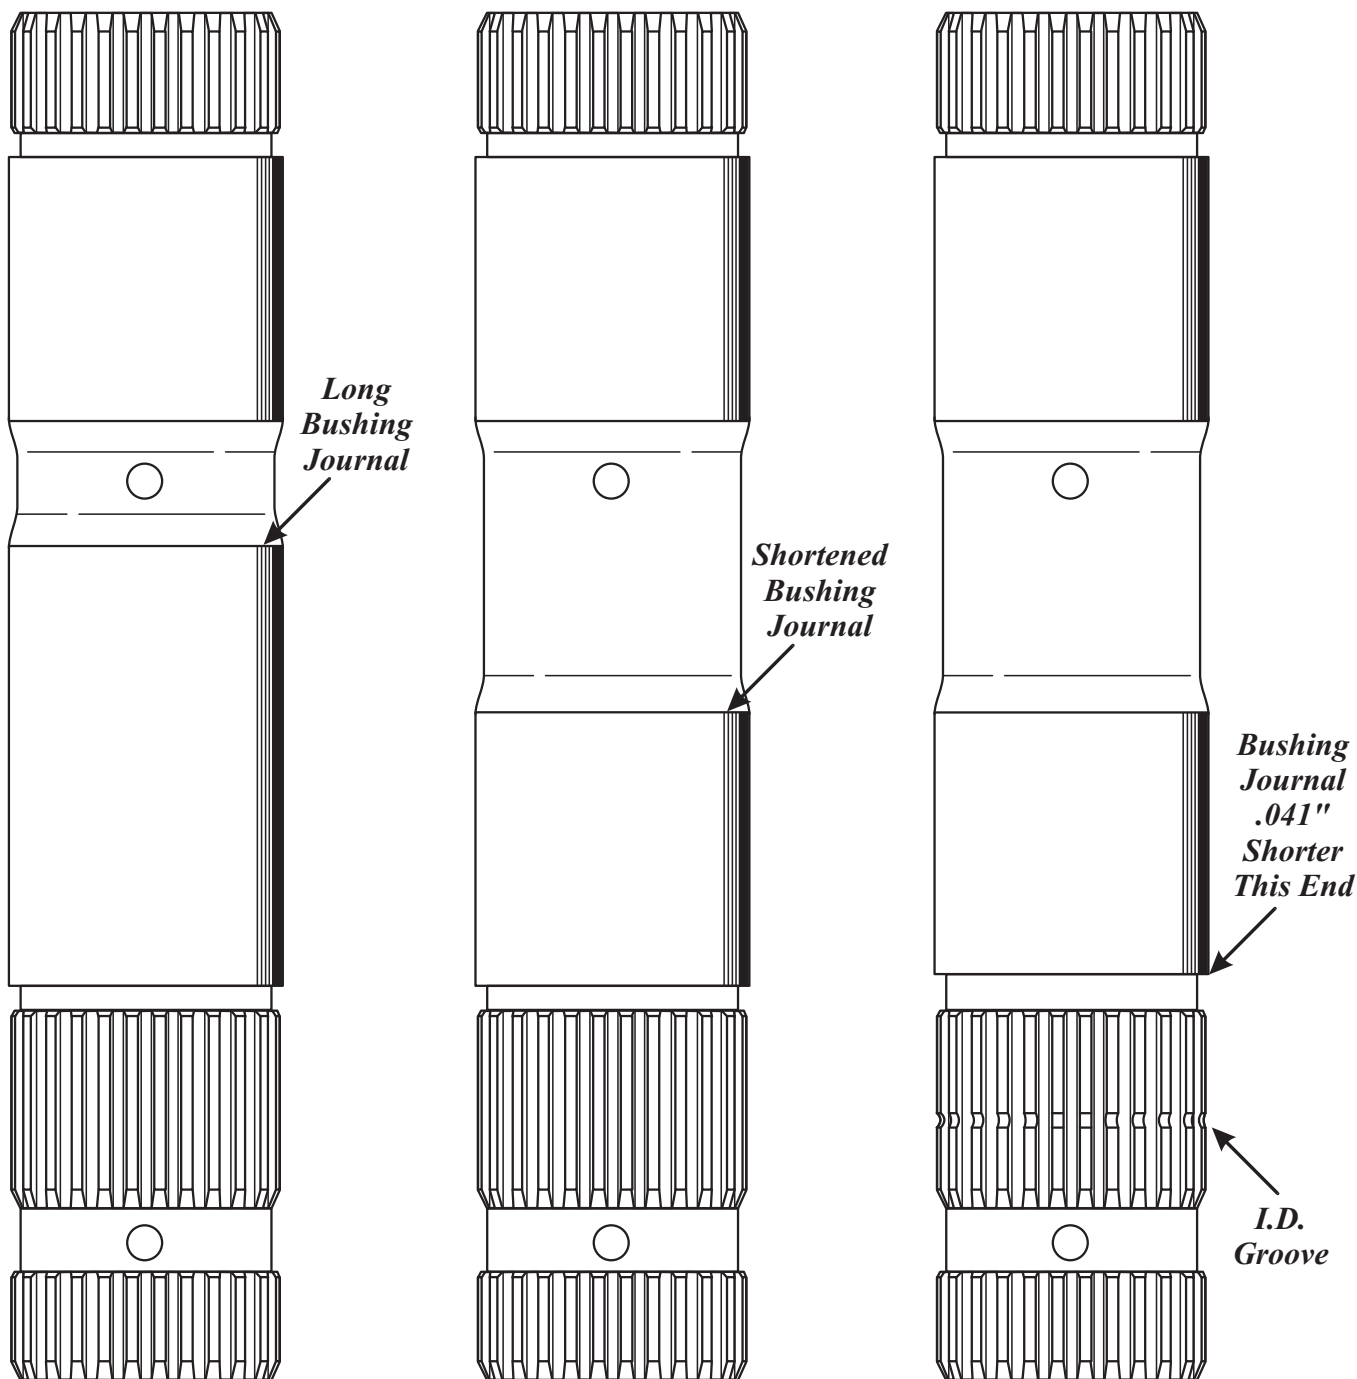
Figure 1

CAUSE: During the overhaul process the original 1997 or later design sun gear shaft was replaced with a 1996 or earlier design sun gear shaft. This was the only piece replaced in the main planetary gear train. All other related gear train parts remain original.

CORRECTION: The sun gear shafts used in 1997 and later center lube transmissions have a shortened bushing journal when compared to the earlier design. Using the earlier design shaft with the longer bushing journal will create a restriction in the oil cooler/lube circuit and cause the converter clutch to drag.

**1ST DESIGN LEVEL
SUN GEAR SHAFT
1991-96**

**2ND DESIGN LEVEL
SUN GEAR SHAFT
1997-98
PART NO. 24207247**

**3RD DESIGN LEVEL
SUN GEAR SHAFT
1999- UP
PART NO. 24207264**

Replace the sun gear shaft with the proper part for your application. (See figure 1)
