Technical Service Information

FORD C-6

DELAYED ENGAGEMENT FORWARD AND REVERSE

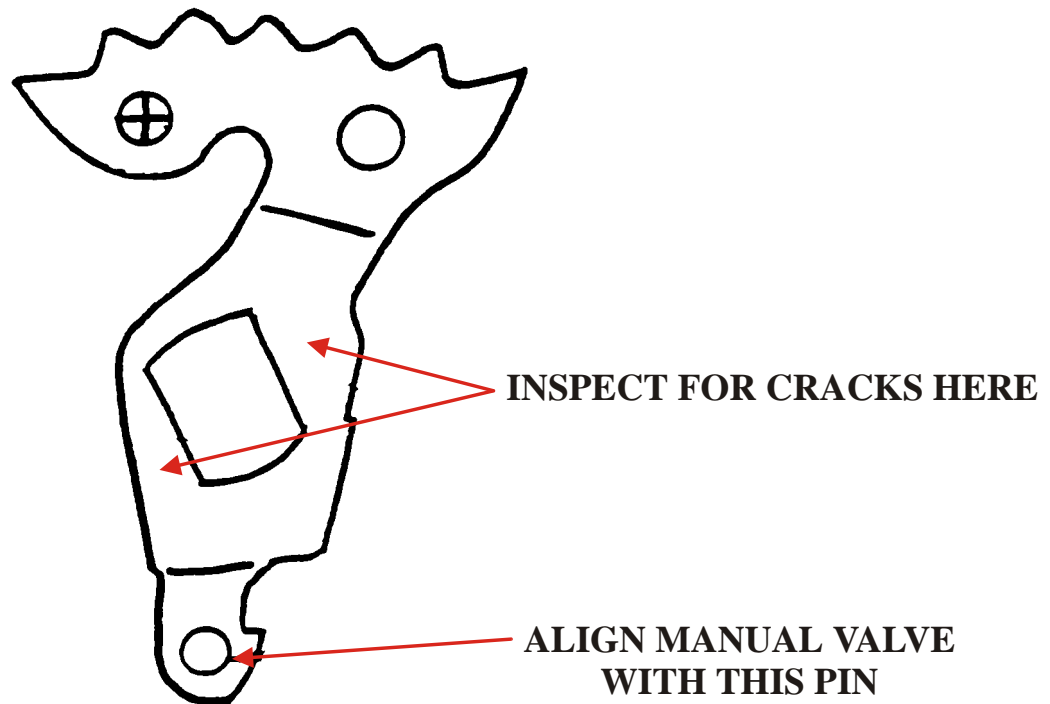
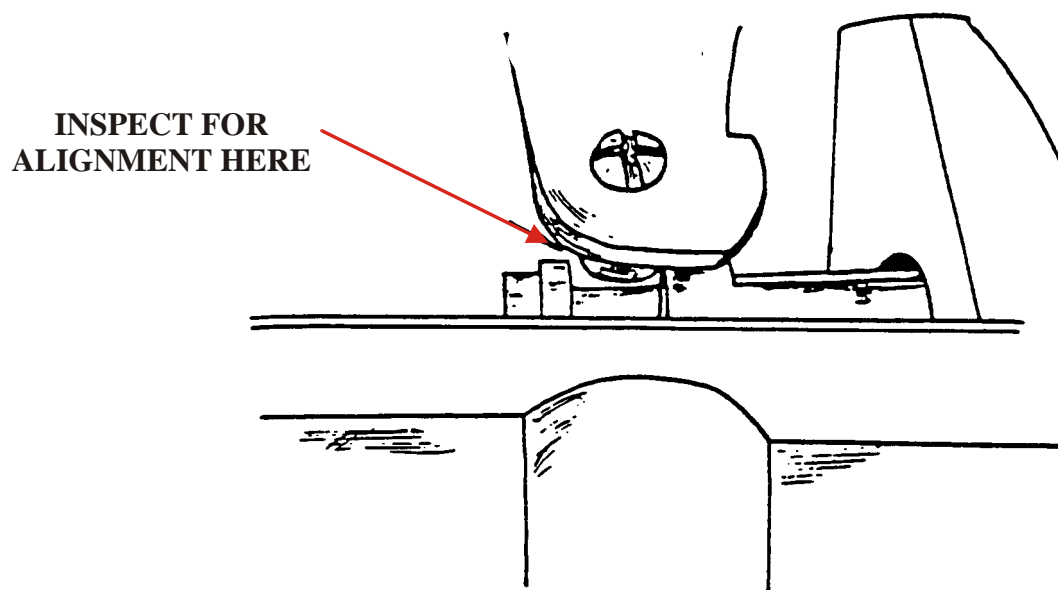
Figure1

COMPLAINT: Any complaint of delayed engagement drive or reverse, any unexplained burn out or any shift related complaint.

CAUSE: The cause can be a bent or cracked internal detent Lever.

CORRECTION: The way to check the alignment is to use an old style C-6 valve body that has the detent in the valve body. On that assembly, place the manual valve in drive position. With the detent lever in the case set in drive set the old style valve body on the transmission. and check that the manual valve lines up with the pin in the detent valve. If the valve and pin do not align, replace the linkage. Inspect all linkage parts for cracking and bending.
