# Technical Service Information

## THM 440-T4 INTERMITTENT LOSS OF REVERSE

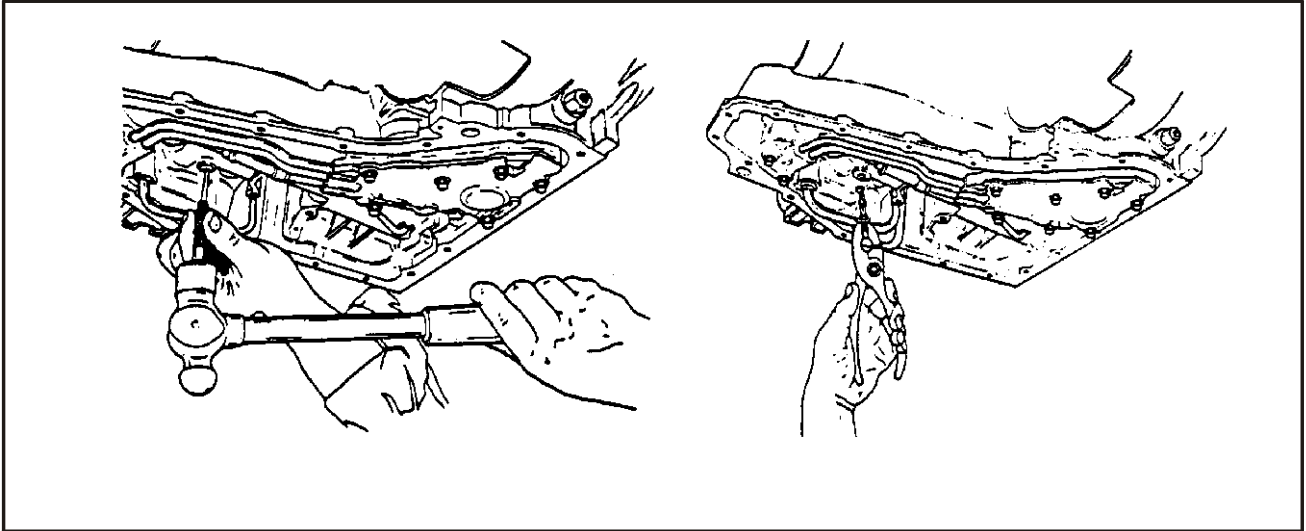
**Figure 1**

**CAUSE:** The cause may be the 1-2 Band Stop (139) being below specification, allowing the 1-2 band to shift off location causing the 1-2 band apply pin to miss the 1-2 band while stroking, and creating a loss of drive only. You will still have reverse.

1. Remove the bottom transaxle oil pan, and oil filter.
2. Using a 3/16" punch and hammer, tap the black plastic adjusting tab in the center of the 1-2 band stop, into the 1-2 Band Stop Assembly, just enough so that the stop can be removed with pliers. (See Figure 1).
3. Install a "New" 1-2 band stop into the J-38229 installation tool, then push the 1-2 band stop into the hole in the case and while pushing up on the base, squeeze the handle of J-38229 installation tool to its preset stop (See Figure 2).
4. Cut off the remaining adjusting tab with diagonals, as shown in Figure 3.
5. The 1-2 band stop height can be checked during a overhaul. First ensure that the stop is not loose in the case. With the transaxle dis-assembled, the 1-2 band stop should protrude 9/16" through the case as shown in Figure 4.
