# Technical Service Information

## FORD ATX HARSH 2-3 UPSHIFT

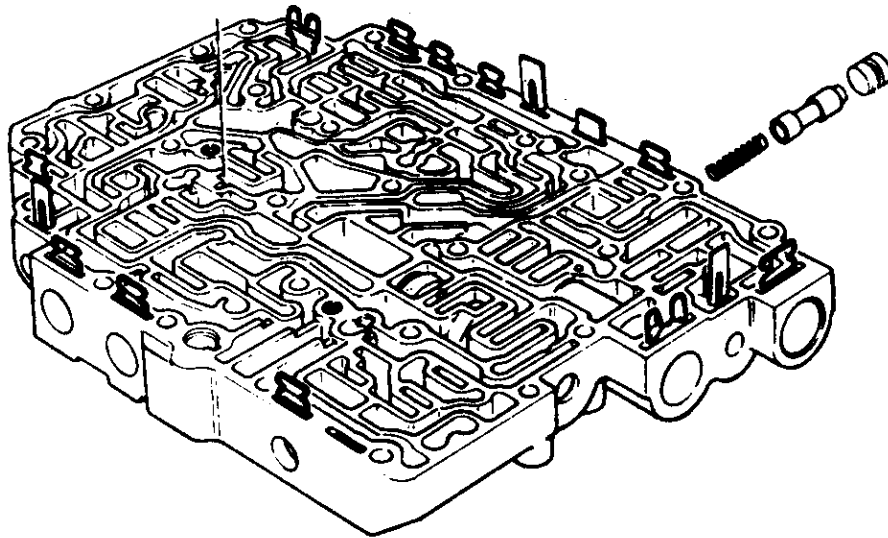
Figure 1

Soft 1-2 shift  
Harsh 1-2 shift

**CAUSE:** 1-2 capacity modulator valve spring calibration

Replace 1-2 capacity modulator valve spring with stronger spring.  
Replace 1-2 capacity modulator valve spring with weaker spring.
