Technical Service Information

THM 4L60 (700-R4) SOFT UP-SHIFTS

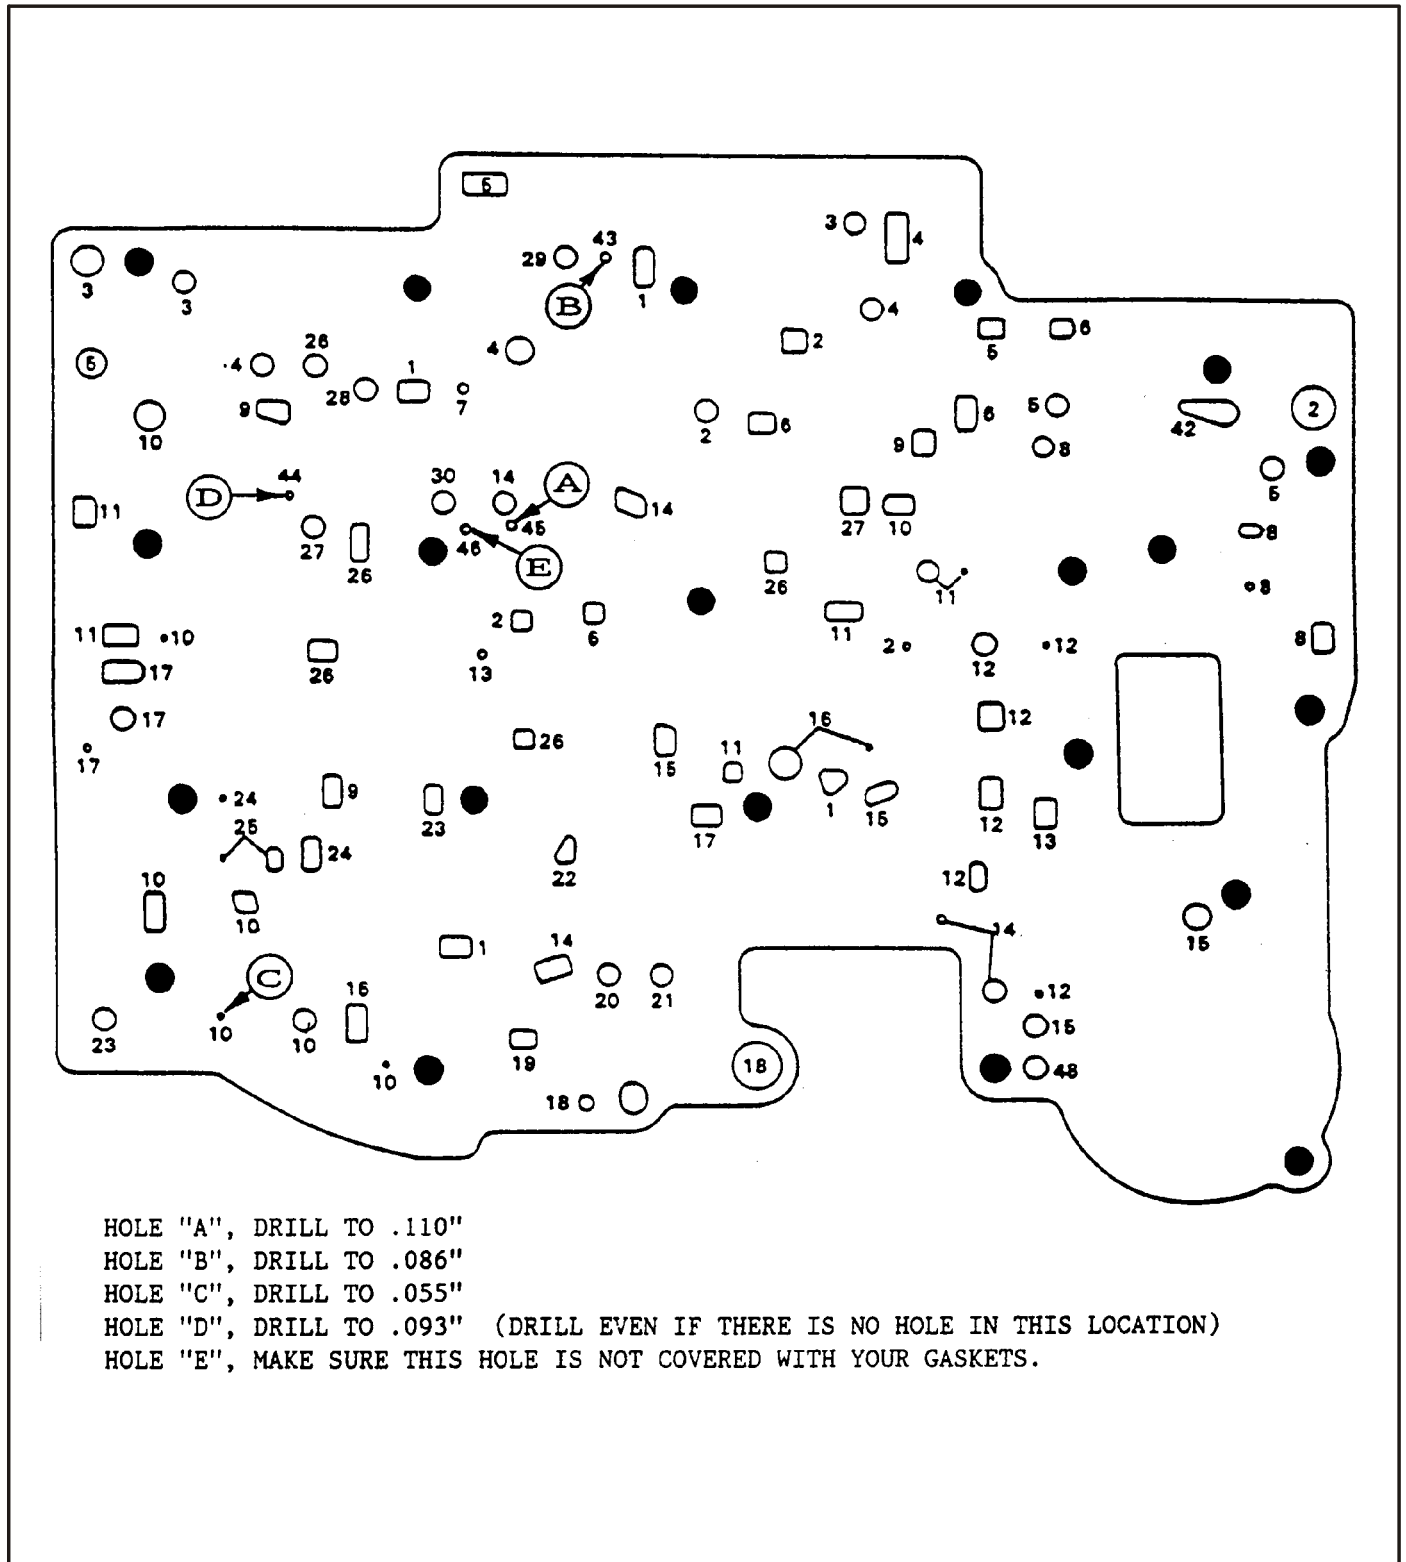
Figure 1

COMPLAINT: Soft and/or mushy up-shifts regardless of throttle position.

CAUSE: Not enough feed oil to the 2-4 band, and the 3-4 clutch pack.

HOLE "E", MAKE SURE THIS HOLE IS NOT COVERED WITH YOUR GASKETS.
If this hole is covered by the gaskets, it will create the following:

- (1) Shifts 1-3 in drive, after initial upshift pattern. First set of upshifts are normal, and will be again, after setting awhile.
- (2) Delayed (5 Seconds) 4-2, or 3-2 kickdown.
- (3) Delayed (5 Seconds) manual downshift from D3 to D2. (Stays in 3rd)
- (4) Binds in reverse, after upshifting to 3rd gear. Normal operation after setting for a while.
- (5) Binds in manual Lo, after upshifting to 3rd gear. Normal operation after setting for a while.
- (6) Results in burnt 3-4 clutch plates. They are usually wiped out on the road test, as this is the exhaust hole for the 3-4 clutch.

CORRECTION: Drill the holes in the spacer plate, as shown in Figure 1, as follows:

HOLE "A", DRILL TO .110".
This will improve the 1-2 shift.

HOLE "B", DRILL TO .086".
This will improve the 2-3 shift. DO NOT drill any larger than .086" as a larger hole will create a flare on the 2-3 shift on some models.

HOLE "C", DRILL TO .055".
This will prevent the T.V. valve from hydraulically locking.

HOLE "D", DRILL TO .093".
This will help prevent the 3-4 clutches from burning. This hole was eliminated on the 1988 and later 5.7L models. If your spacer plate does not have this hole, use the gasket as a template and drill it to .093".
