## MITSUBISHI GALANT AND ECLIPSE SPYDER

### ENGINE SURGE AT 55-65 MPH.

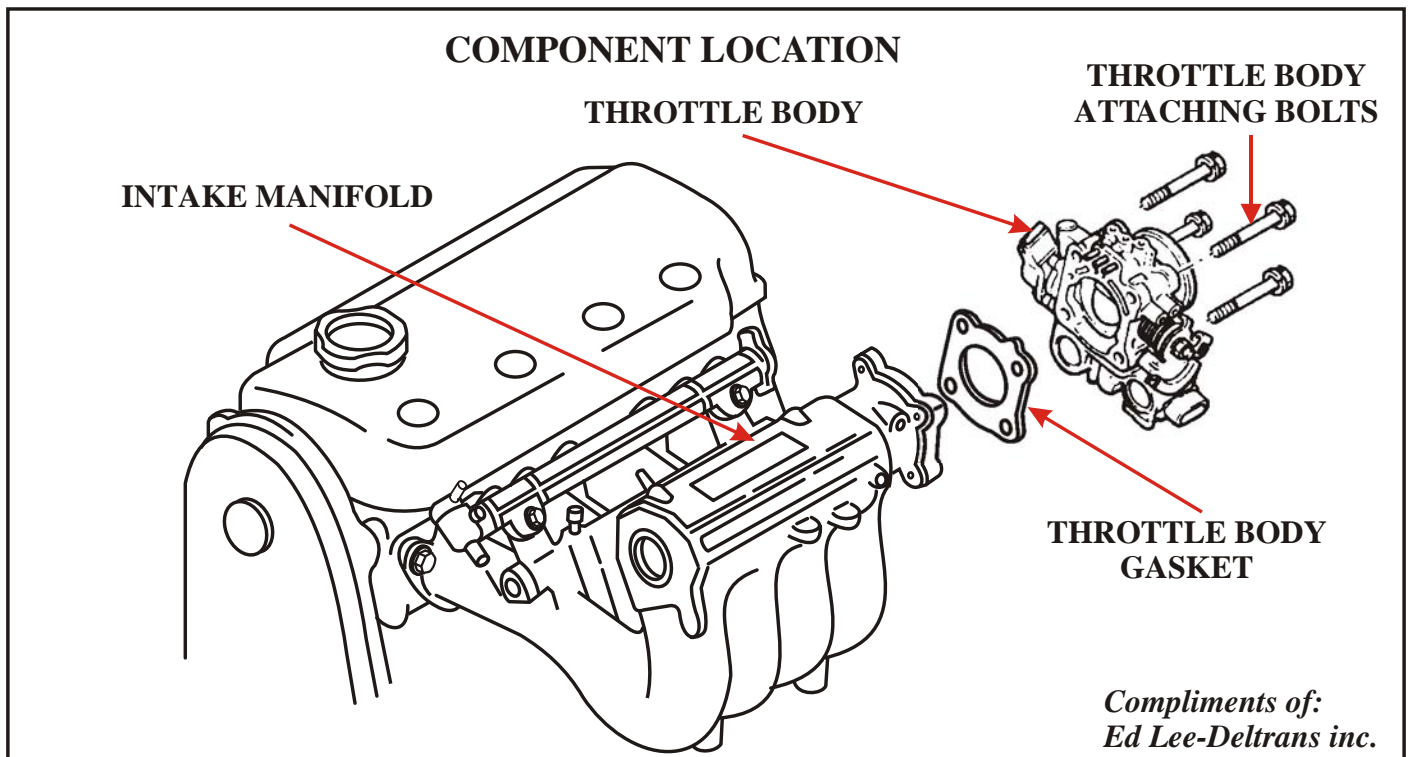
**CAUSE:** This condition may be caused by a mis-alignment of the throttle body on the intake manifold (See Figure 1 for location). A "Gap" caused by this mis-alignment may cause a supersonic noise or turbulence which causes the Air Flow Sensor to operate improperly (See Figure 2).
