Technical Service Information

THM 200-4R DELAYED REVERSE ENGAGEMENT 1988 - 1989 ONLY

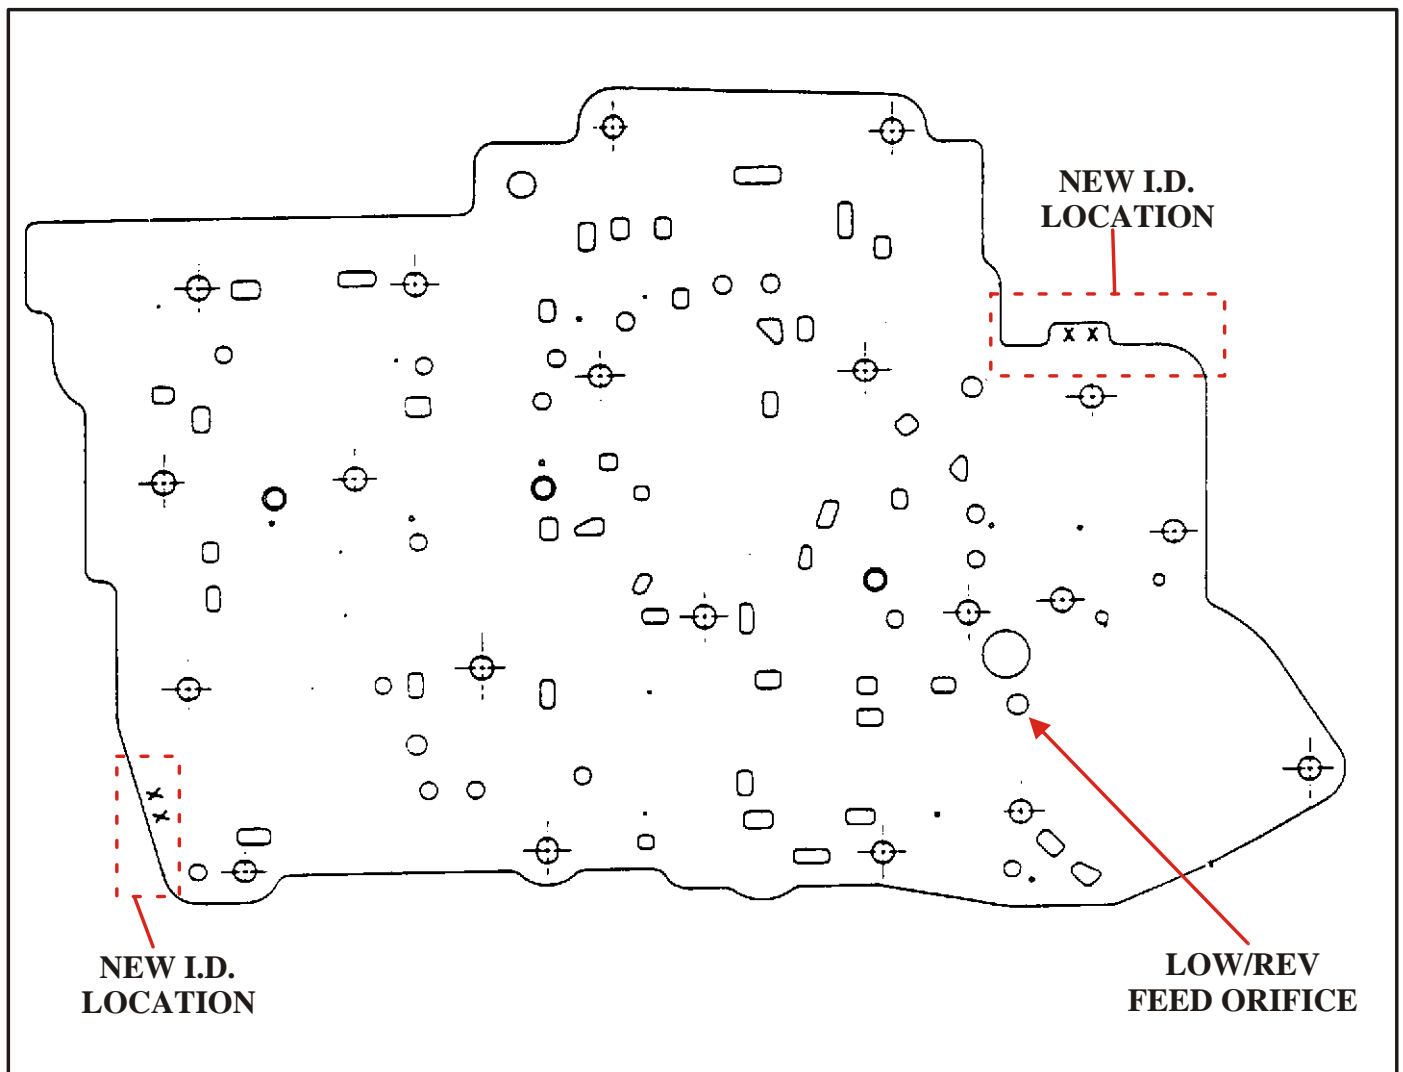
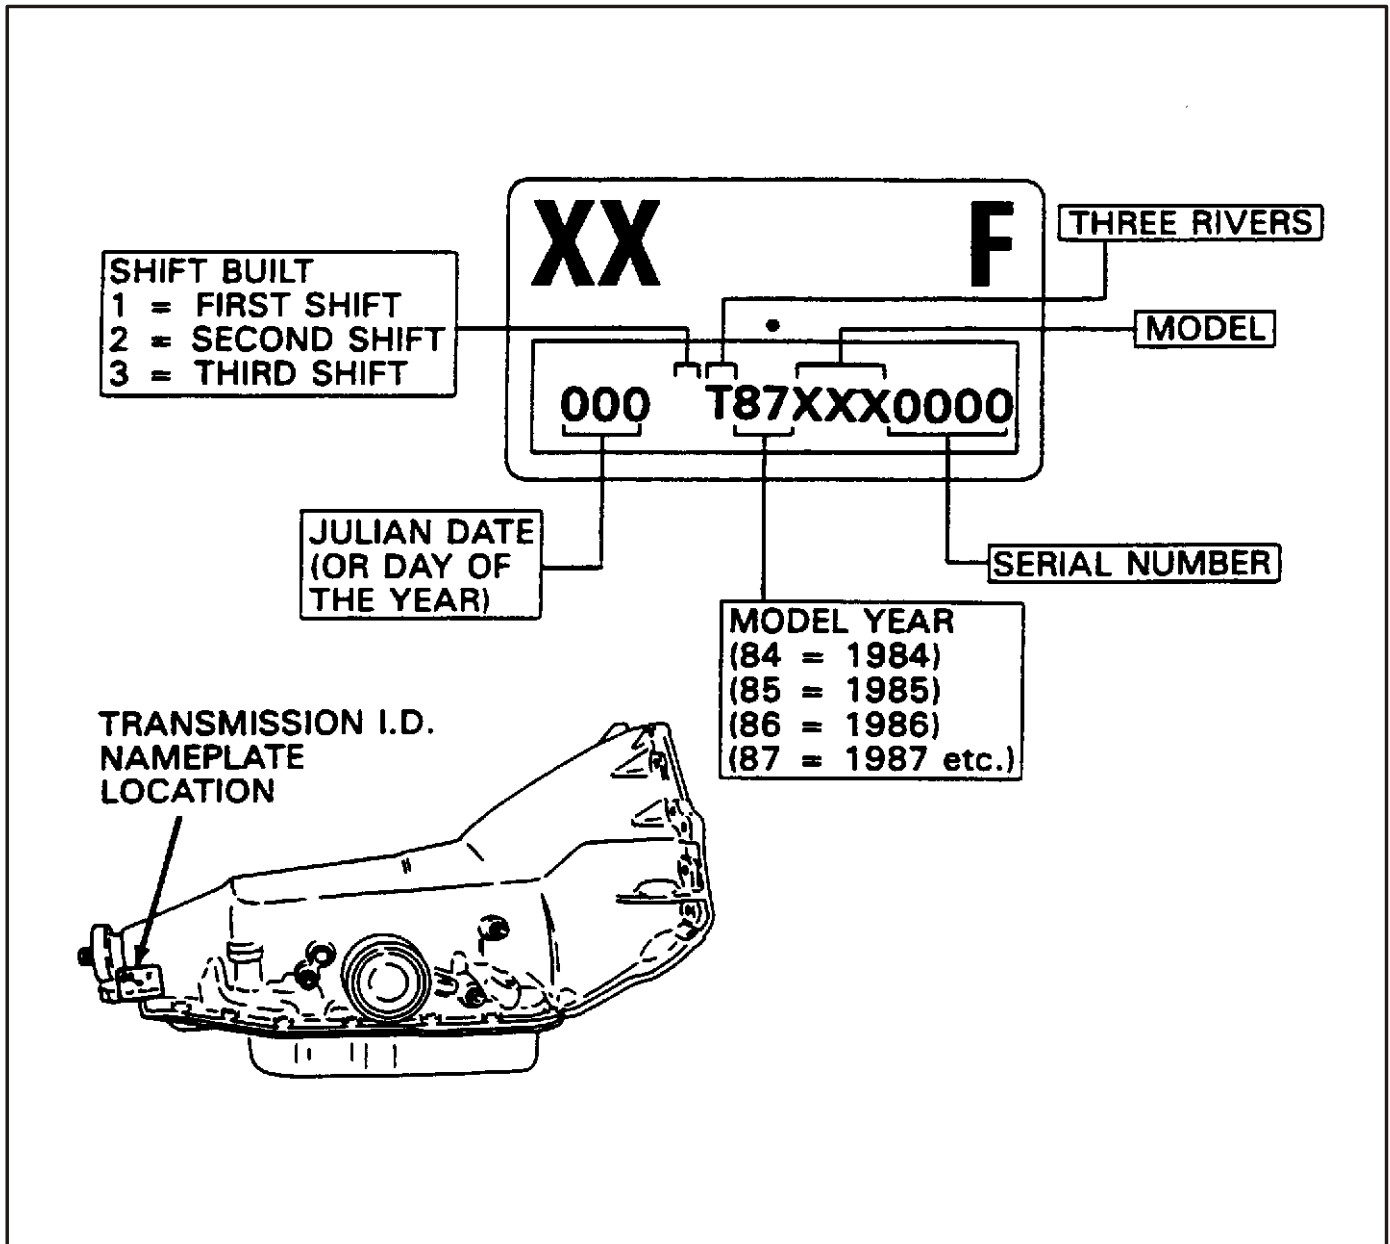
COMPLAINT: Some 1988-1989 THM 200-4R transmissions built after March 14, 1988 (Julian Date 074) and before July 7, 1989 (Julian Date 188) may experience a delayed engagement to reverse.

CAUSE: Valve body spacer plate calibration.

CORRECTION: Enlarge the LO/REVERSE feed orifice with a 1/8" drill bit. A revised spacer plate was used in all units produced after July 7, 1989. Refer to Figure 1 for orifice location in spacer plate.
