# Technical Service Information

## THM 440-T4 LOCKS IN REVERSE

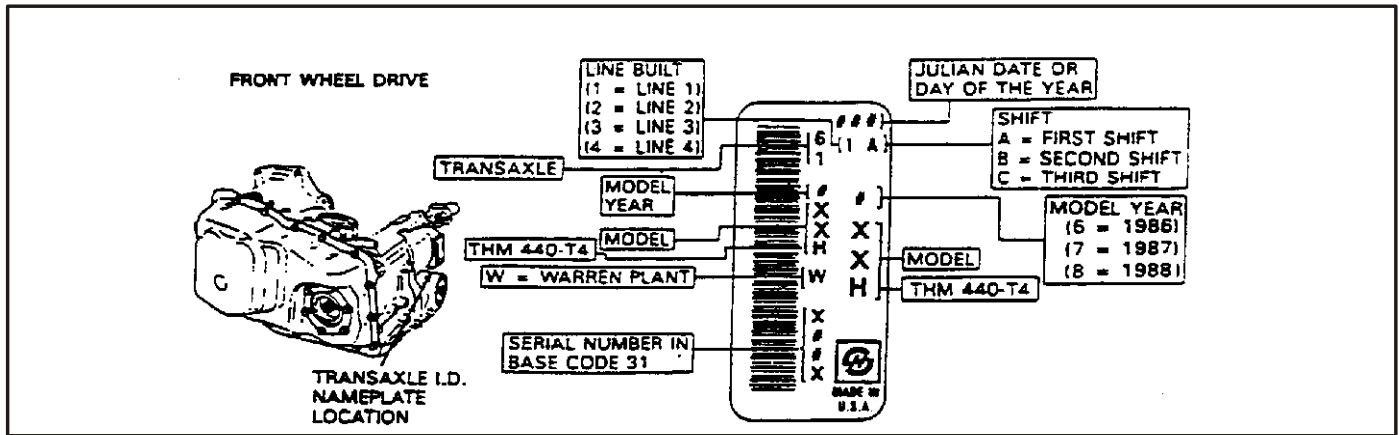
Figure 1

A 1984 through 1987 vehicle equipped with a THM 440-T4 transaxle may have an intermittent no reverse or locking in reverse condition un-til shifted to a forward range prior to shifting into reverse ("un-loading" the parking pawl). This condition may be caused by a "dent" on the parking pawl that does not allow the pawl to release until "un-loaded".

Effective May 1, 1987 (Julian Date 121) all 1987 THM 440-T4 transaxles were produced with parking pawl assemblies not having a "dent".
