Technical Service Information

THM 4L60 (700-R4)

NO WIDE OPEN 3-4 SHIFT (POLICE ONLY)

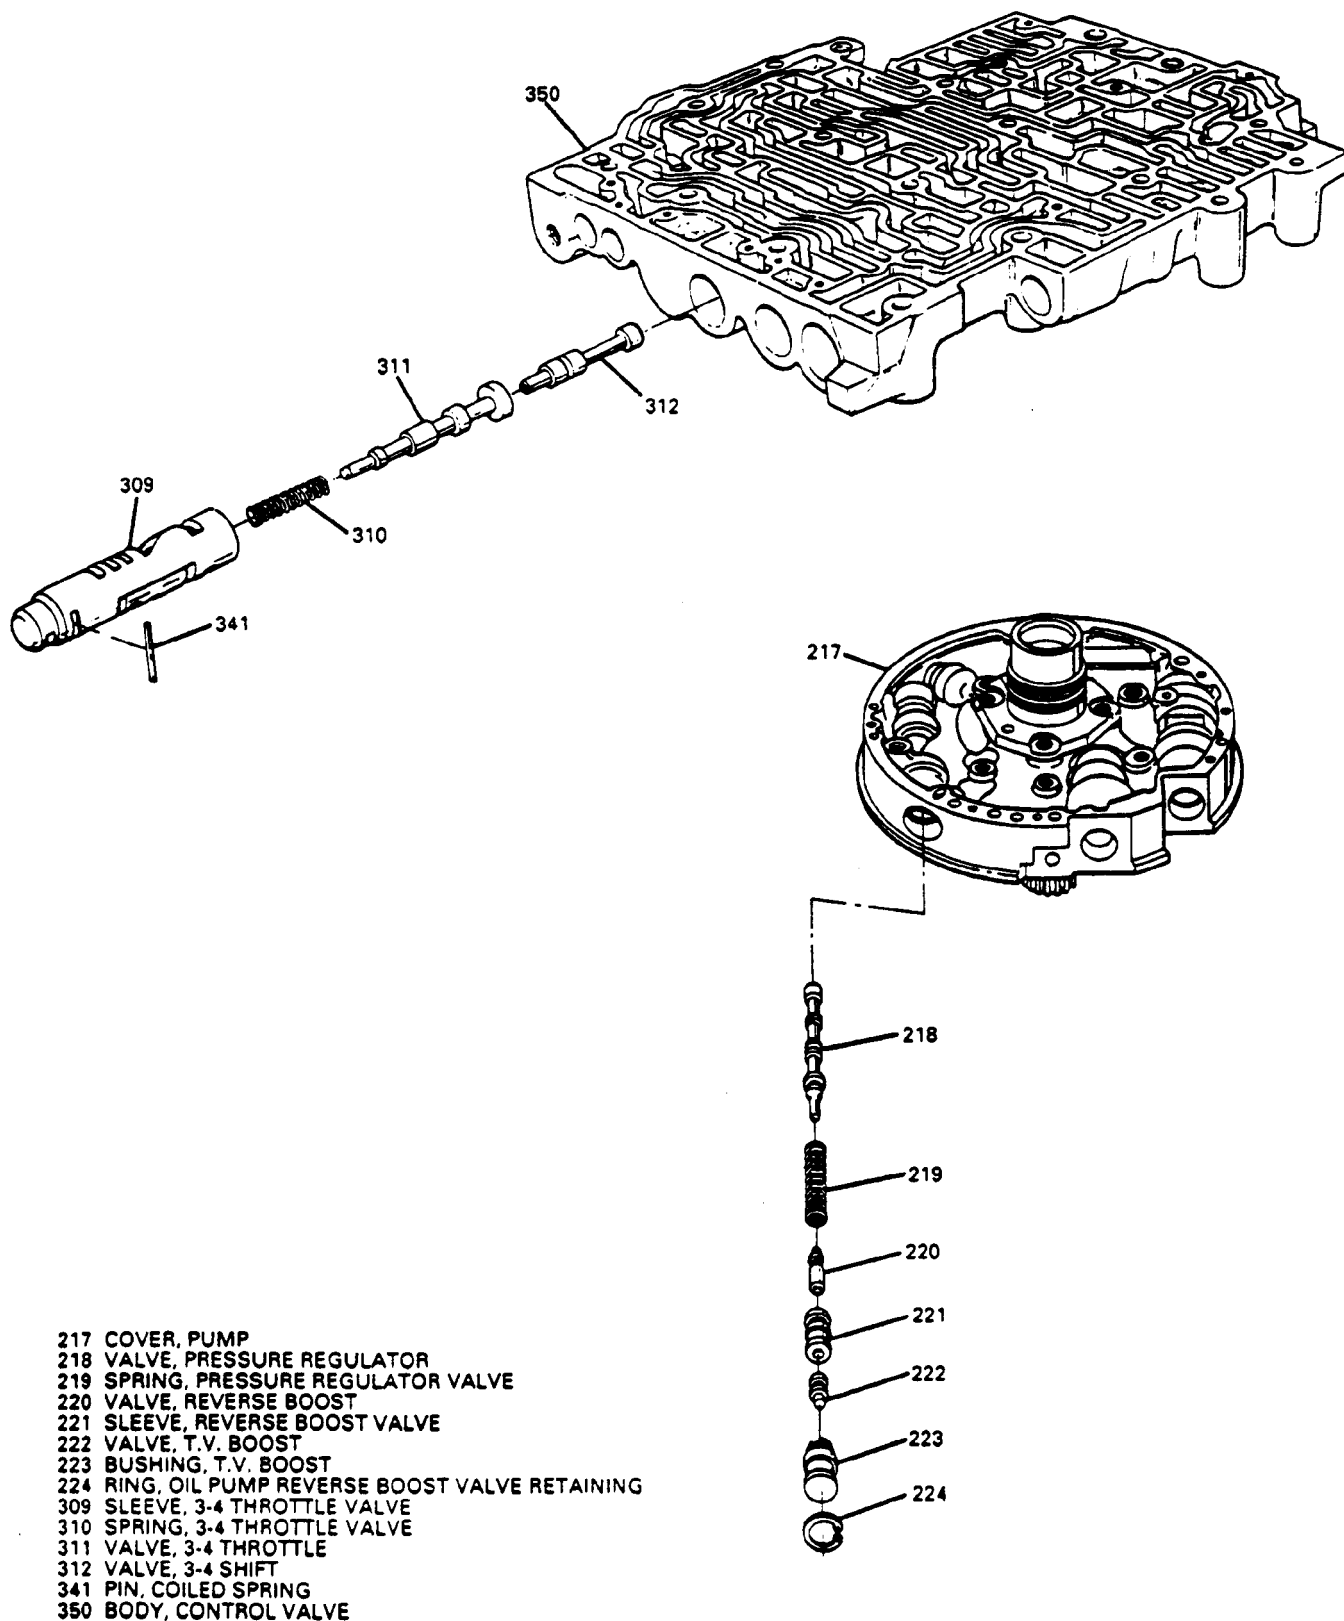
Figure 1

COMPLAINT: Some 1989-1991 Police vehicles with the 5.7L engine, may experience a loss of wide open throttle 3-4 upshift when hot. The models affected are 9YNM, OBPM, 1BFM.

CAUSE: Wrong transmission calibration. An updated transmission calibration has been released to address this condition.

Install the new T.V. Boost Valve and Bushing into the pump cover as shown in Figure 1.

Install the new 3-4 Throttle Valve, Bushing, and Spring into the valve body assembly as shown in Figure 1.
