Technical Service Information

CHRYSLER OR JEEP 42RE-46RE STALLING IN REVERSE AND/OR PLANETARY FAILURE

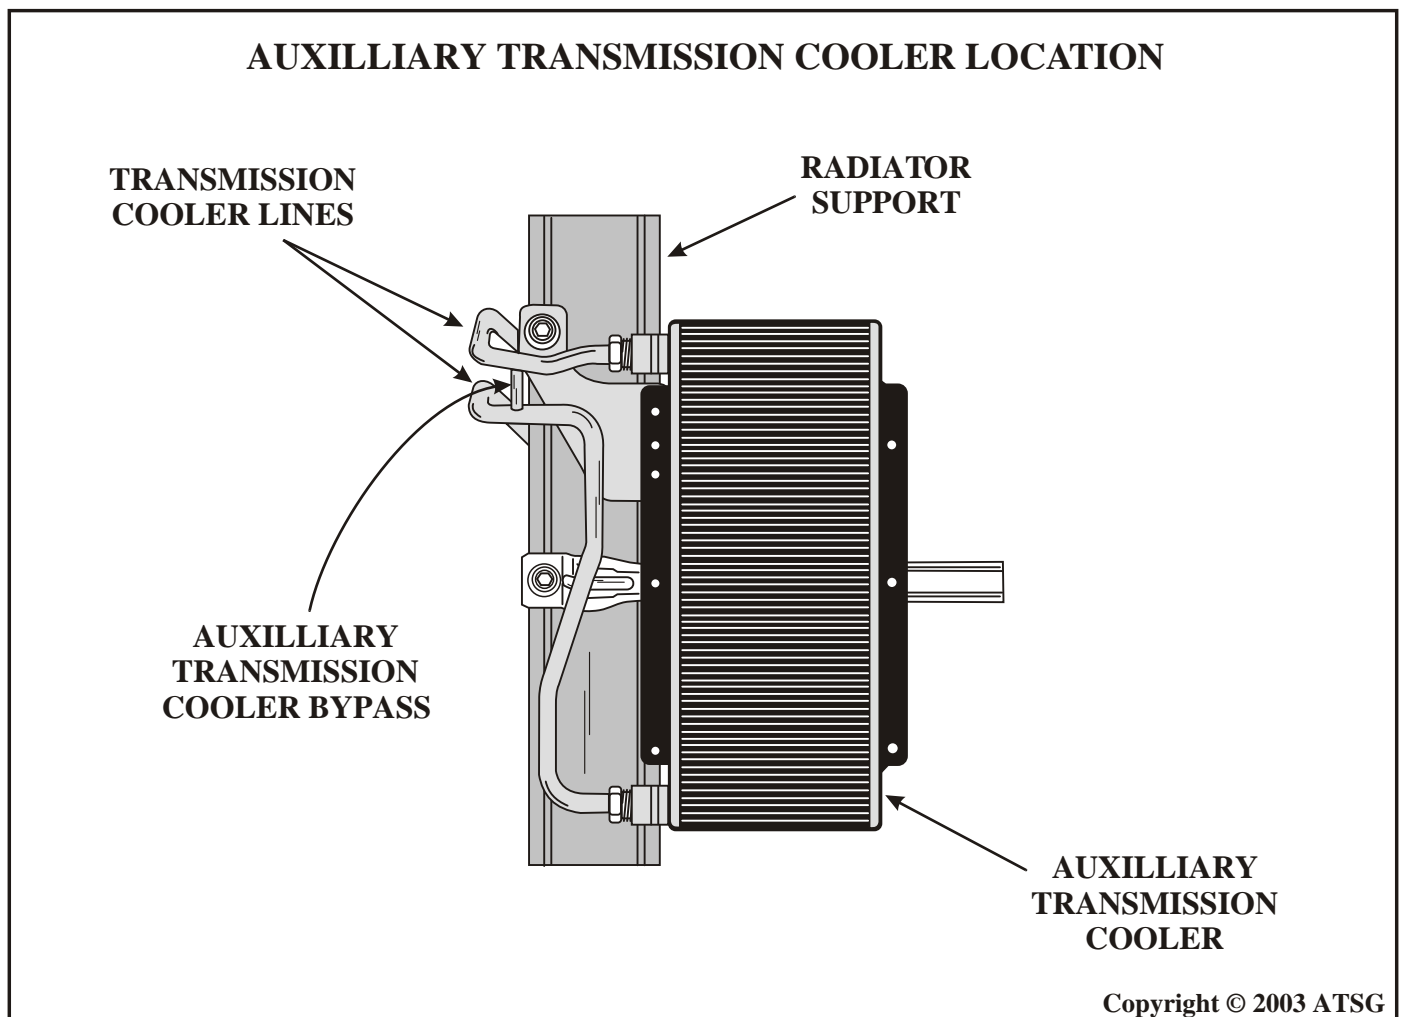
Figure 1

CAUSE: The cause may be, a restricted Auxillary Transmission Cooler. **NOTE:** During the "flushing" process, this may be overlooked because of a "Bypass" tube, as shown in Figure 1, that connects the two cooler lines together, mis-leading the technician into thinking that the Auxillary Transmission Cooler is clear. The Auxillary Transmission Cooler can not be flushed very easily because of its fin type construction, as shown in Figure 2 (*Note: the Auxillary Cooler has a thermal bypass that does not open until the fluid or cleaning solvent is at temperatures around 100° F*). This can also cause valves to hang as well as continual clogging of the Governor Solenoid Screen.

CORRECTION: Replace the Auxillary Transmission Cooler as needed.

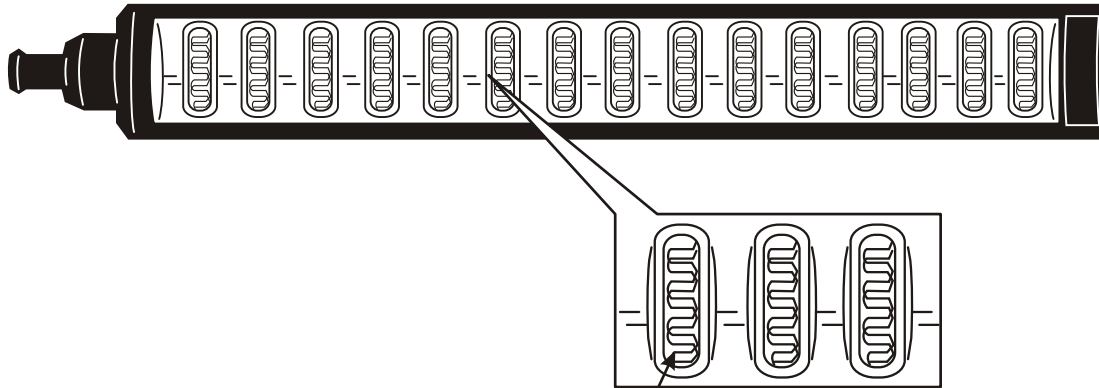
Figure 2

AUXILLIARY TRANSMISSION COOLER CUT-AWAY

***THE AUXILLARY TRANSMISSION COOLER HAS
A FIN TYPE CONSTRUCTION WHICH MAKES
COOLER FLUSHING ALMOST IMPOSSIBLE***
