FORD 5R110W "Torqshift"

INTERNAL HARNESS OR SOLENOID BODY SERVICE

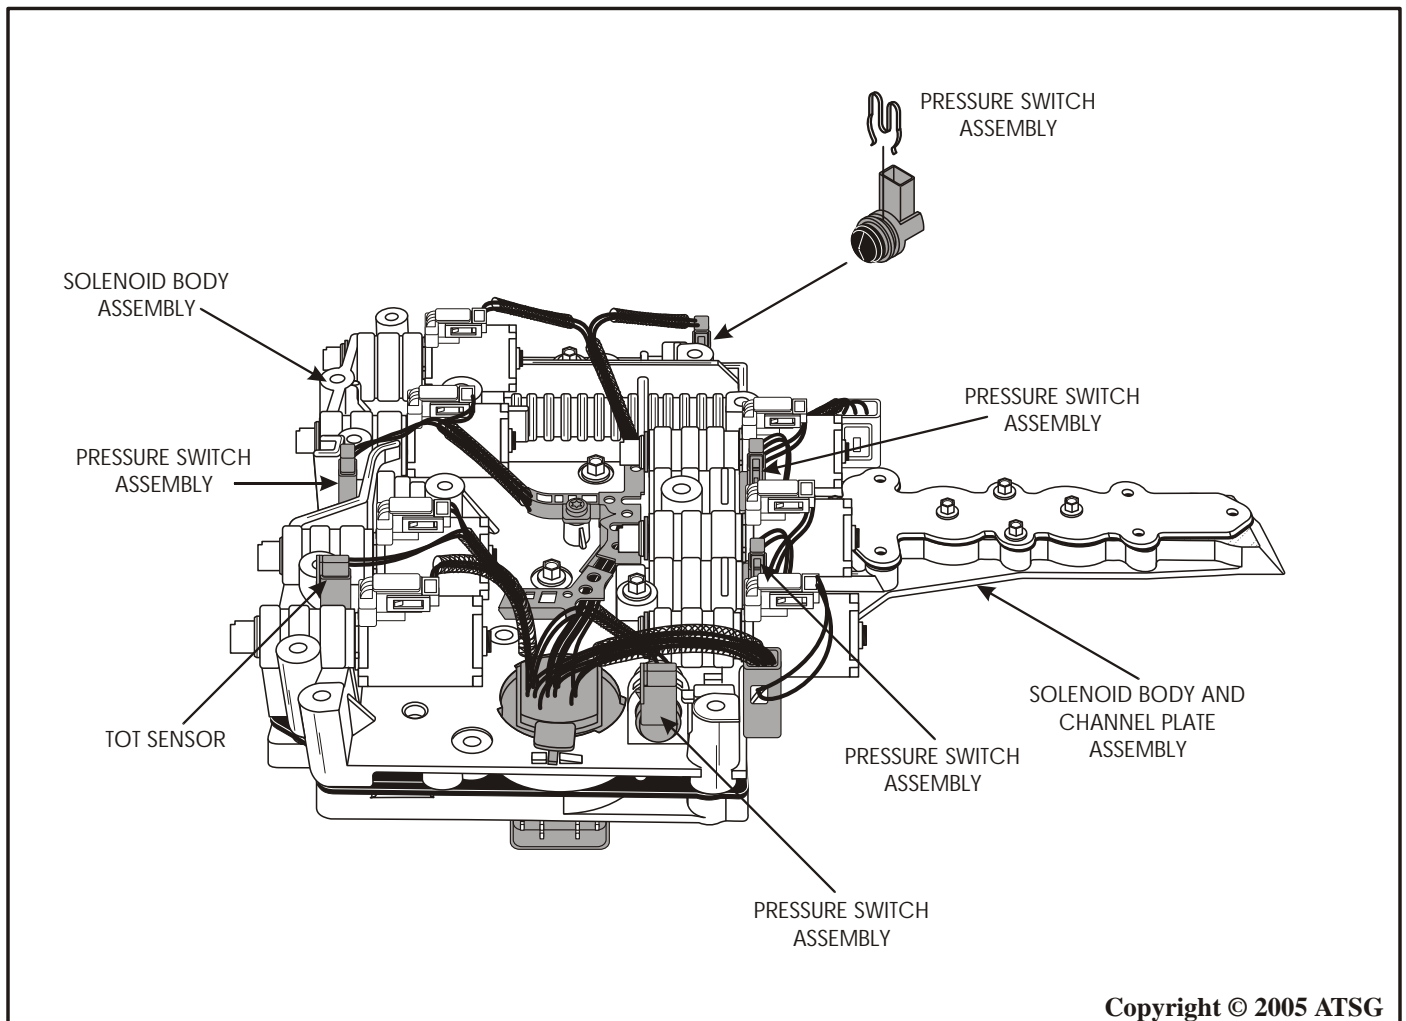
1. You may have to install a new service harness, without pressure switch connectors, into a unit that has pressure switches in the solenoid body. (See Figure 1 for locations)
2. You may have to install a new service solenoid body, without pressure switches, into a unit that has the original internal harness with pressure switch connectors. (See Figure 1 for locations)

Note: *These are both acceptable repairs and will not affect the function or operation of the transmission. Use of the pressure switch input was dropped from the vehicle calibration before the 2003 model year went into production.*
