# Technical Service Information

## THM 4L80-E

### HIGH LINE PRESSURE (NO BANANA PARTS)

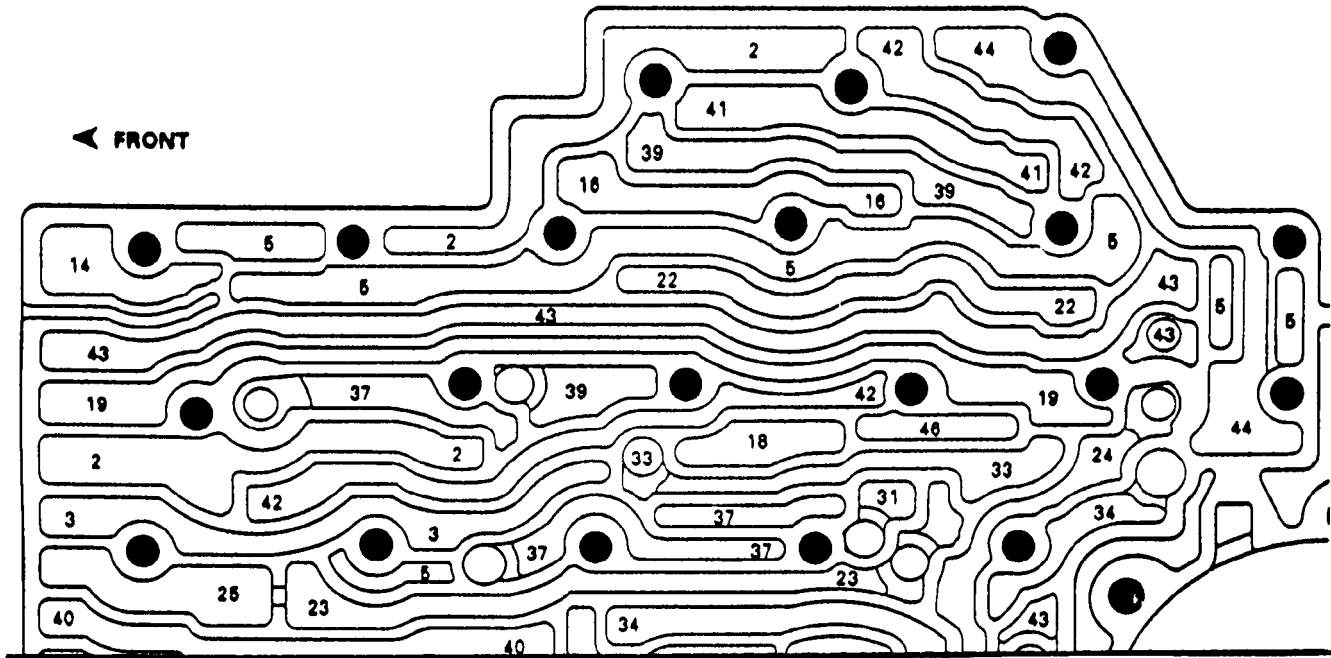
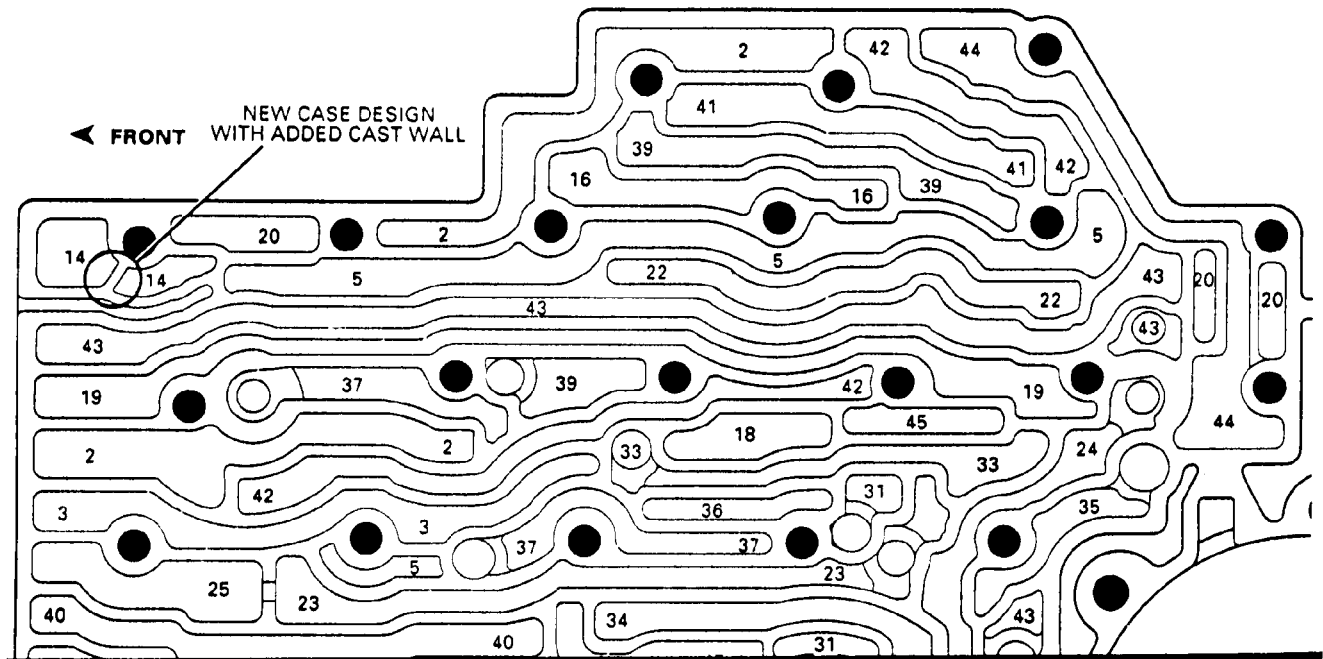
Figure 1

(1) TRANSMISSION CASE - Oil dam added in the torque signal circuit in the location shown in Figure 1, to orifice torque signal oil thru the revised spacer plate to the boost valve.

**CORRECTION:** Install compatible parts. See acceptable combinations listed below.

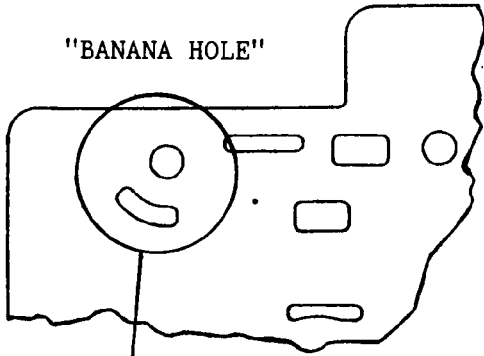
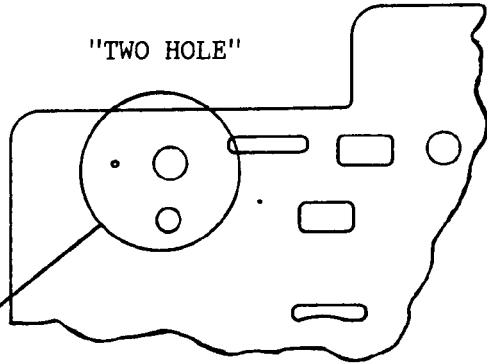
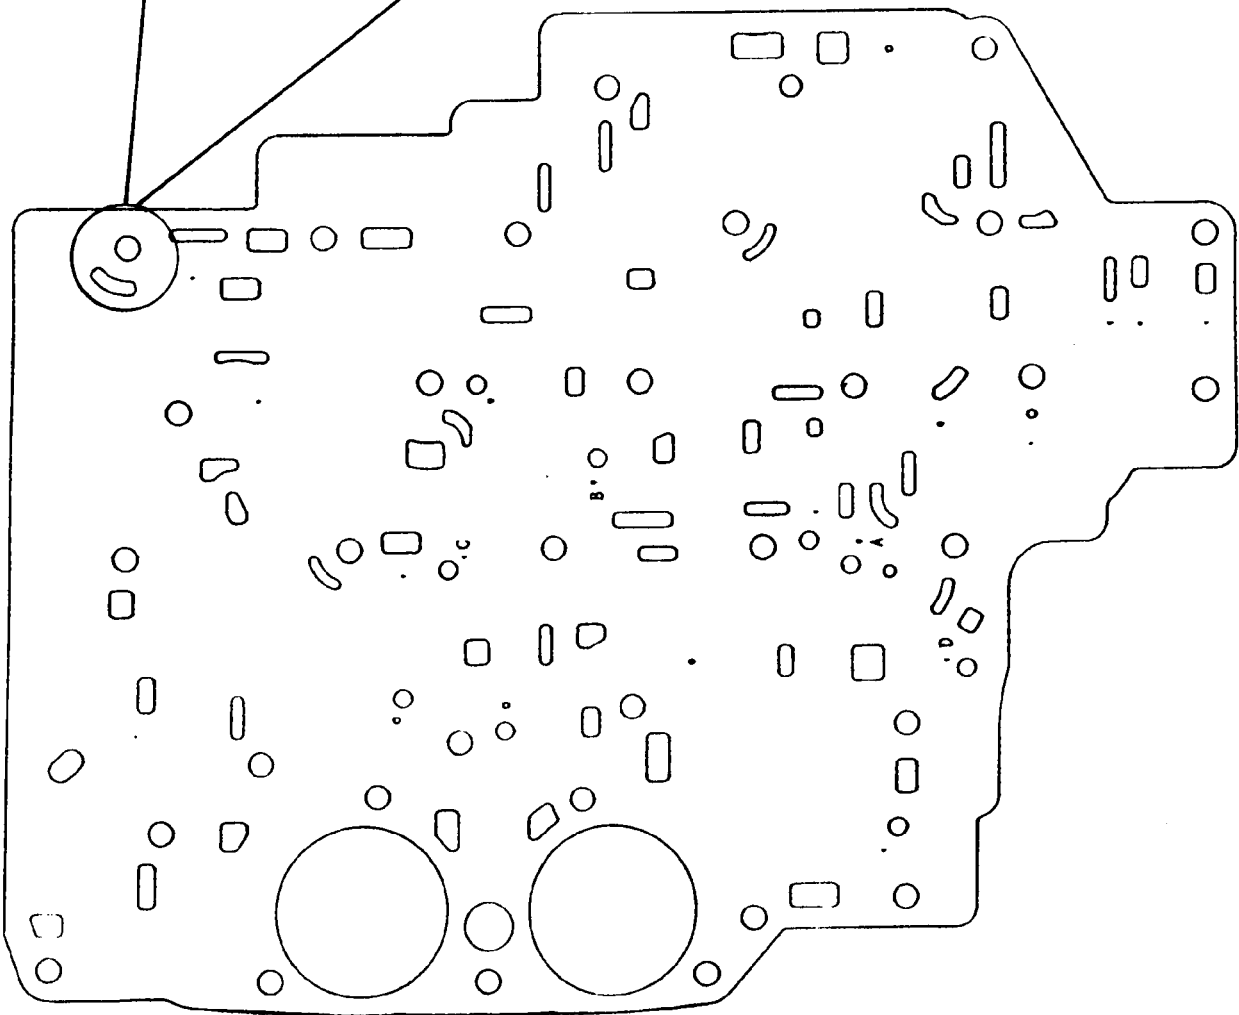
Figure 2

(2) VALVE BODY SPACER PLATE - The "Banana Hole" in the previous spacer plate was eliminated, with a round feed hole and orifice hole added on each side of the new dam in the case to make orifice effective (See Figure 2).

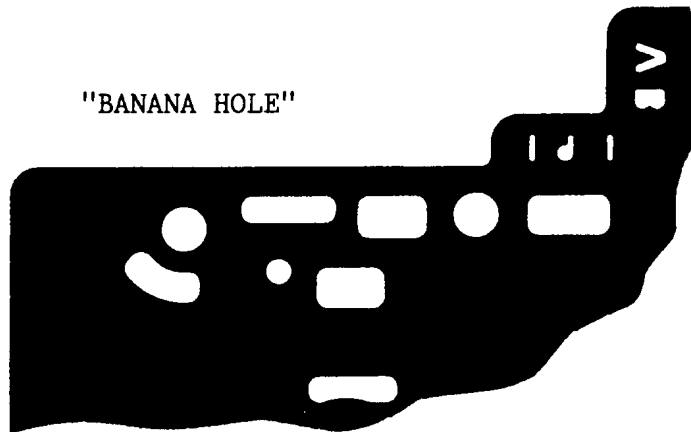
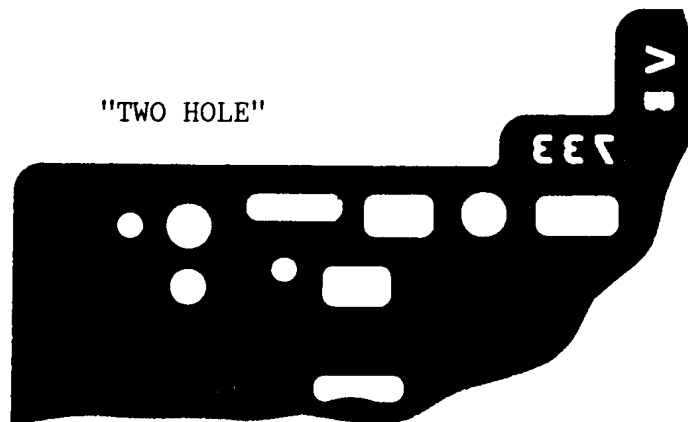
Figure 3

(3) SPACER PLATE GASKETS - Revised hole configuration to accommodate the new spacer plate and case, as shown in Figure 3.
