TOYOTA A-340 SERIES TRANSMISSION FLUID OVERHEATS

COMPLAINT: Some Toyota vehicles, equipped with the A-340 series transmissions, may exhibit a condition of Transmission Fluid Overheating due to poor cooler flow, while the Torque Converter Clutch is "ON."

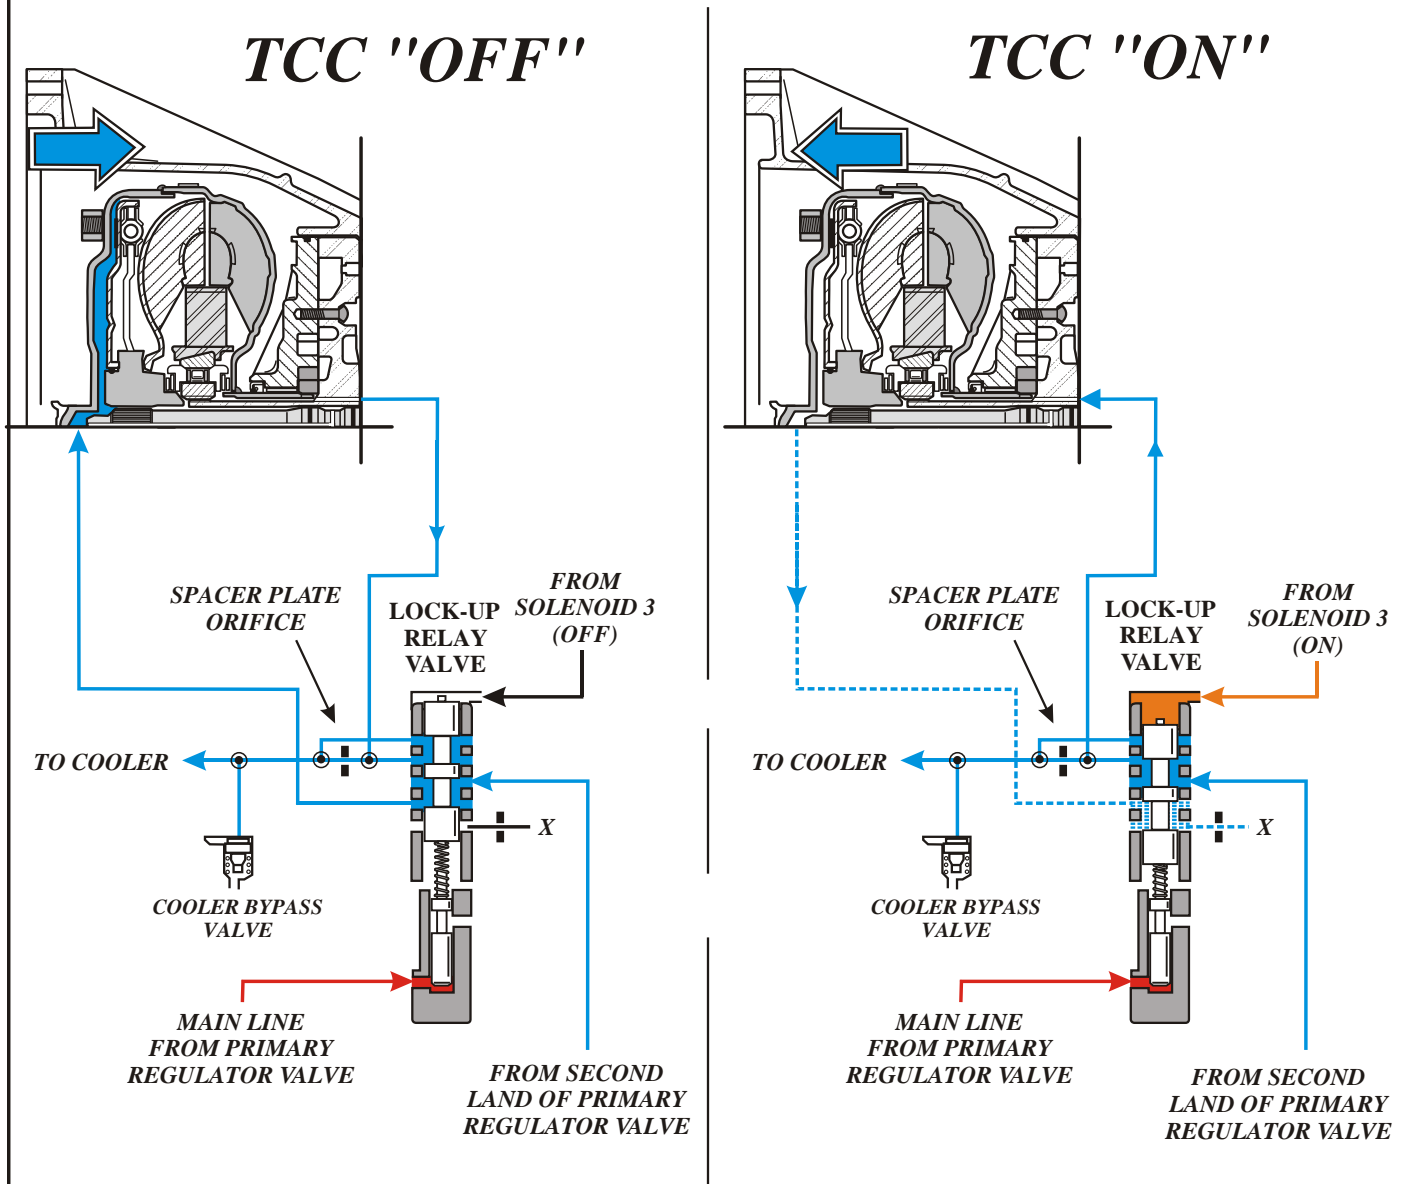
PARTIAL HYDRAULIC SCHEMATIC OF TORQUE CONVERTER CLUTCH OPERATION

- A worn Primary Regulator Boost Valve Sleeve, causing line pressure to be higher than normal, placing the Primary Regulator Valve in a position where it restricts Converter Apply Pressure, that is sent to the Lock-up Relay Valve, as shown in the partial circuit diagram in Figure 1.
- A worn Lock-up Relay Valve Sleeve, causing a loss of Converter Apply Pressure and or Solenoid 3 signal pressure, as shown in the partial hydraulic circuit diagram in Figure 1.

SUMMARY: When the Torque Converter Clutch is "OFF," Converter pressure, from the 2nd land of the Primary Regulator Valve goes thru the 2nd and 3rd land of the Lock-up relay valve, thru the torque Converter and returns to the Lock-up Relay Valve between the 1st and 2nd land where it is connected to the "To Cooler passage."

When the Torque Converter Clutch is "ON," Solenoid 3 is turned ON which strokes the Lock-up Relay Valve and switches the Converter pressure, from the 2nd land of the Primary Regulator Valve, to Converter Apply pressure. This pressure is directed thru the 1st and 2nd land of the Lock-up Relay Valve to apply side of the Torque Converter Clutch and, thru an orifice, to the "To Cooler Passage."

PROBLEM AREAS: The first problem area is from the Primary Regulator Boost Sleeve. Wear in this sleeve can cause Line pressure to be higher than normal minimizing Converter pressure from the 2nd land of the Primary Regulator Valve. The second problem area is wear in the Lock-up Relay Valve Sleeve. Wear in this sleeve may cause a loss of Converter Apply Pressure while in Lock-up and even a loss of Solenoid 3 signal pressure, which may not fully stroke the Lock-up Relay Valve against its spring.

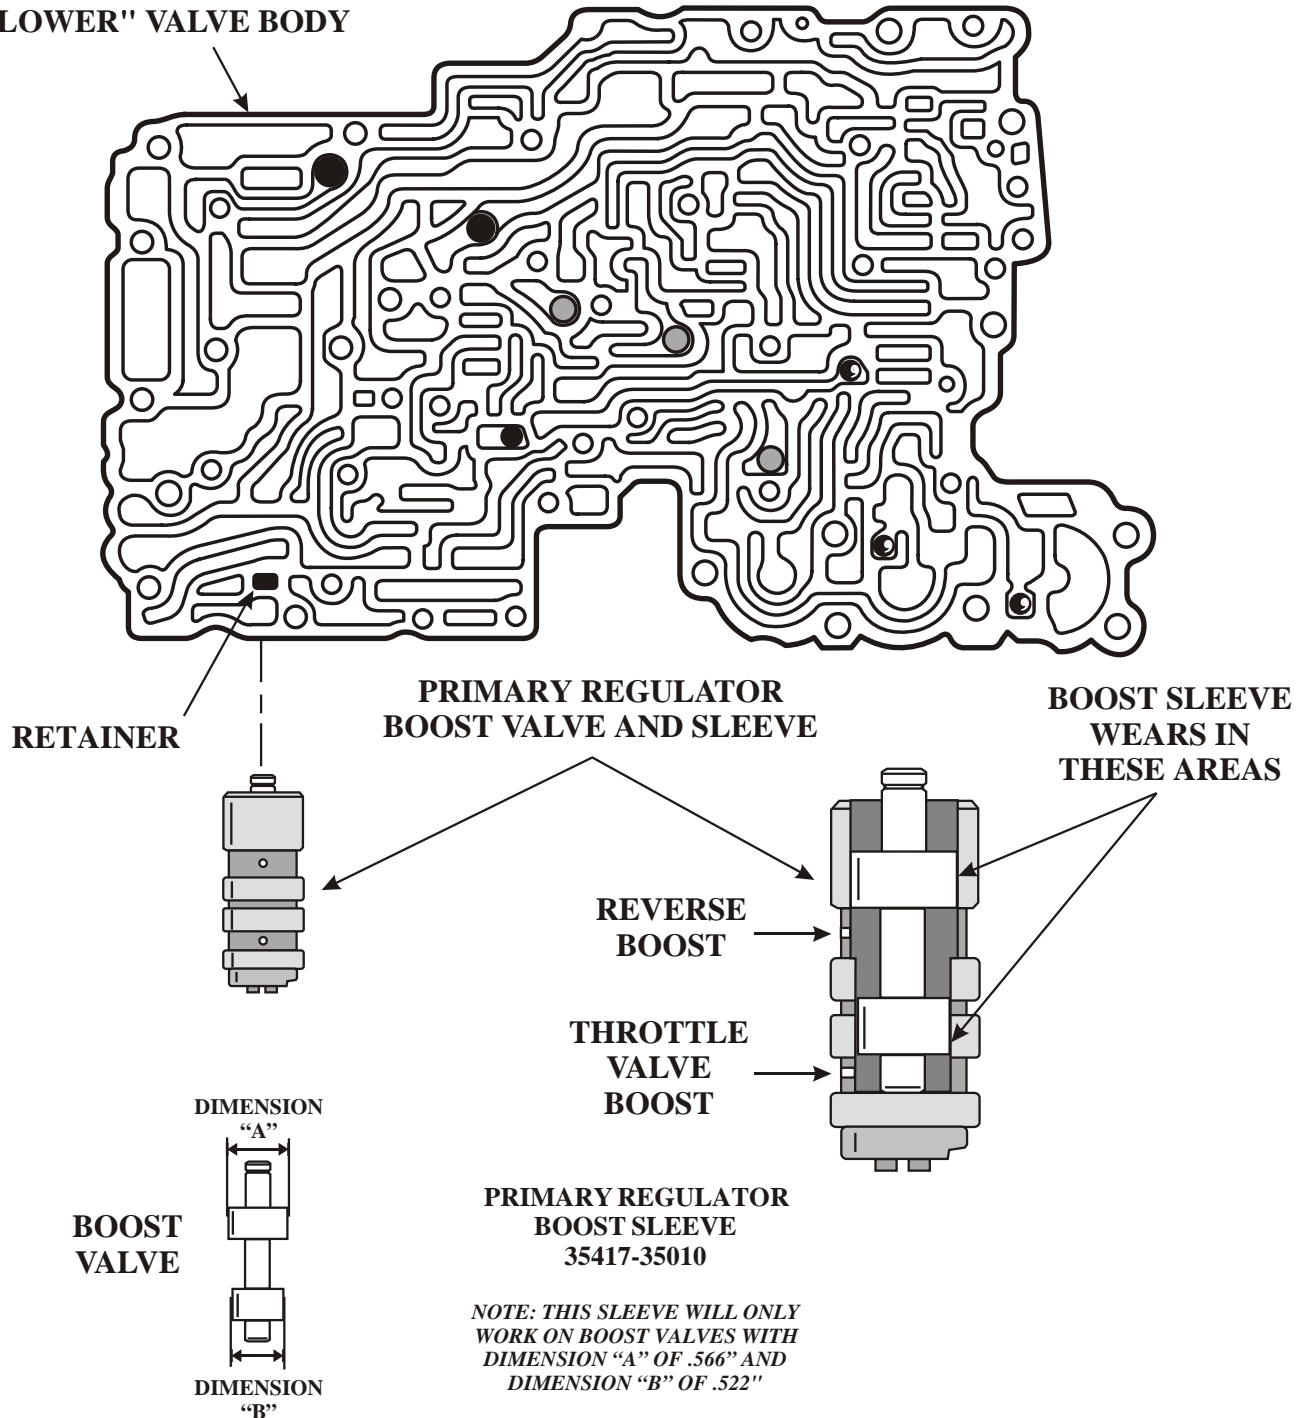
PRIMARY REGULATOR VALVE LOCATION

NOTE: Wear in the Primary Boost Valve Sleeve may place the Primary Regulator valve in a position which can cause higher than normal line pressure, which limits Torque Converter Apply Pressure as well as cooler flow.

- Refer to Figure 2 and locate the Primary Regulator Valve Boost Sleeve and check for wear in the areas shown. Replace the sleeve as necessary.
- Refer to Figure 3 and locate the Lock-up Relay Valve line-up. Check for wear as shown and replace as necessary.

Primary Regulator Boost Sleeve (Toyota part no.)35417-35010

NOTE: This part number is for the Boost Valve dimensions as shown in Figure 2.

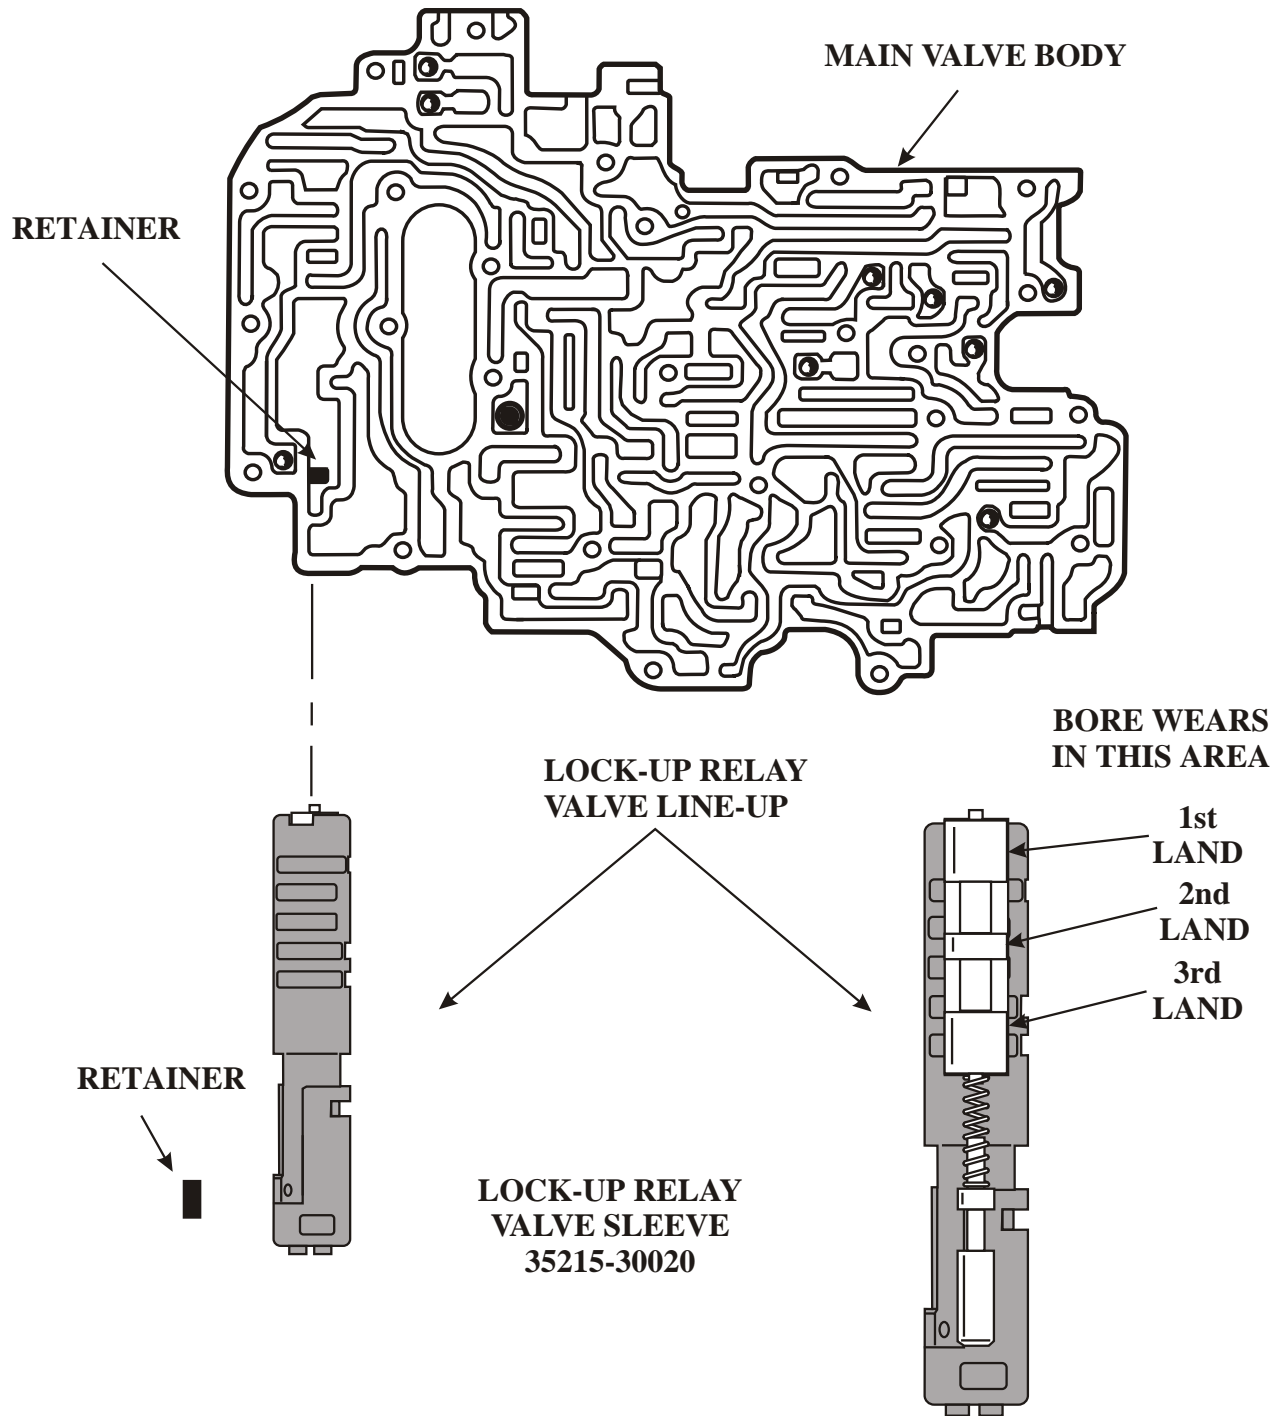
Figure 3

LOCK-UP RELAY VALVE LOCATION

Wear in the 1st land of the Lock-up Relay Valve bore may cause a loss of Solenoid no.3 signal pressure, which may place the valve into a partially stroked position instead of a fully stroked position, when the TCC is applied. Wear in the 2nd and 3rd land, while the TCC is ON, may cause Converter apply pressure to be connected to the already exhausting converter off pressure, which may cause a loss of converter apply pressure as well as cooler flow.

Lock-Up Relay Valve Sleeve (Toyota part no.)35215-30020

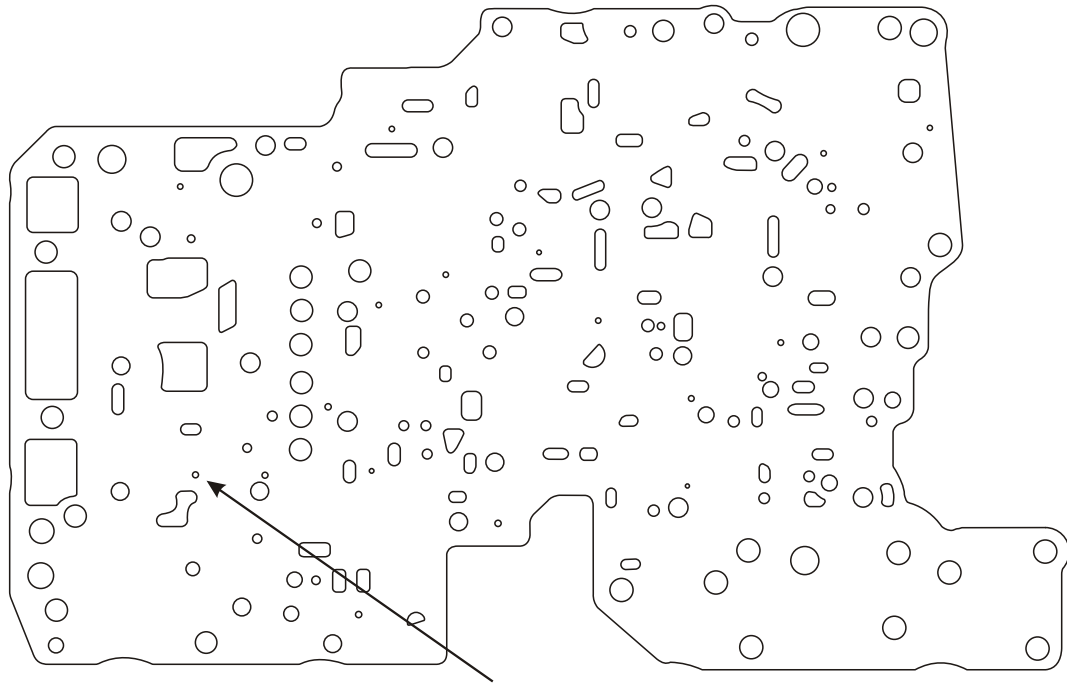
MAIN CONTROL VALVE BODY SPACER PLATE

**TO COOLER
ORIFICE**

**O.E. DIAMETER
IS .059"
(ORIFICE SIZE MAY VARY)**

NOTE: Refer to Figure 4 and enlarge the orifice, in the Main Valve Body Spacer Plate, .040" to .050" larger than its original size (the size shown may vary model to model). This will help increase cooler flow.

**ENLARGE THIS ORIFICE
.040" TO .050" LARGER
THAN THE ORIGINAL SIZE**
