# Technical Service Information

## **FORD 4R44E/4R55E ERRATIC OR NO LINE PRESSURE RISE**

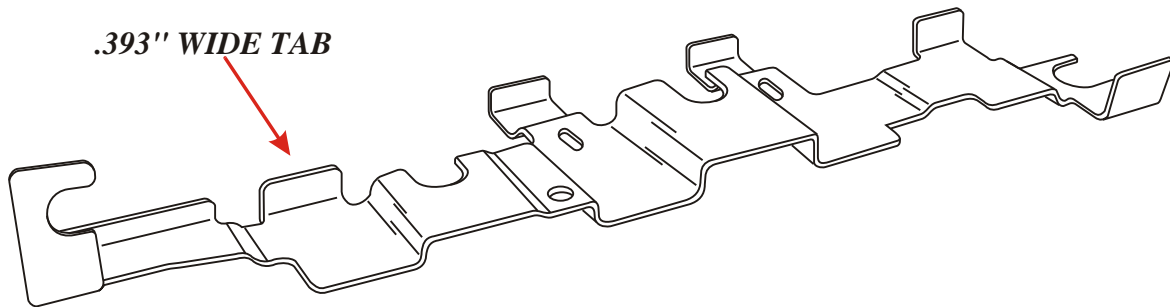
## ***PREVIOUS DESIGN RETAINER***

**CAUSE:** The cause may be the EPC solenoid has blown out of the valve body due to a broken solenoid retaining bracket, holding in the EPC solenoid.

**CORRECTION:** Replace the early style solenoid retaining bracket, with the new design retaining bracket, as shown in Figures 1 & 2.

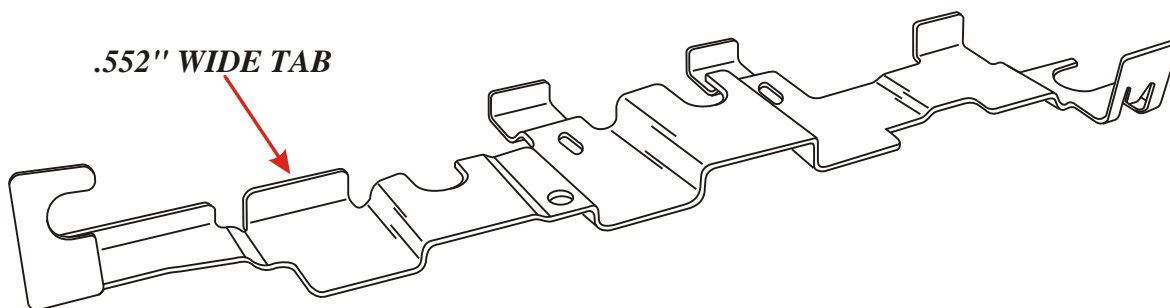
Figure 2

## ***NEW DESIGN RETAINER PART NUMBER XL2Z-7L491-AA***

Solenoid Retaining Bracket (New Design) .....XL2Z-7L491-AA
