Technical Service Information

FORD 5R55N NO 4TH OR 5TH GEAR

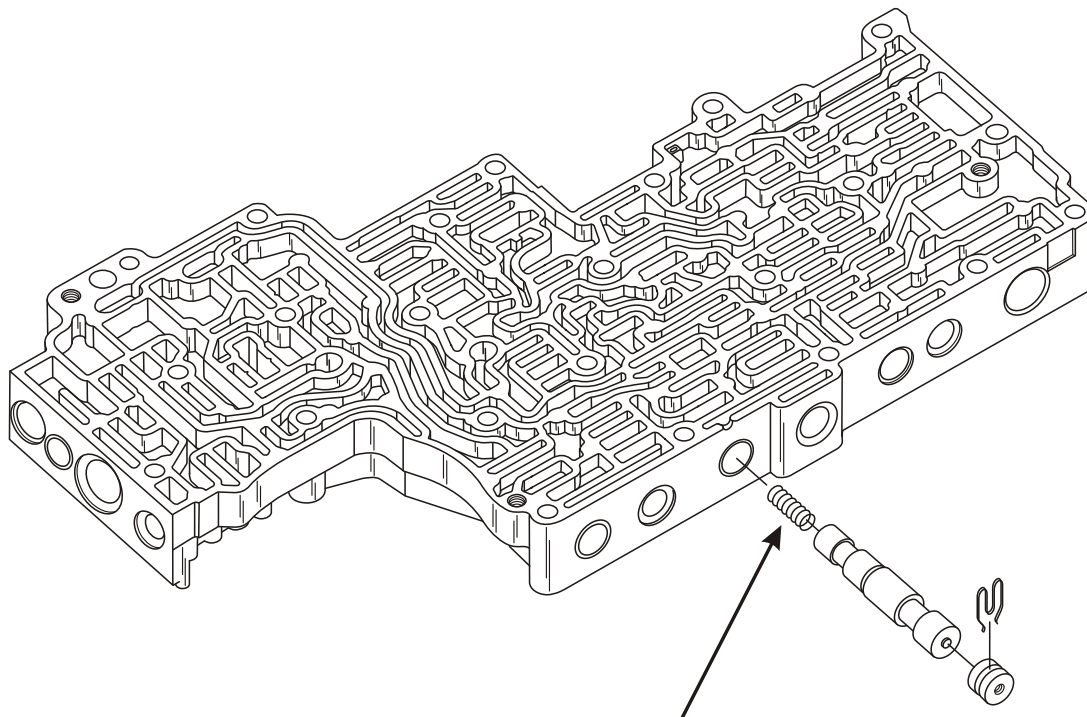
Figure 1

CAUSE: One possible cause is a broken 4-3 Pre-stroke Intermediate Band Control Spring, as shown in Figure 1.

*4-3 Pre-stroke Intermediate
Band Control Spring*

CORRECTION: Replace spring from another 5R55N valve body or find a spring that is as close to the original spring, dimension listed below. Sonnax® will have one available soon under part number 56947J-S1

FREE LENGTH	.880"
DIAMETER	.294"
WIRE DIAMETER	.033"
APPROX. COILS	8

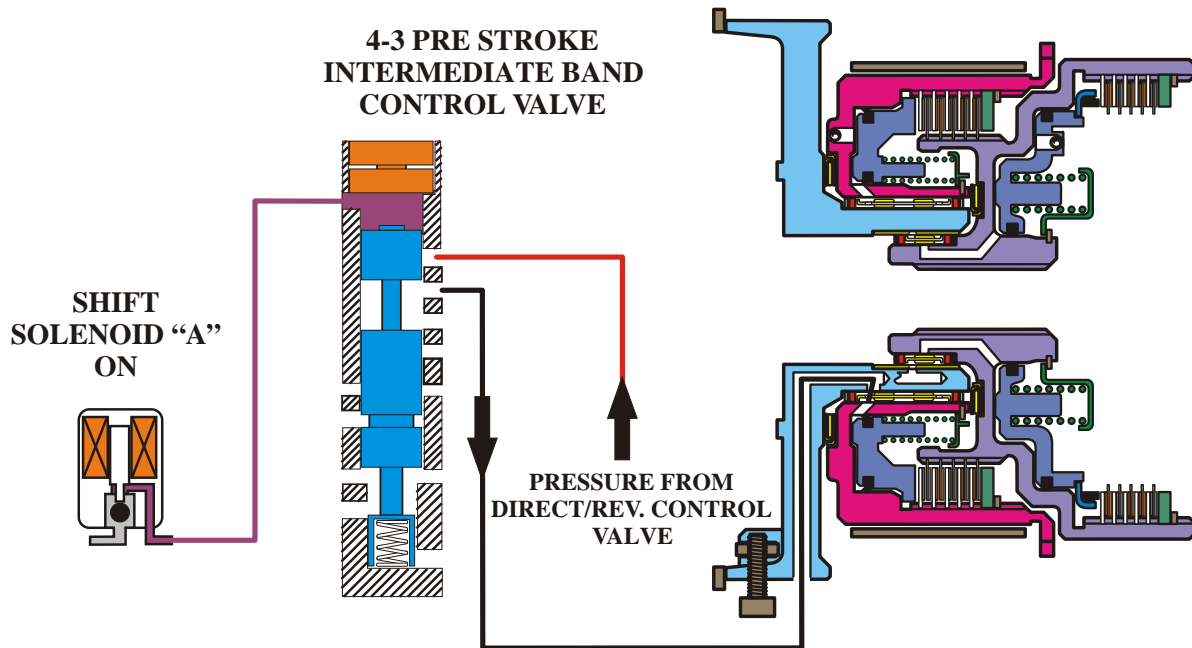
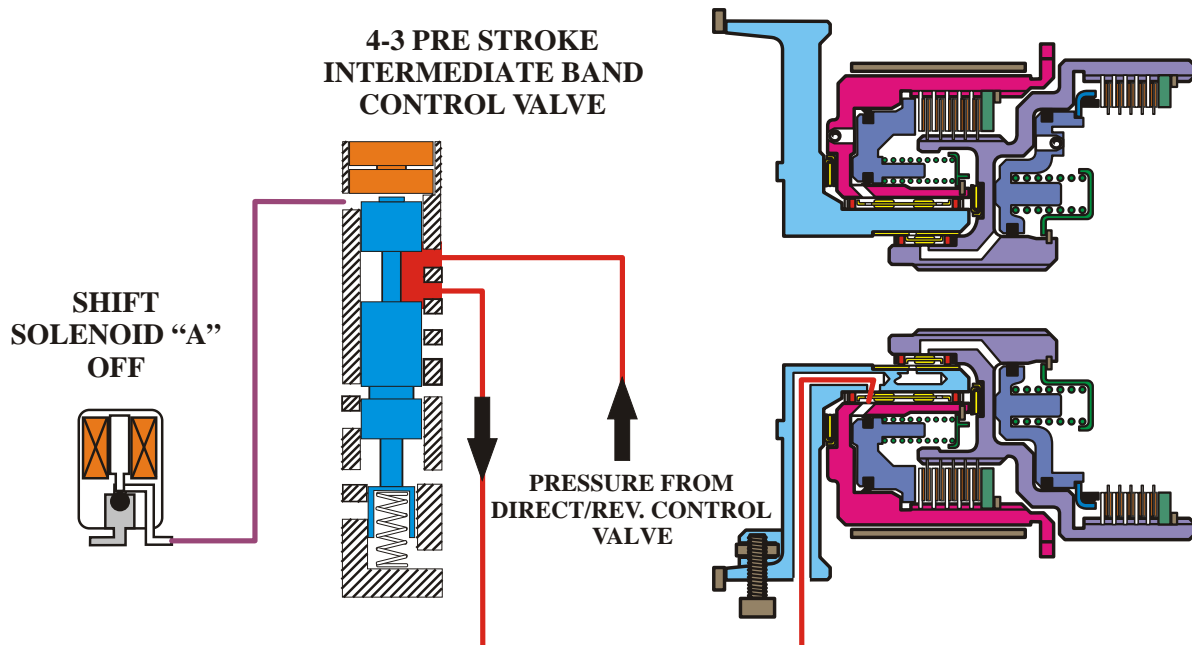
Figure 2

4-3 PRE STROKE INTERMEDIATE BAND CONTROL VALVE POSITION IN 3rd GEAR

4-3 PRE STROKE INTERMEDIATE BAND CONTROL VALVE POSITION IN 4th AND 5th GEAR

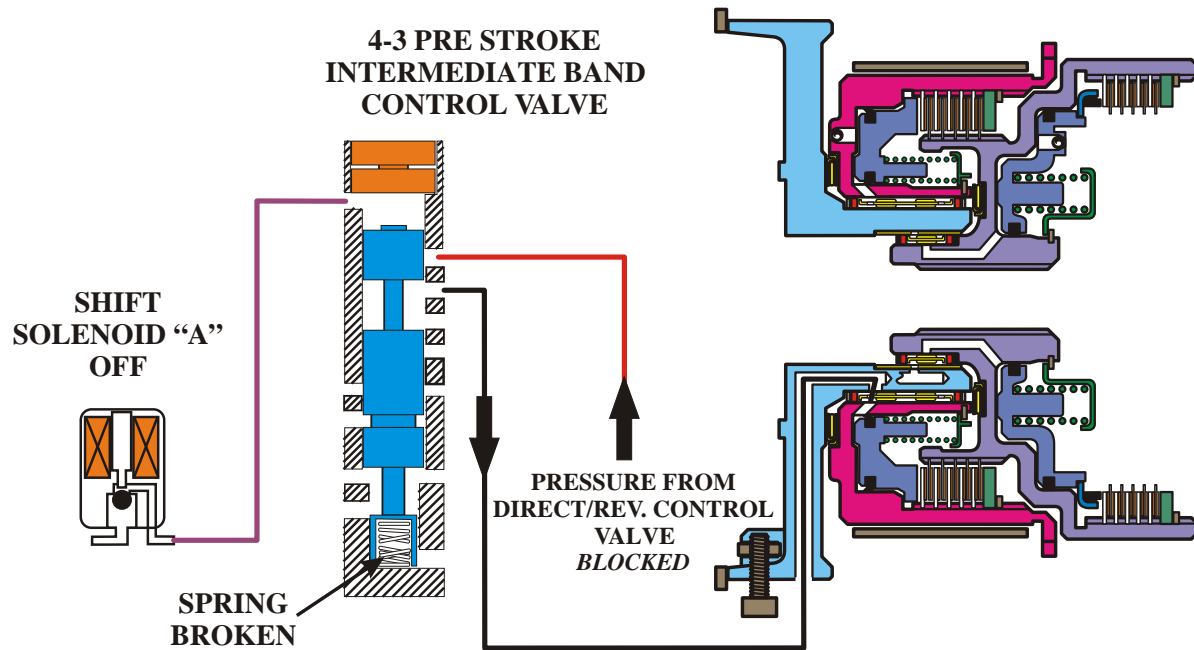
Figure 3

REASON: When the 4-3 Pre-stroke Intermediate Band control spring breaks, the passage to the Direct Clutch is blocked by the valve as shown in partial schematic in Figure 3. See Figure 2 for a partial schematic showing the function of the 4-3 Pre-stroke Intermediate Band Control Valve.

4-3 PRE STROKE INTERMEDIATE BAND CONTROL VALVE POSITION IN 4th AND 5th GEAR SPRING BROKEN
