ACURA MODEL "RO" NO 2-3 UPSHIFT COLD

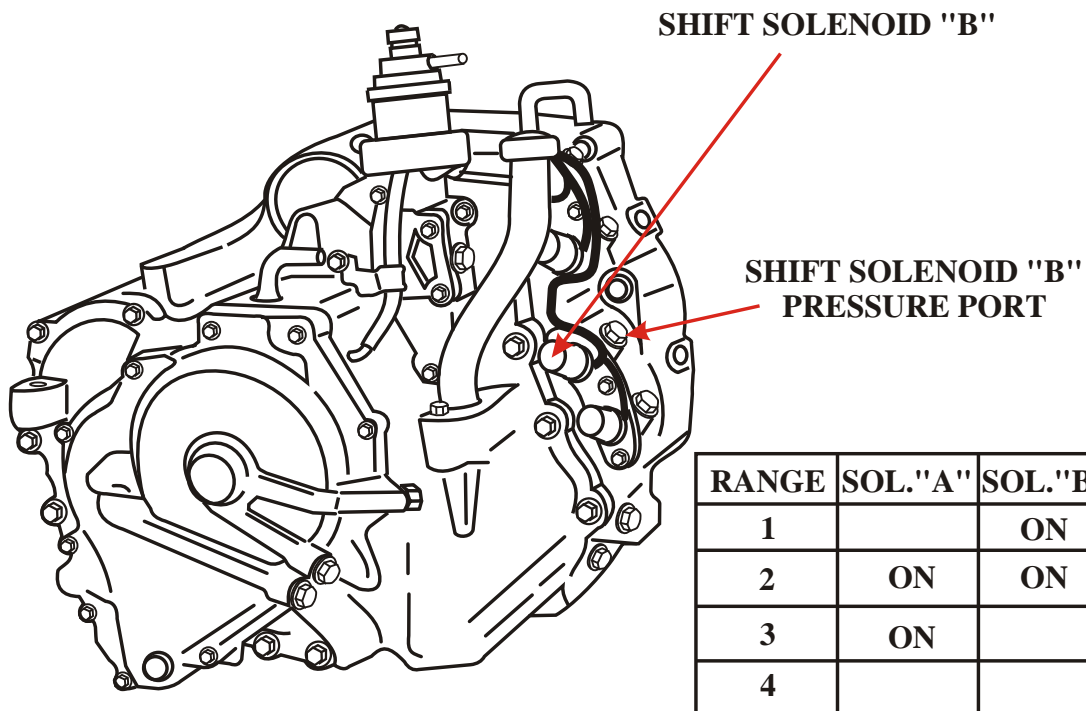
Figure 1

SOLENOID AND PORT LOCATION

ALL SOLENOIDS NORMALLY CLOSED

CORRECTION: To correct this condition first install a 0-100 psi. pressure gage onto the solenoid "B" pressure port when cold. In first and second gear solenoid "B" pressure is between 0 and 10 psi. In third gear solenoid "B" pressure should be 70-80 psi. If the solenoid "B" pressure stays at 0-10 psi. until the vehicle warms up, replace the shift solenoids. If solenoid "B" pressure increases to 70-80psi. than the 2-3 shift should have occurred. This would indicate that the 2-3 shift valve is sticking. Refer to Figure 2 to locate and ensure that the 2-3 shift valve falls in and out of it's bore on it's own weight. NOTE: Refrigerate the valve body before re-assembly to be sure that the valve is free.

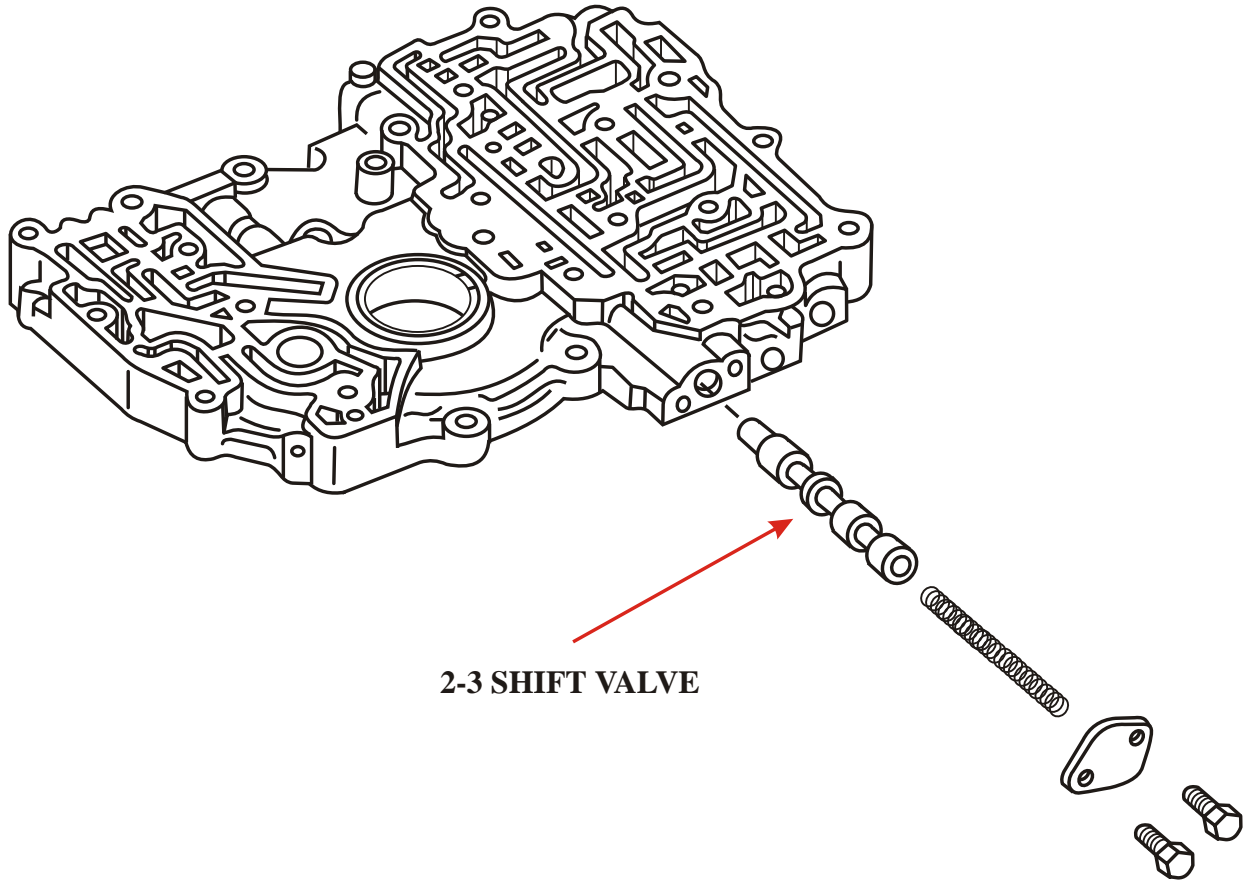
Figure 2

CAUSE: The cause may be, a stuck open "B" solenoid when cold or a sticking 2-3 shift valve in the valve body when cold.

MAIN VALVE BODY
