Technical Service Information

THM 4L60-E ACCUMULATOR PISTON WEAR

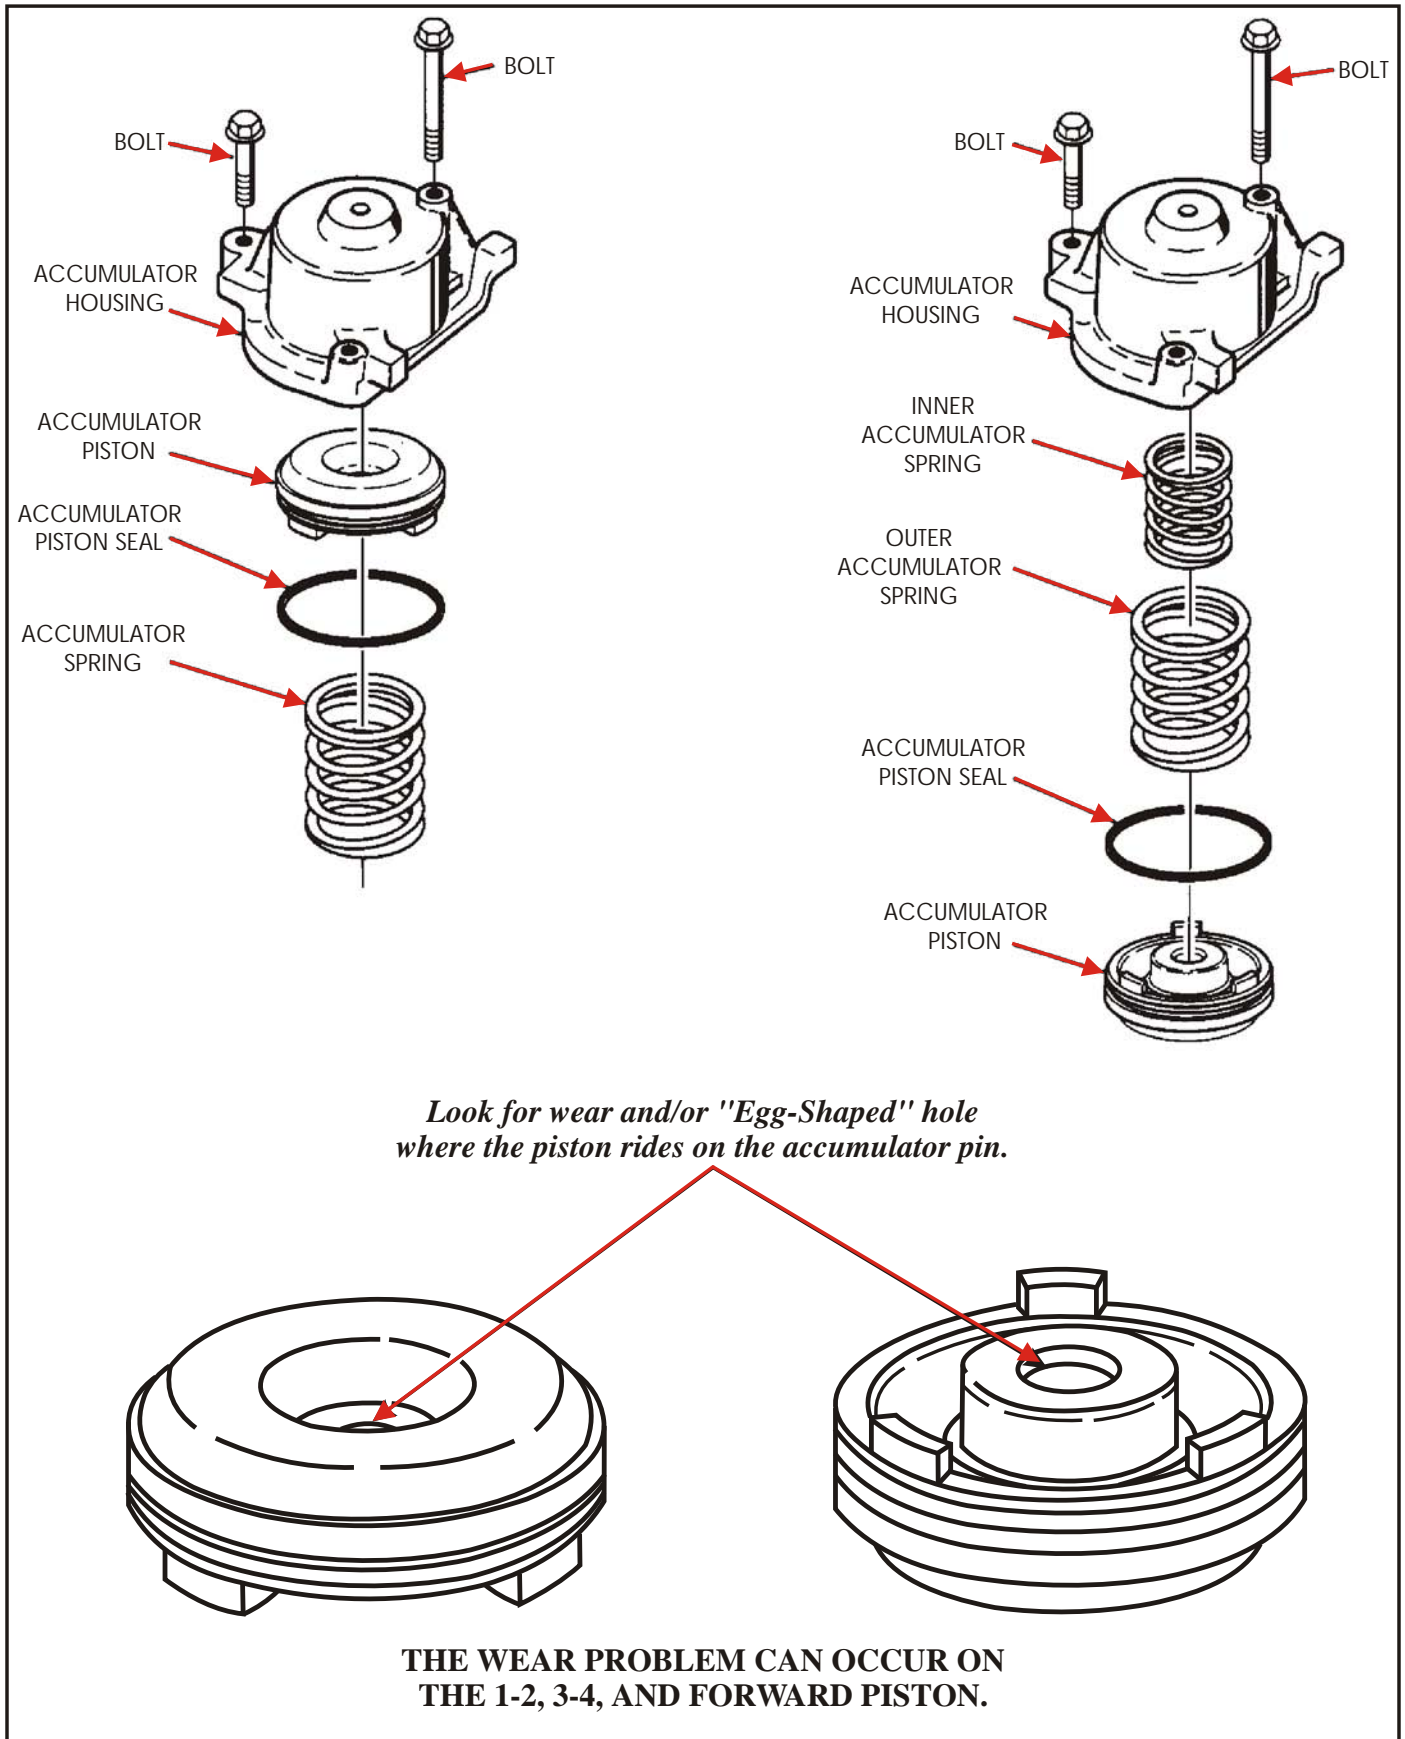
Figure 1

COMPLAINT: When the accumulator piston wears with an "Egg-Shaped" hole where the accumulator piston strokes, it can create a delayed engagement to drive, slipping condition in forward gears, slipping 1-2 shift, slipping 3-4 shift, depending on which accumulator piston is worn, and how bad it is worn.

CAUSE: The cause may be, a worn accumulator piston pin bore (See Figure 1).

CORRECTION: Replace the accumulator piston with the proper part number from "Service Information" as shown below.
