NISSAN FRONT OR REAR DRIVE PREMATURE PLANETARY FAILURE

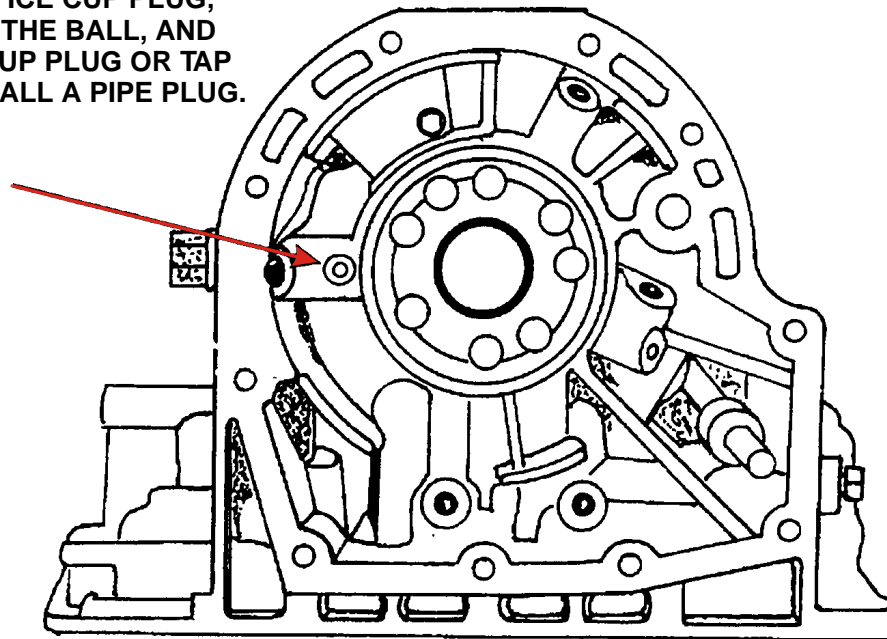
Figure 2

COMPLAINT: Planetary gears failed due to lack of lubrication, while the hydraulic system and friction material does not seem to be damaged.

CAUSE: Lubrication may be restricted or even totally cut off due to clutch material from the converter clutch clogging the fins or tubes inside of the radiator cooler.

VIEW FROM REAR OF CASE

Check the case bushings for wear and replace them if they are worn. Also make sure that the case bushings have not moved so that they block the lubrication feed passage to the output shaft. To assure maximum lube to the output shaft and planets, remove and discard the orificed cup plug, the lube relief ball, and the spring as shown in figure 2 and **INSTALL A SOLID PLUG IN PLACE OF THE ORIFICED CUP PLUG.**

**REMOVE THIS ORIFICE CUP PLUG,
THE SPRING, AND THE BALL, AND
INSTALL A SOLID CUP PLUG OR TAP
THE CASE AND INSTALL A PIPE PLUG.**
