Technical Service Information

ALLISON 1000/2000 SERIES

3RD OR 5TH GEAR STARTS

DTC P0705, P0706, P0708

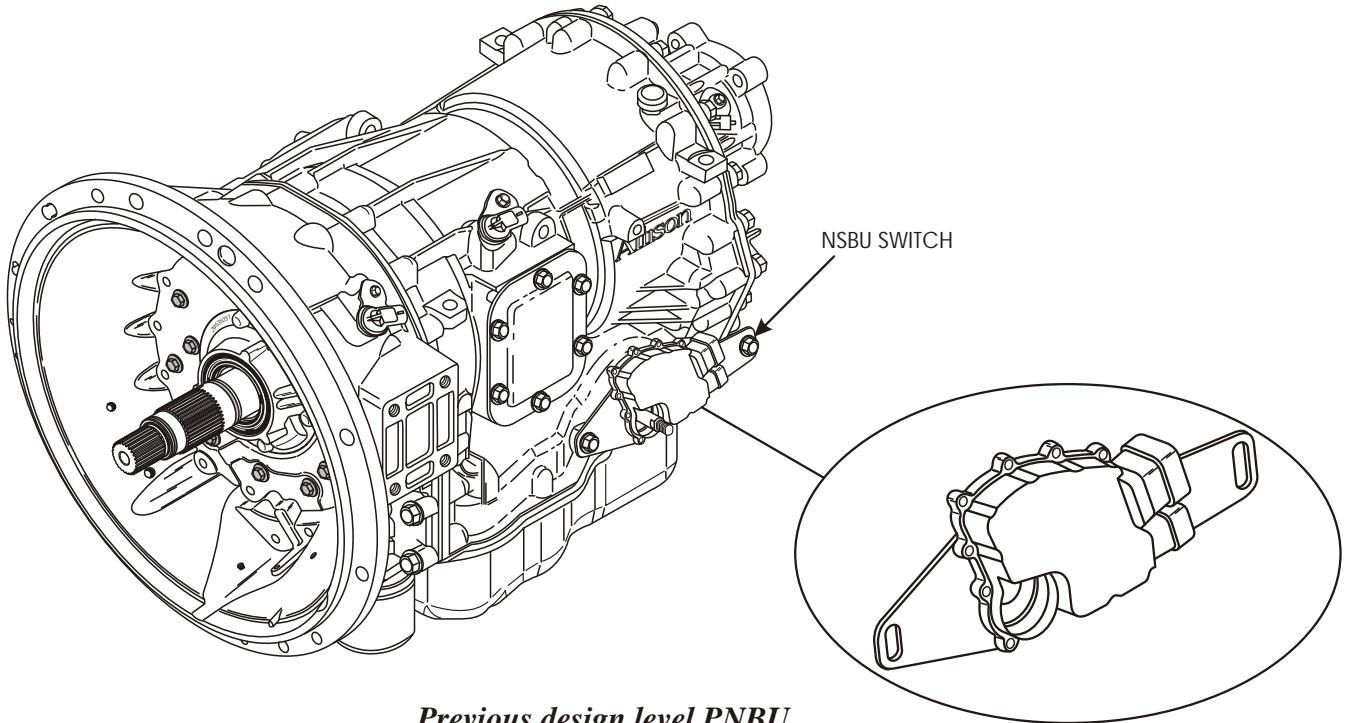
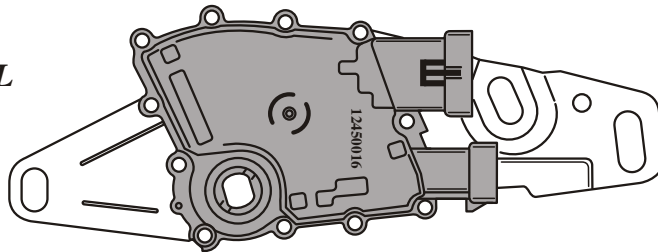
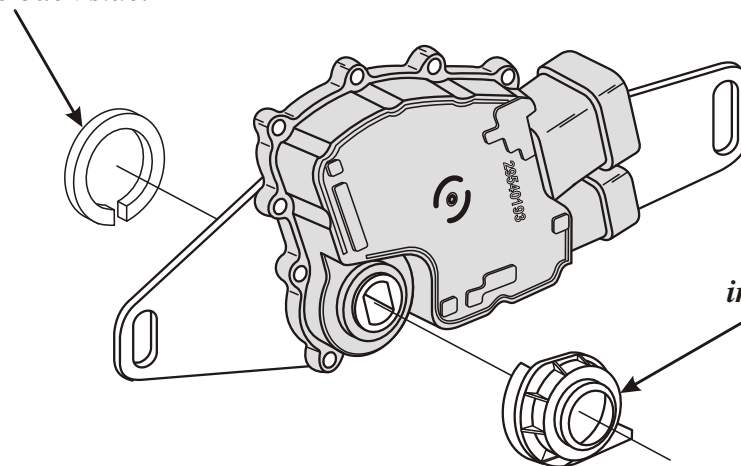
Figure 1

CAUSE: The cause may be, a defective Neutral Start Back-Up (NSBU) switch, created by weather intrusion. The NSBU switch is mounted on the exterior of the transmission and rotated by the manual shaft, as shown in Figure 1.

*Previous design level PNB
Switch is "Black" in color.*

**"PREVIOUS"
DESIGN LEVEL**

*New PNB Switch has
seal glued to back side.*

**"NEW"
DESIGN LEVEL**

*New service package
includes cover for front
side of new switch.*

*New design level PNB Switch is "Tan" in color,
and is available under OEM part number 29540479.*

CORRECTION: There is now available from OEM parts sources, a revised NSBU switch that has improved sealing capabilities to help prevent water intrusion, and is available under OEM part number 29540479. (See Figure 1) Since the original switch is the same part number as the 4L60-E switch, high ambient heat may have caused the sealing compound in the switch to melt and flow into the connectors, sealing the connectors to the switch. There is now available from OEM sources, service repair connectors for both the 7-way and the 4-way connectors under part numbers 15305887 and 15305925 (See Figure 3).

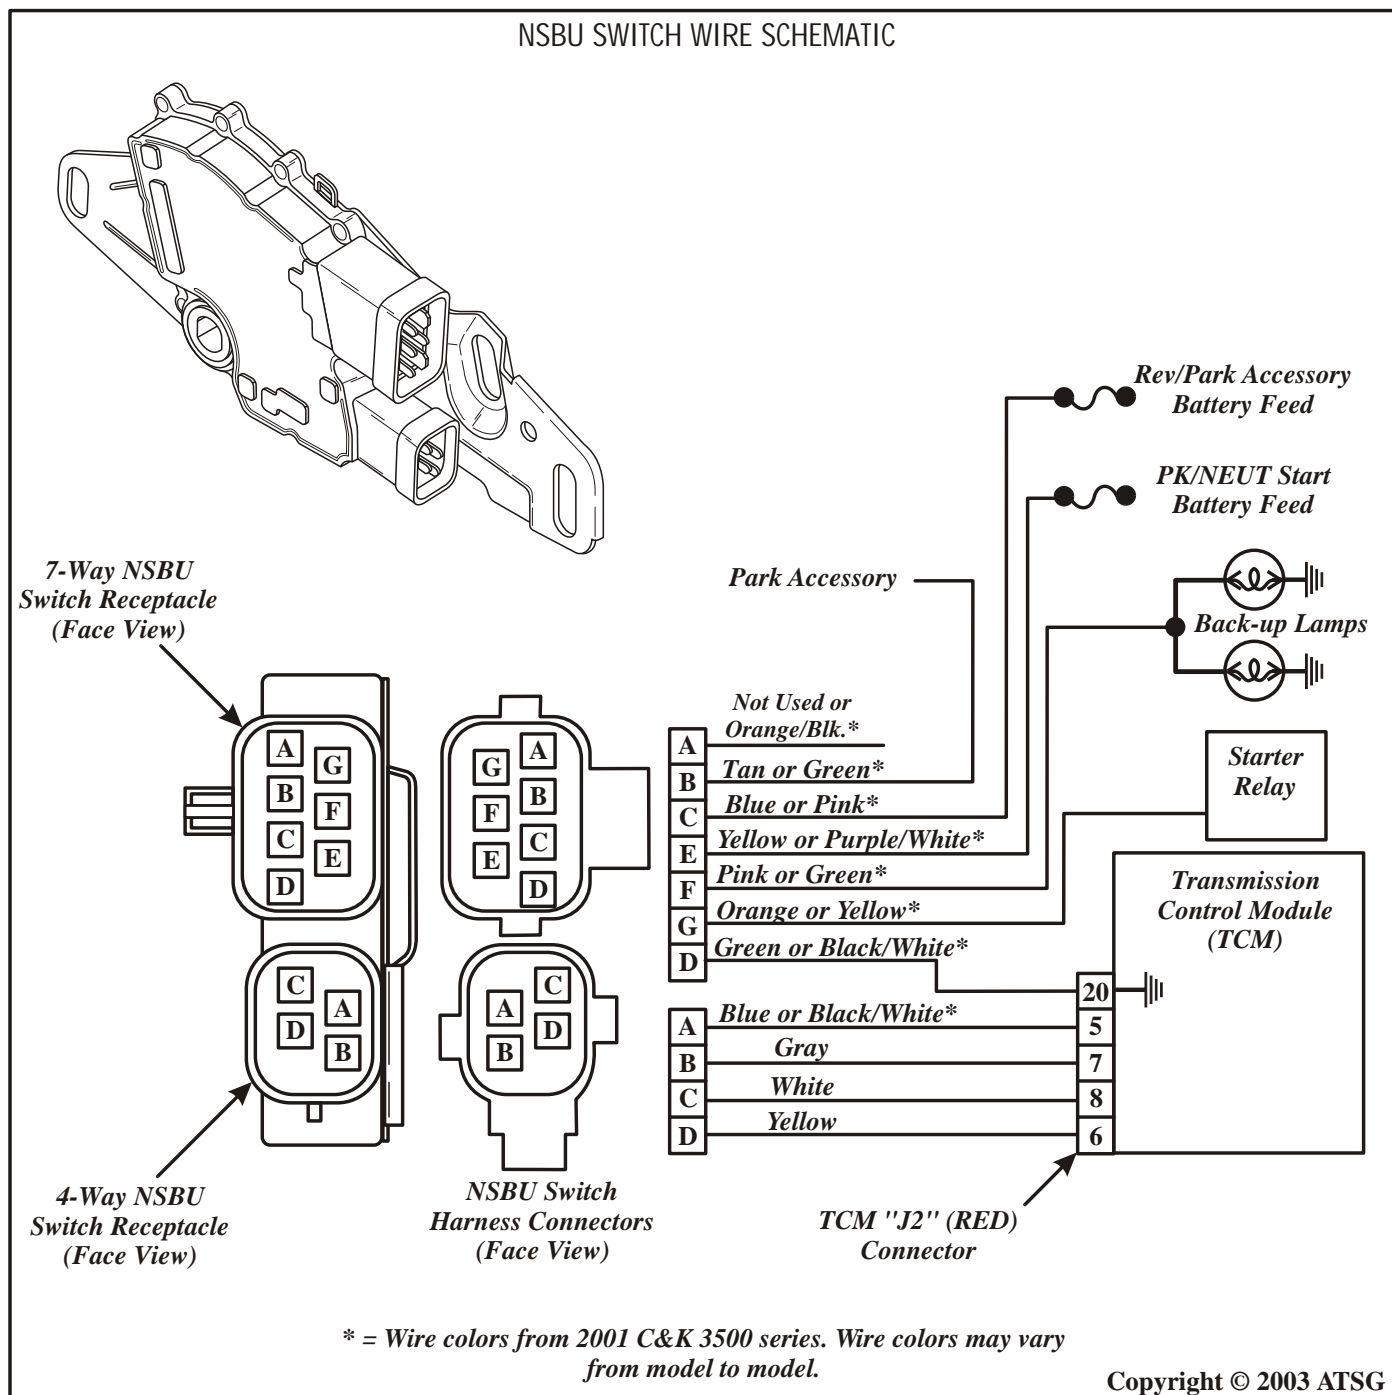
The installation of a transmission mounted Neutral Start/ Reverse Signal switch is required. This switch commonly referred to as an "NSBU Switch", mounts directly onto the transmission case from the outside and detects the angular position of the manual shift selector shaft. This position is relayed to the TCM so that certain vehicle control functions can be coordinated with the position of the shift controls. The NSBU Switch has redundant circuitry to alert the TCM in the event of a single wire or switch failure. The switch is interfaced to the starter circuit, and the reverse signal provision may be used to activate vehicle back-up lights and/or reverse warning devices.

Note: The service connector pigtails use wires that are all the same color. Use the old connector as a pattern to ensure that the new wires are connected to the vehicle harness correctly. This switch is in a wet area, and it is *imperative* that the wires be soldered and heat-shrink tubing be used to insure water-tight connections. Refer to Figure 1 for the location of the Park/Neutral Position Switch. Refer to Figure 2 for a full wiring schematic of the Park/Neutral Position Switch circuit for diagnostic purposes.

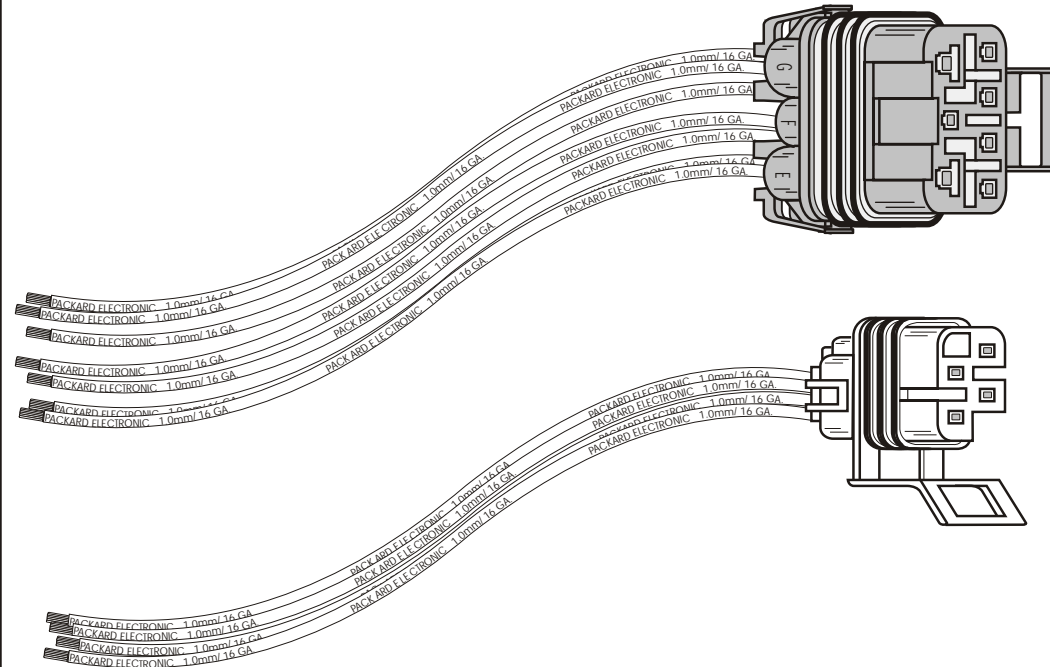
Figure 3

NSBU SWITCH REPAIR CONNECTORS

**PART NUMBER
15305887**

**PART NUMBER
15305925**
