KM 175

END CLUTCH SHAFT AND INPUT SHAFT MODIFICATIONS

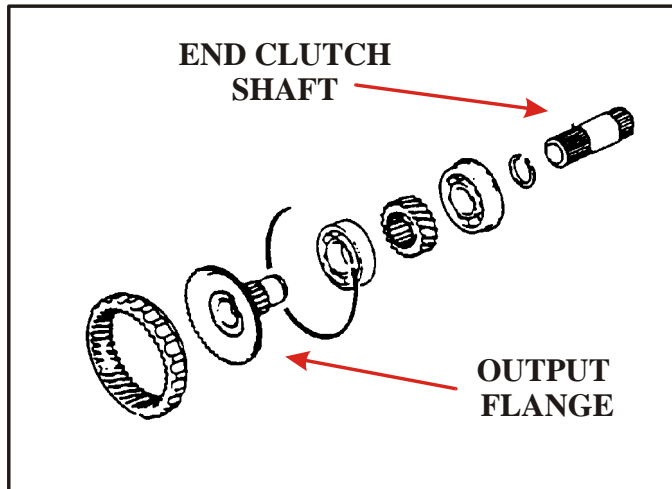
Figure 1

A series of changes have been made to the end clutch shaft, output flange assembly and input shaft (Figures 1 and 2) of the KM177 automatic transaxle used in 1988 Galant Sigma vehicles. These changes have been made to improve the lubrication capability and wear resistance of these components. When servicing the KM177 transaxle, be aware of these differences.

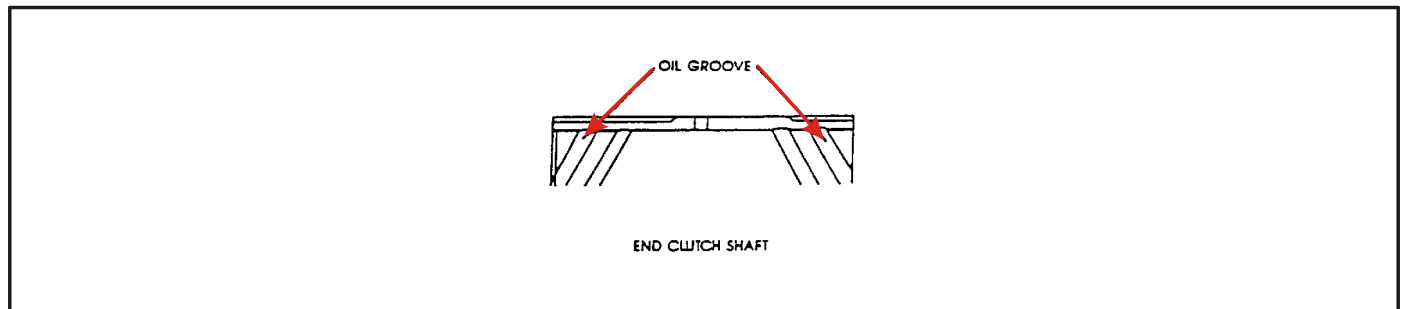
End Clutch Shaft — To improve lubrication of the output flange bushing, a spiral oil groove has been added to the inner diameter of the end clutch shaft as shown in Figure 4 below. This change was effective from August 1987 production (from transaxle number DL6587).

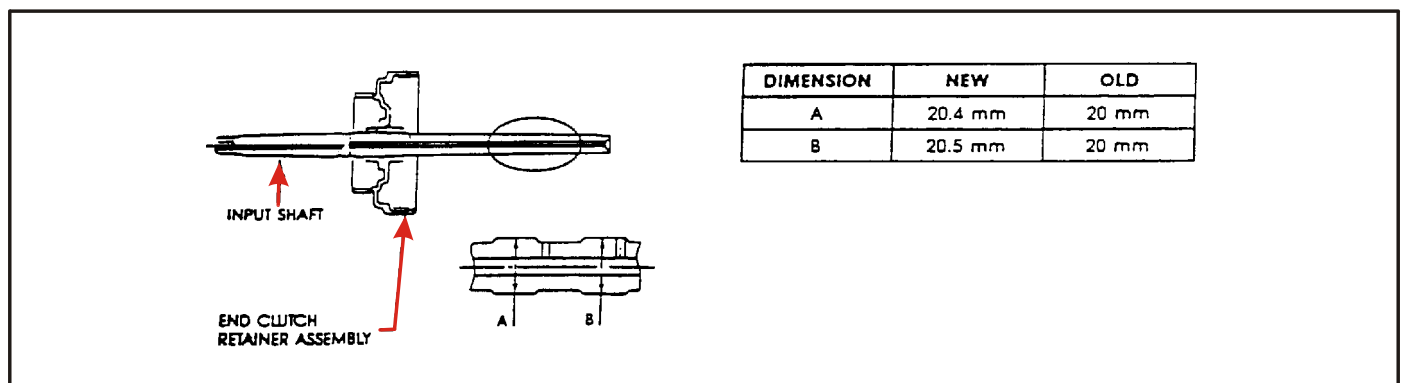
Figure 5

Input Shaft — To improve lubrication at the output flange bushing, the outer diameter of the input shaft (rear clutch retainer assembly) has been increased at two locations as shown in Figure 5. This change was effective from October 1987 production (from transaxle number DS9008).

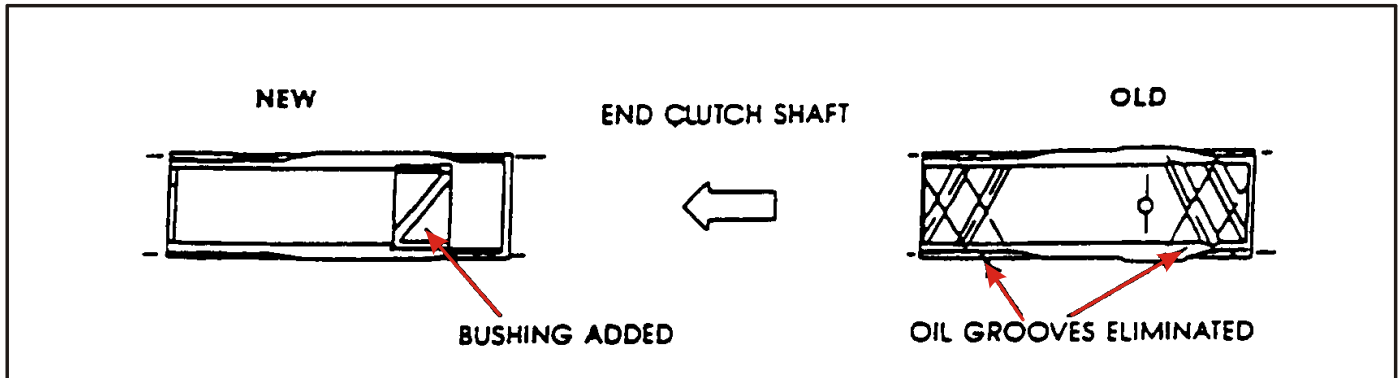
Figure 6

End Clutch Shaft — On the inside of the end clutch shaft, the oil grooves have been eliminated and a bushing has been added to improve wear resistance as shown in Figure 6. One bushing inside the output flange assembly has been eliminated as shown in Figure 7. These changes were effective from November 1987 production (from transaxle number DW3442).
