Technical Service Information

MAZDA / FORD CD4E ERRATIC UPSHIFTS AND DOWNSHIFTS

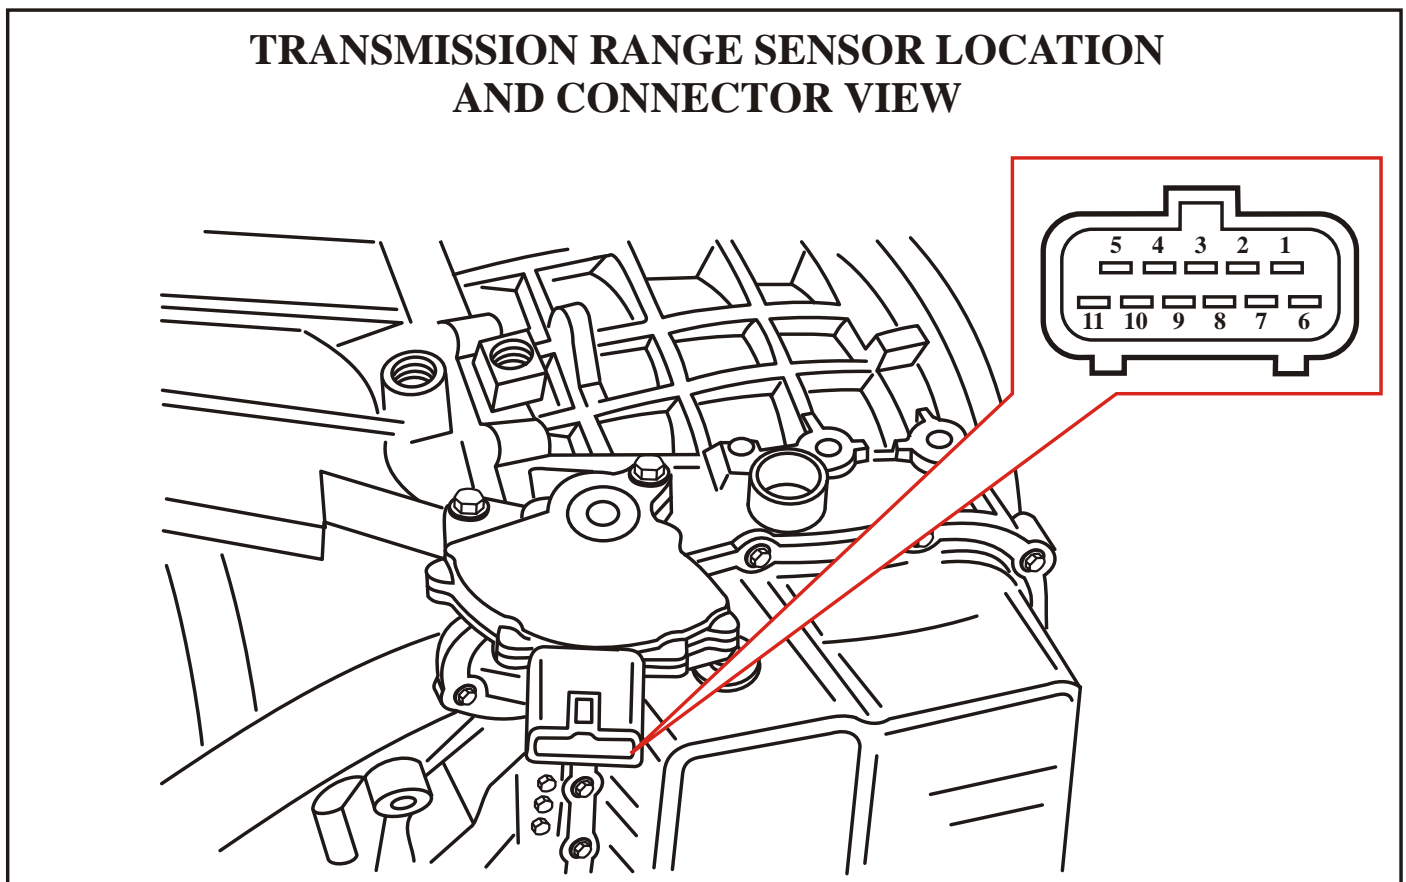
COMPLAINT: Vehicles equipped with CD4E transaxles may exhibit erratic upshifts or downshifts, wrong gear starts with no upshifts and / or no reverse with or without a flashing M.I.L (malfunction indicator lamp). Upon trouble code retrieval, one or more of the following codes may be present: 522, 634, 659, 667, 668, 675.

CAUSE: The cause may be, a faulty Transmission Range Switch.

CORRECTION: Refer to Figure 1 for the location of the Transmission Range Switch and refer to Figure 2 for terminal I.D. and to test the switch in each range for the correct ohm and voltage value. Replace the switch if it fails this test.

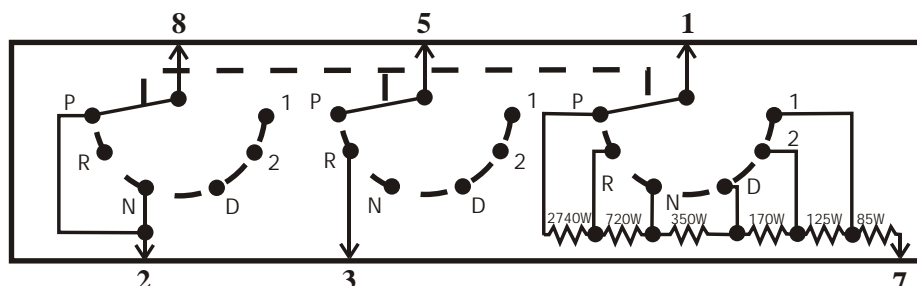
Figure 2

CONNECT OHM METER BETWEEN TERMINALS 1 & 7 TO CHECK RESISTANCE

RANGE	RESISTANCE		VOLTAGE RANGE
	MIN.	MAX.	
PARK	3770	4607	3.97-4.85 v
REVERSE	1304	1593	3.24-3.46v
NEUTRAL	660	807	2.55-3.11v
DRIVE	361	442	1.88-2.30v
2	190	232	1.23-1.51v
1	78	95	0.61-0.75v

BACK PROBE VOLTMETER LEADS INTO THE TWO WIRES IN TERMINALS 1 & 7 TO CHECK VOLTAGE
