Technical Service Information

EAGLE 4HP-18 INTERMITTENT FLAIR ON 2\3 SHIFT

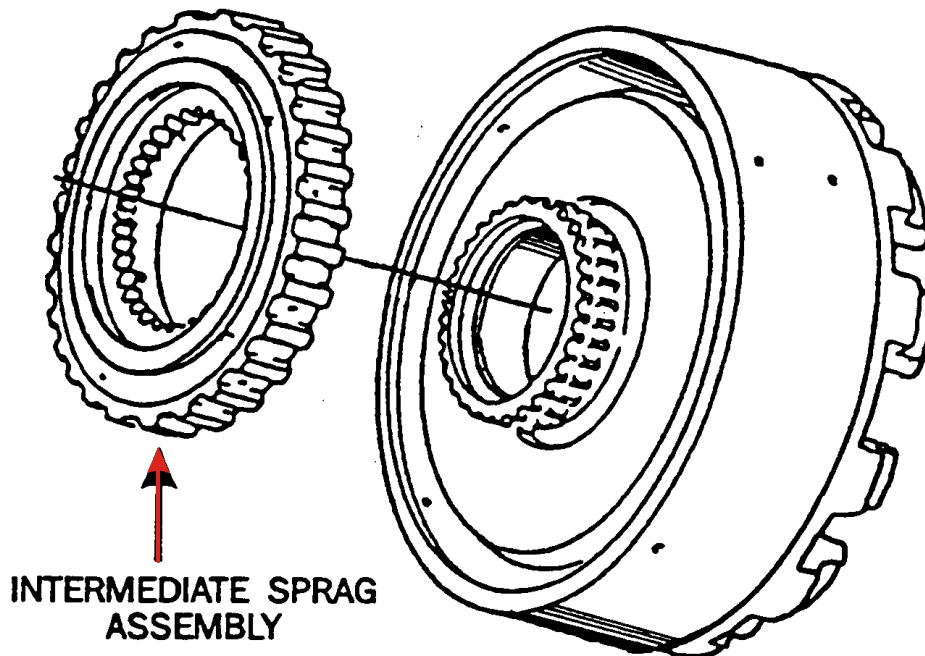
Figure 1

COMPLAINT: Intermittent flare on a 2-3 shift. The fluid is clean and does not have a burnt odor to it.

CAUSE: The intermediate sprag is failing to hold the intermediate clutches causing a flare until the 3-4 clutches apply.

CORRECTION: Replace the intermediate sprag assembly, refer to figure 1 below.
