Technical Service Information

FORD AOD NO 4TH GEAR

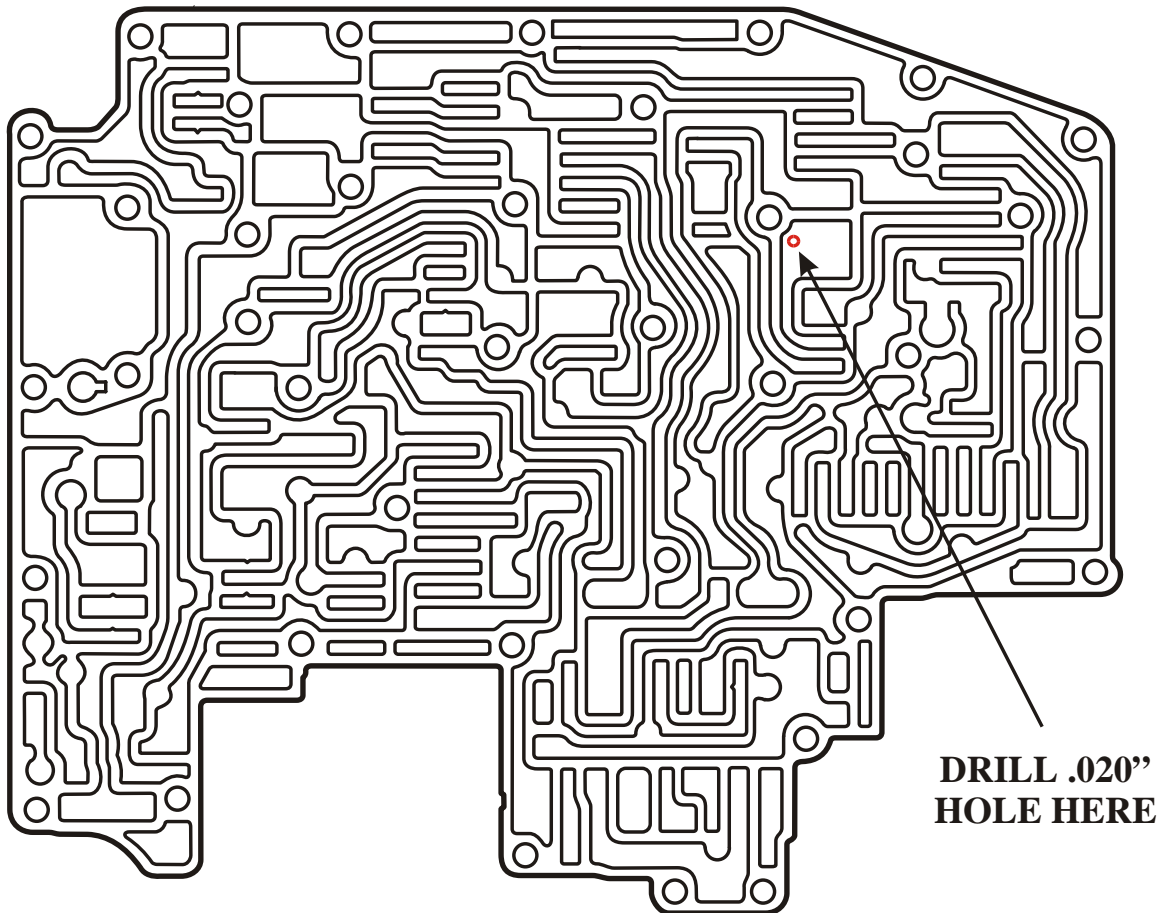
COMPLAINT: Very late 4th gear, or NO 4th gear.

CAUSE: Valve Body and/or Case cross leaks.

CORRECTION: Drill a vent hole through valve body casting, in the 3-4 T.V. modulator circuit, using a .020" drill bit. See Figure 1 for the location. The smaller drill bits can usually be obtained at the local hobby shop.
