# Technical Service Information

## FORD AX4N HARSH 1-2 SHIFT

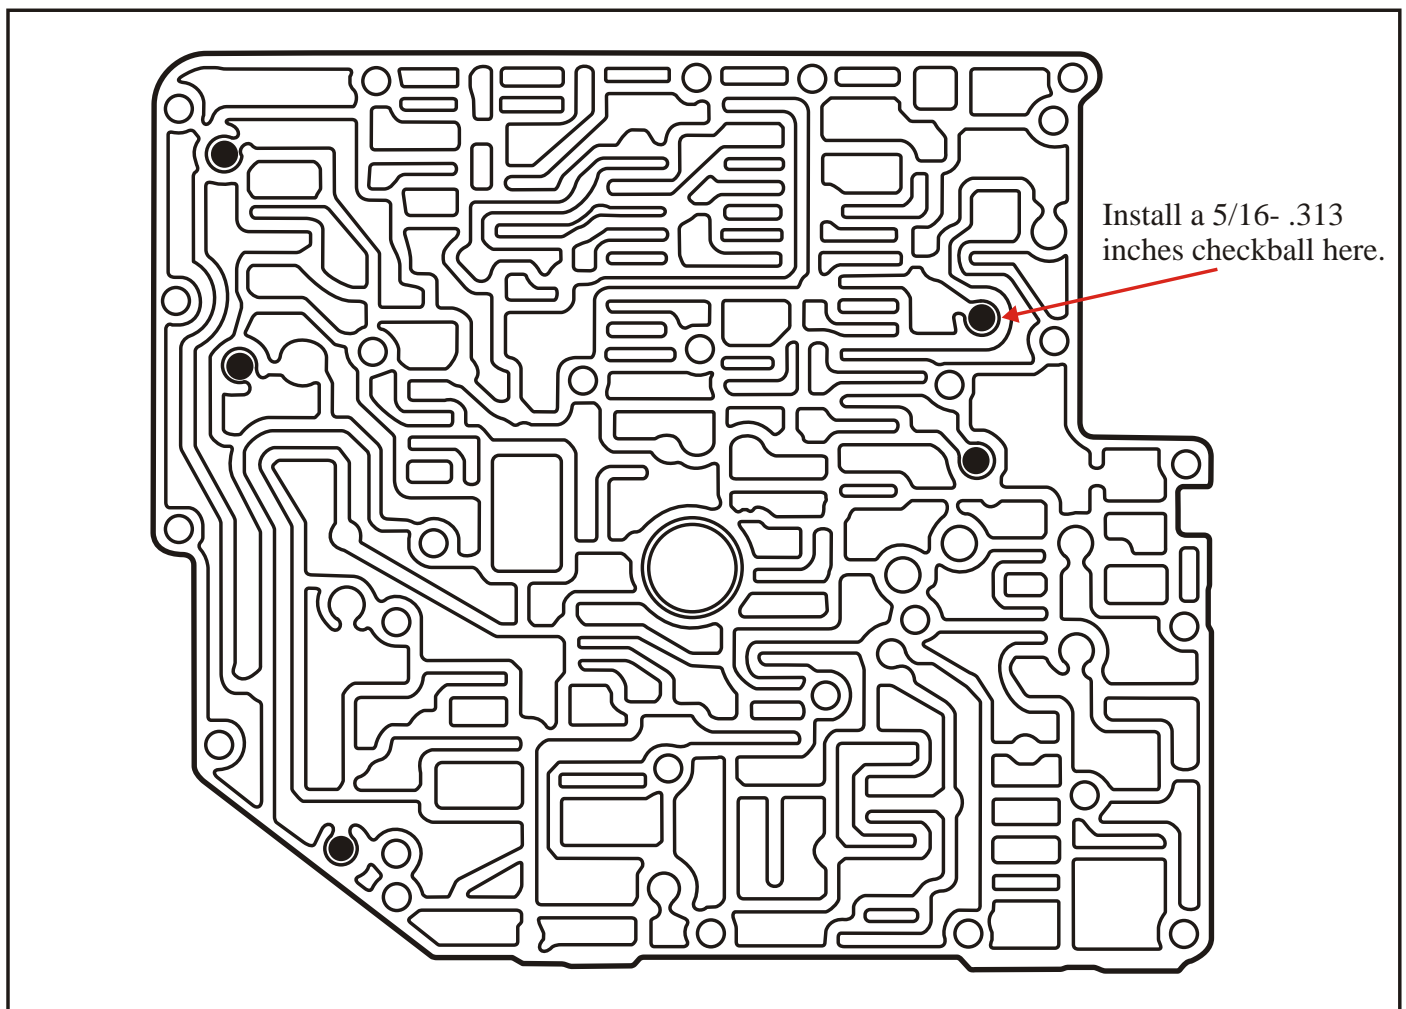
Figure 1

**COMPLAINT:** Before and/or after rebuild, the vehicle may exhibit a harsh 1-2 upshift.

**CAUSE:** The cause may be a missing B10 checkball from the valve body. A missing B10 checkball will allow Intermediate Clutch oil to flow un-orificed into the Intermediate clutch, causing the shift to be harsh.

**CORRECTION:** To correct this condition, install a 5/16 - .313 inches checkball at the B10 location. See Figure 1.
