## NISSAN QUEST RE4FO4A FORD 4F20E VILLAGER SOFT OR FLARED UP-SHIFTS AFTER OVERHAUL

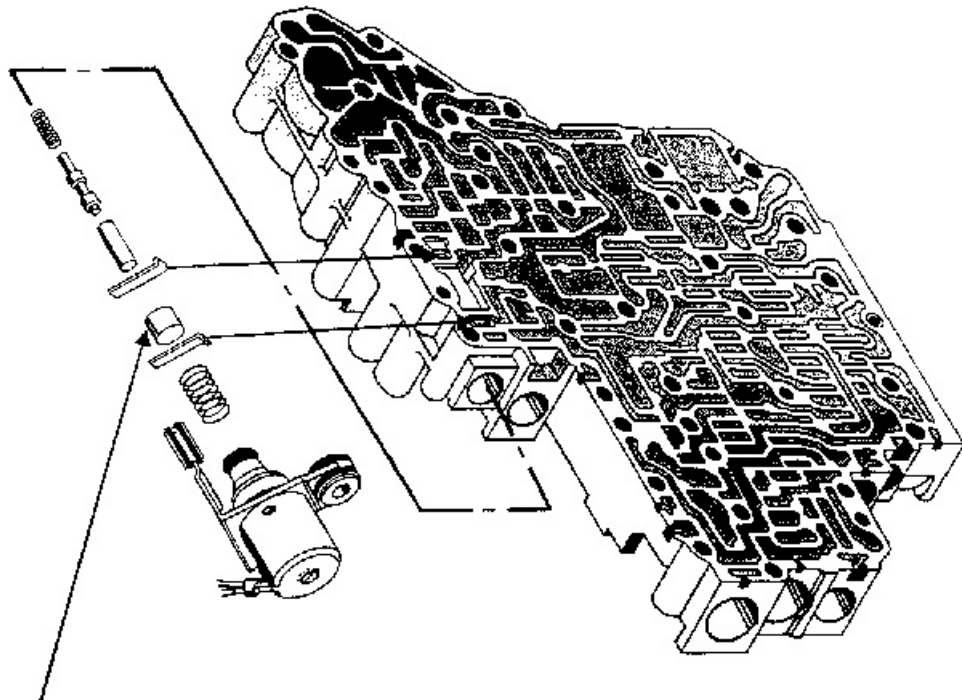
Figure 1

- COMPLAINT:** After overhaul, the transaxle may exhibit soft and/or flared up-shifts, and may display a chatter on take off.
- CAUSE:** One cause may be, a mis-located bore plug in the valve body where the pressure control solenoid is located (See Figure 1). This will allow all boost oil to exhaust through the keeper slot, preventing the line pressure solenoid from having any oil to control line pressure rise.

**INCORRECT BORE PLUG LOCATION**

- CORRECTION:** Install the keeper in the valve body, THEN THE BORE PLUG, then the spring and the pressure control solenoid, as shown in Figure 2. This bore plug acts as a wall to contain the oil which the pressure control solenoid uses to raise line pressure. The only purpose of the spring between the bore plug and solenoid, is to prevent the bore plug from walking towards the solenoid and blocking oil from reaching the pressure control solenoid. Install the line-up as shown in Figure 2.
