Technical Service Information

FORD AX4S/AX4N NO REVERSE

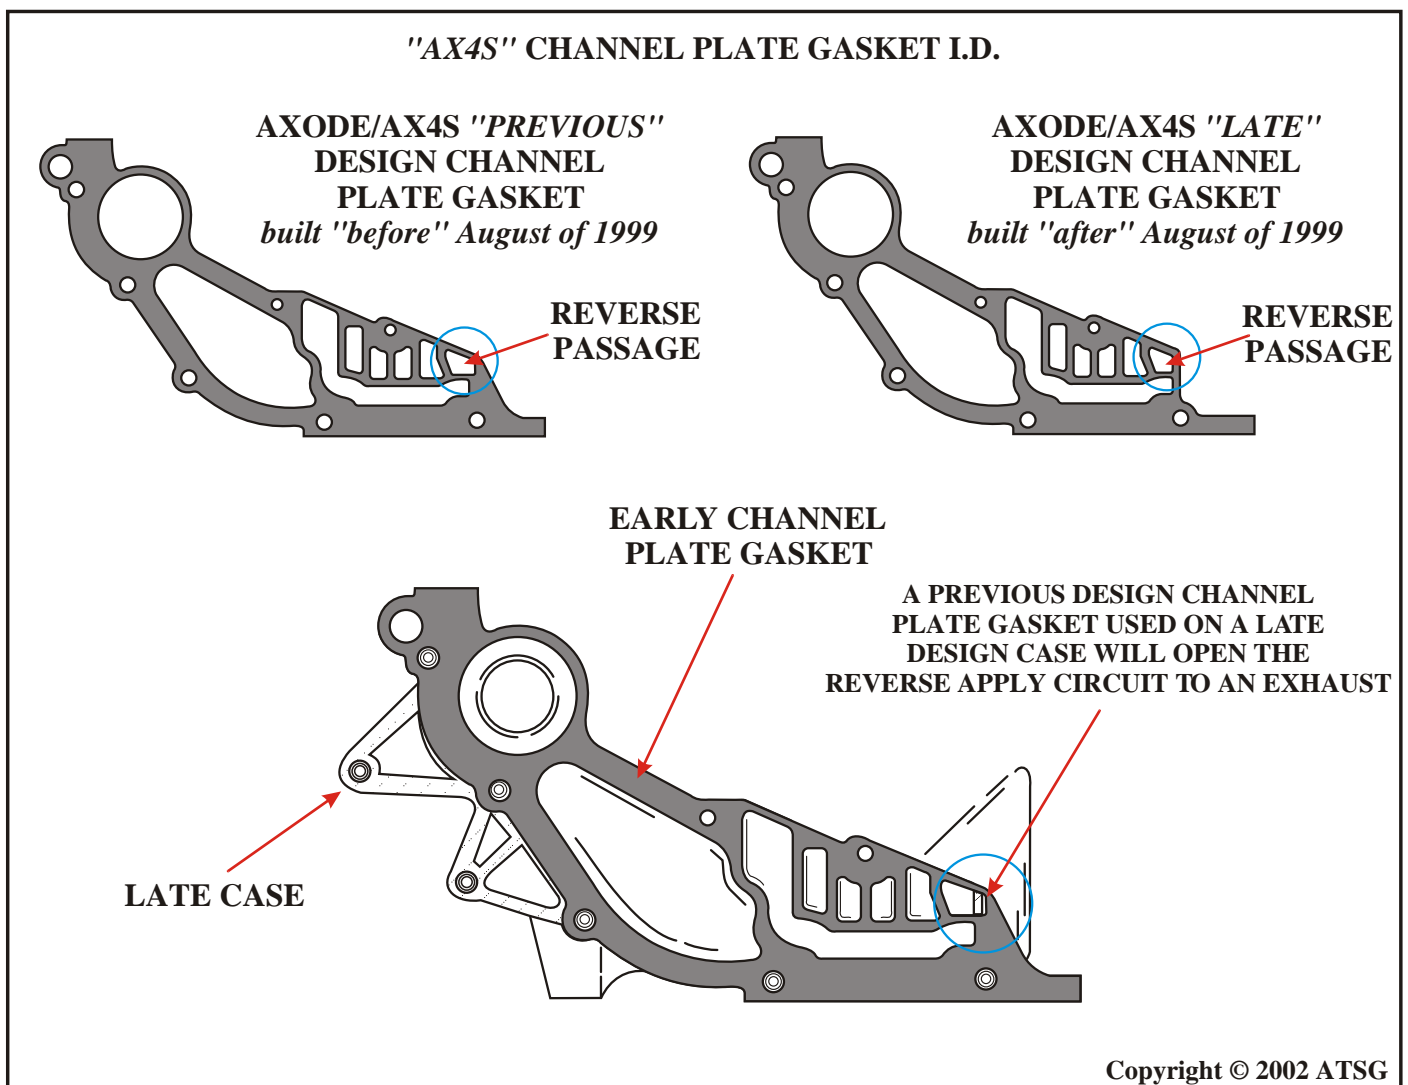
CAUSE: The cause may be, that the *Previous Design* Channel Plate Gasket, was used on a *Late Design* case as shown in Figure 1. When this happens, Reverse apply pressure will be exhausted back into the case because of the gasket hanging over the case casting.

CORRECTION: AX4S-Refer to Figure 1 to identify the correct Channel Plate Gasket for the application of vehicle you are working on.
AX4N-Refer to Figure 2 to identify the correct Channel Plate Gasket for the application of vehicle you are working on.
