Technical Service Information

MAZDA/PROBE GF4A-EL TROUBLE CODES 6, 25 AND 55

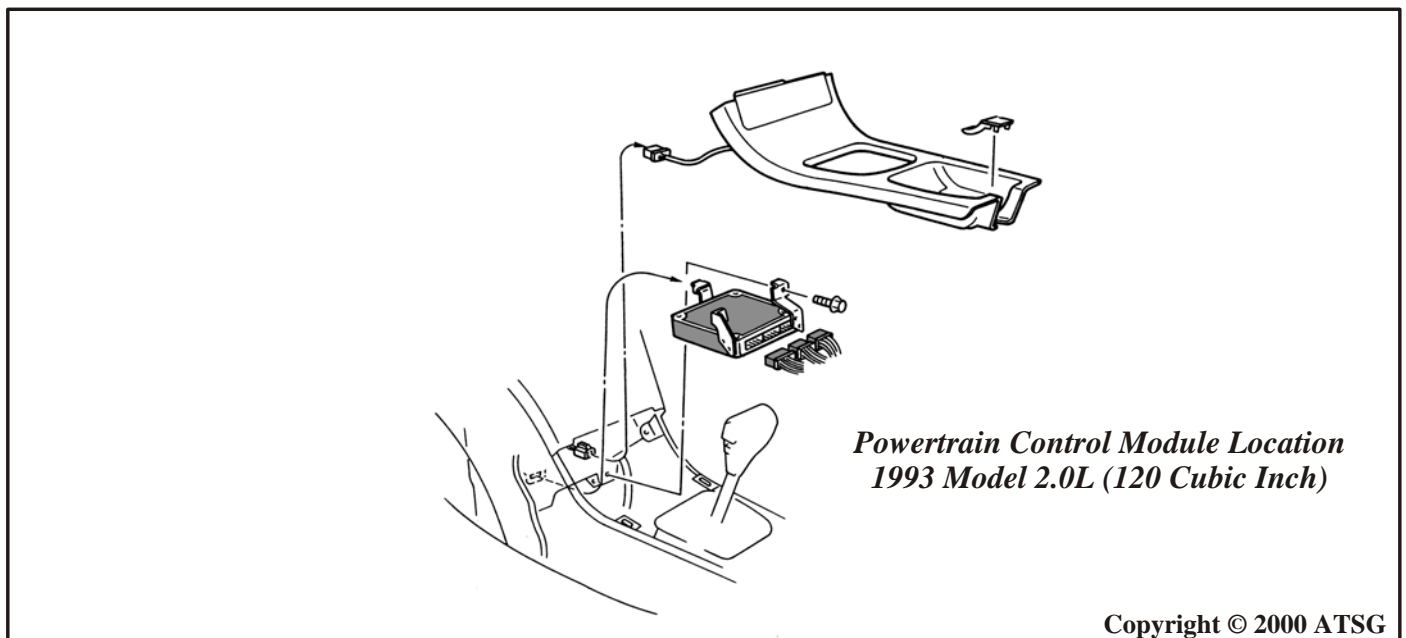
Figure 1

CORRECTION: The PCM can be located below the front center of the console (See Figure 1). From here all three circuits can be verified for proper operation ***before*** changing the computer. If the following voltage checks are observed, change the PCM. Refer to Figure 2 for connector terminal identification.

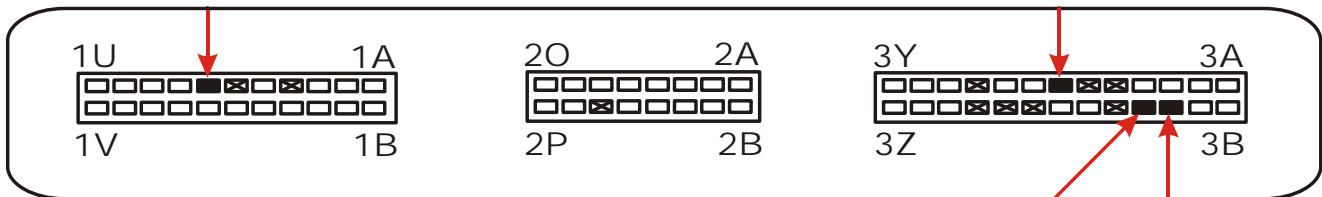
Figure 2

Code 6-VSS: *Approximate 5 volt pulse should be seen as the wheels are rotated slowly.*

1M
Green/Red

Code 25-FPCS: *System Voltage should be seen on this wire unplugged from the computer.*

3M
Green

3H
Red
PSG-
3F
White
PSG+

Code 55-PSG: *AC voltage should increase proportionally with turbine shaft speed rotation*

Code 6 VSS - An approximate 5 DC volt pulse should be seen on the green wire with a red tracer going to terminal 1M as the wheels rotate slowly. An averages of 2.5 volts will be observed during driving conditions.

Code 25 FPCS - Unplug connector 3. With the key on and engine of, system voltage should be observed on the green wire going to terminal 3M.

Code 55 PSG - Plug connector three back into the PCM. Set meter to AC volts and probe the white wire at terminal 3F with the positive meter lead. Probe the red wire at terminal 3H with the negative lead. AC volts should be observed as soon as the vehicle is started and should increase proportionally with turbine shaft rotation.
