Technical Service Information

SUBARU 4-ATAXLE - PHASE II

NO REVERSE

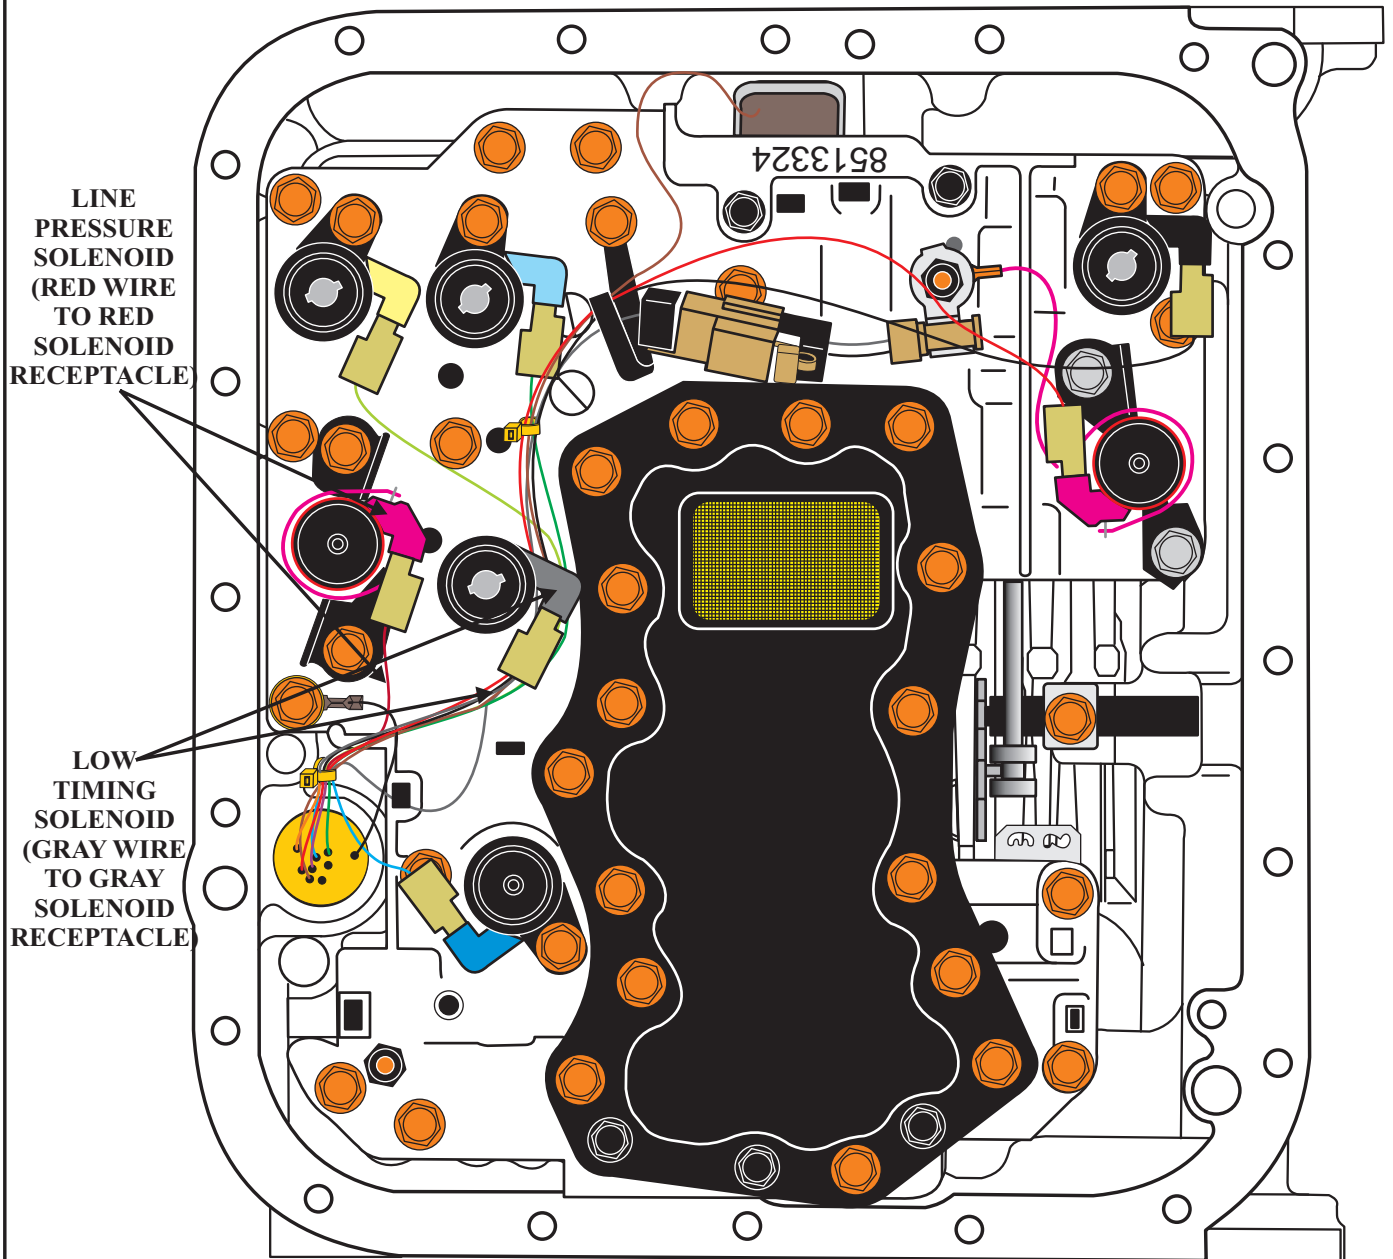
CAUSE: The Low Clutch Timing and Pressure Control Solenoid connectors have been switched.

SOLENOID & TCM GROUND LOCATION

CORRECTION: Because the Pressure Control and Low Clutch Timing Solenoids are in close proximity of each other, it is easy to switch their connectors. The connector ends are all the same color and are interchangeable, however, **the wire color should match the solenoid connector**, Refer to Figure 1 for solenoid identification.

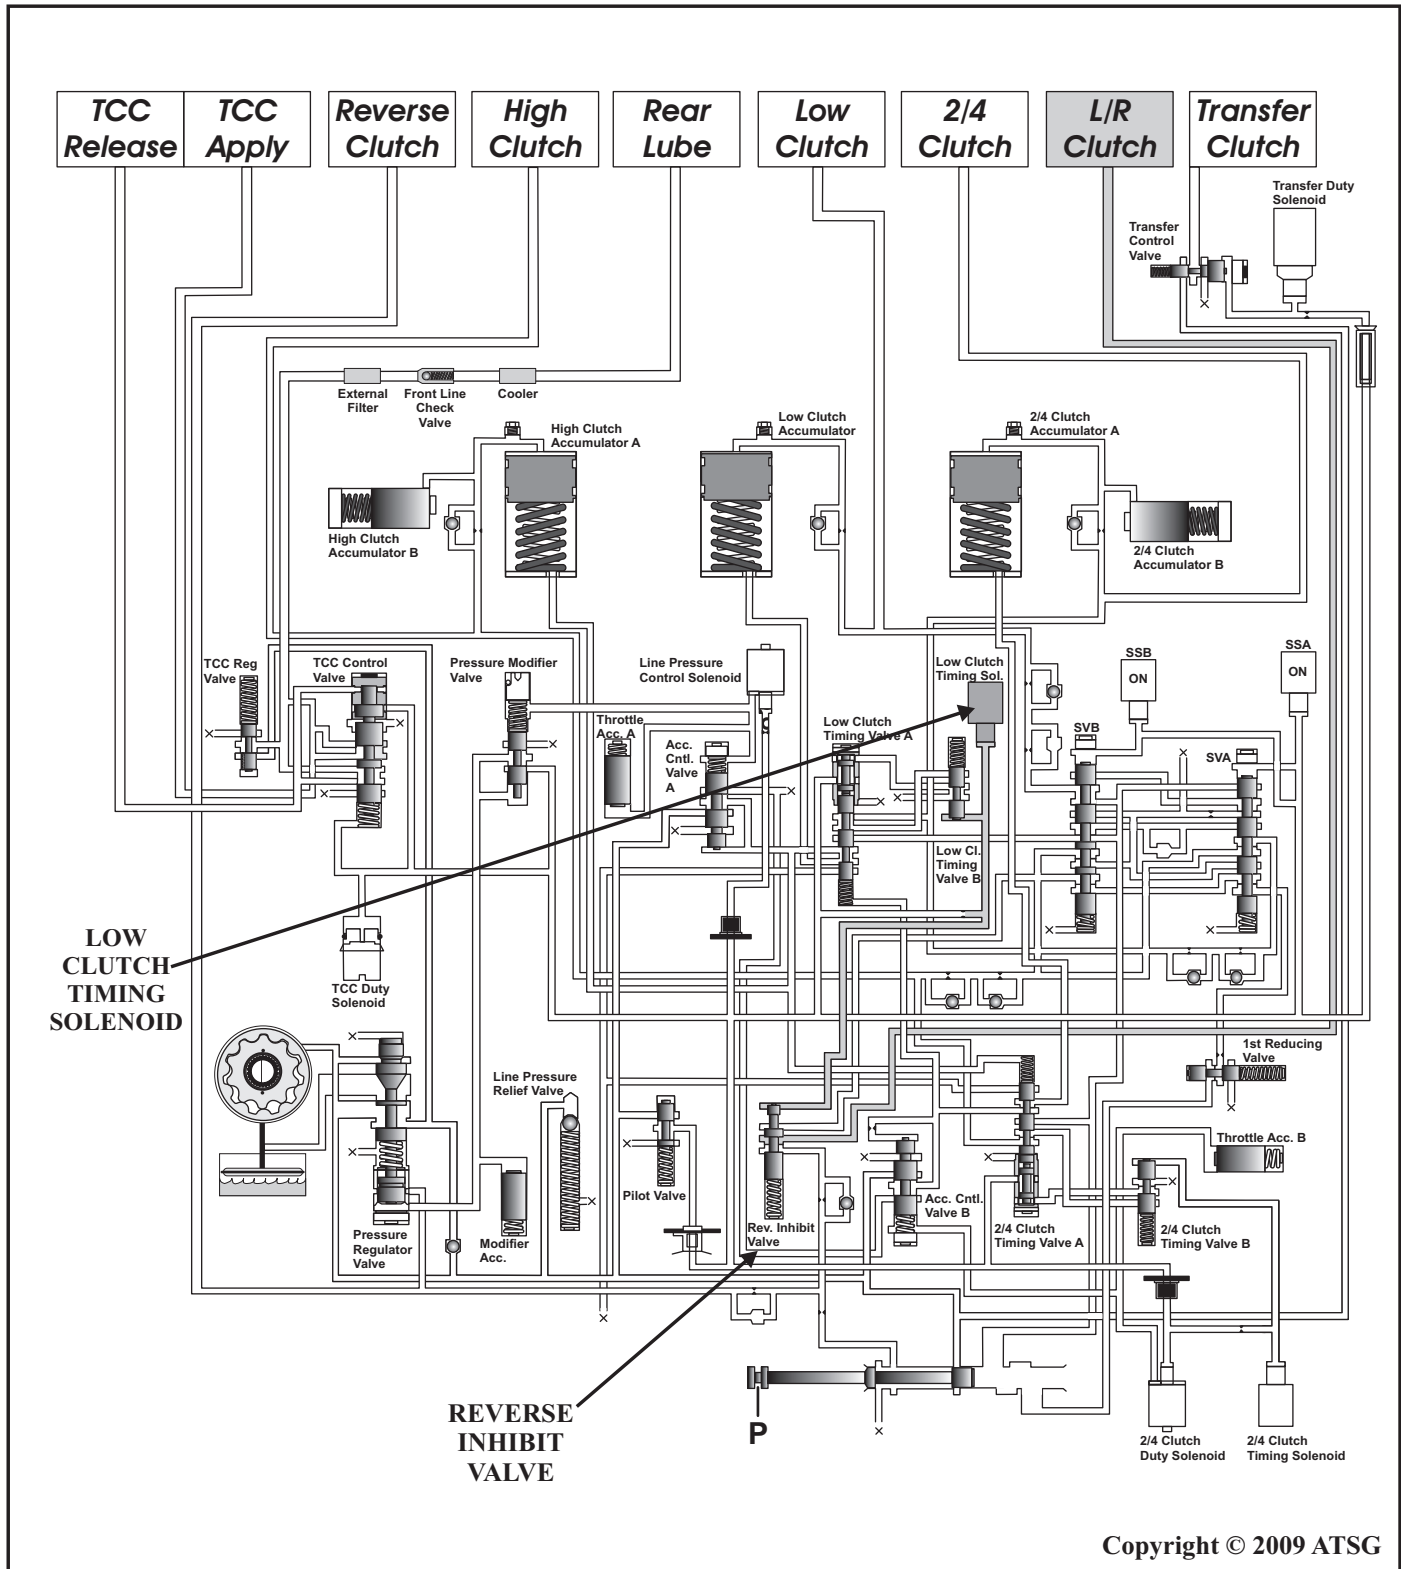
Figure 2

The no reverse condition is a result of the Low Clutch Timing Solenoid running all the time due to the Pressure control Solenoid connector that is plugged into it. This causes oil to stroke the Reverse Inhibit Valve as seen in the hydraulic schematic in Figure 2. When the shift lever is in the reverse position and the engine is turned off, The Low Clutch Timing Solenoid is also turned off thereby draining the reverse inhibit circuit at which time the valve spring strokes the reverse inhibit valve in the opposite direction which will now momentarily charge the Low/Reverse clutch circuit causing momentary reverse engagement.

NO REVERSE & DELAYED FORWARD ENGAGEMENT
