NISSAN RE4FO2A AND RL4FO2A NO SECOND OR FOURTH AFTER REBUILD

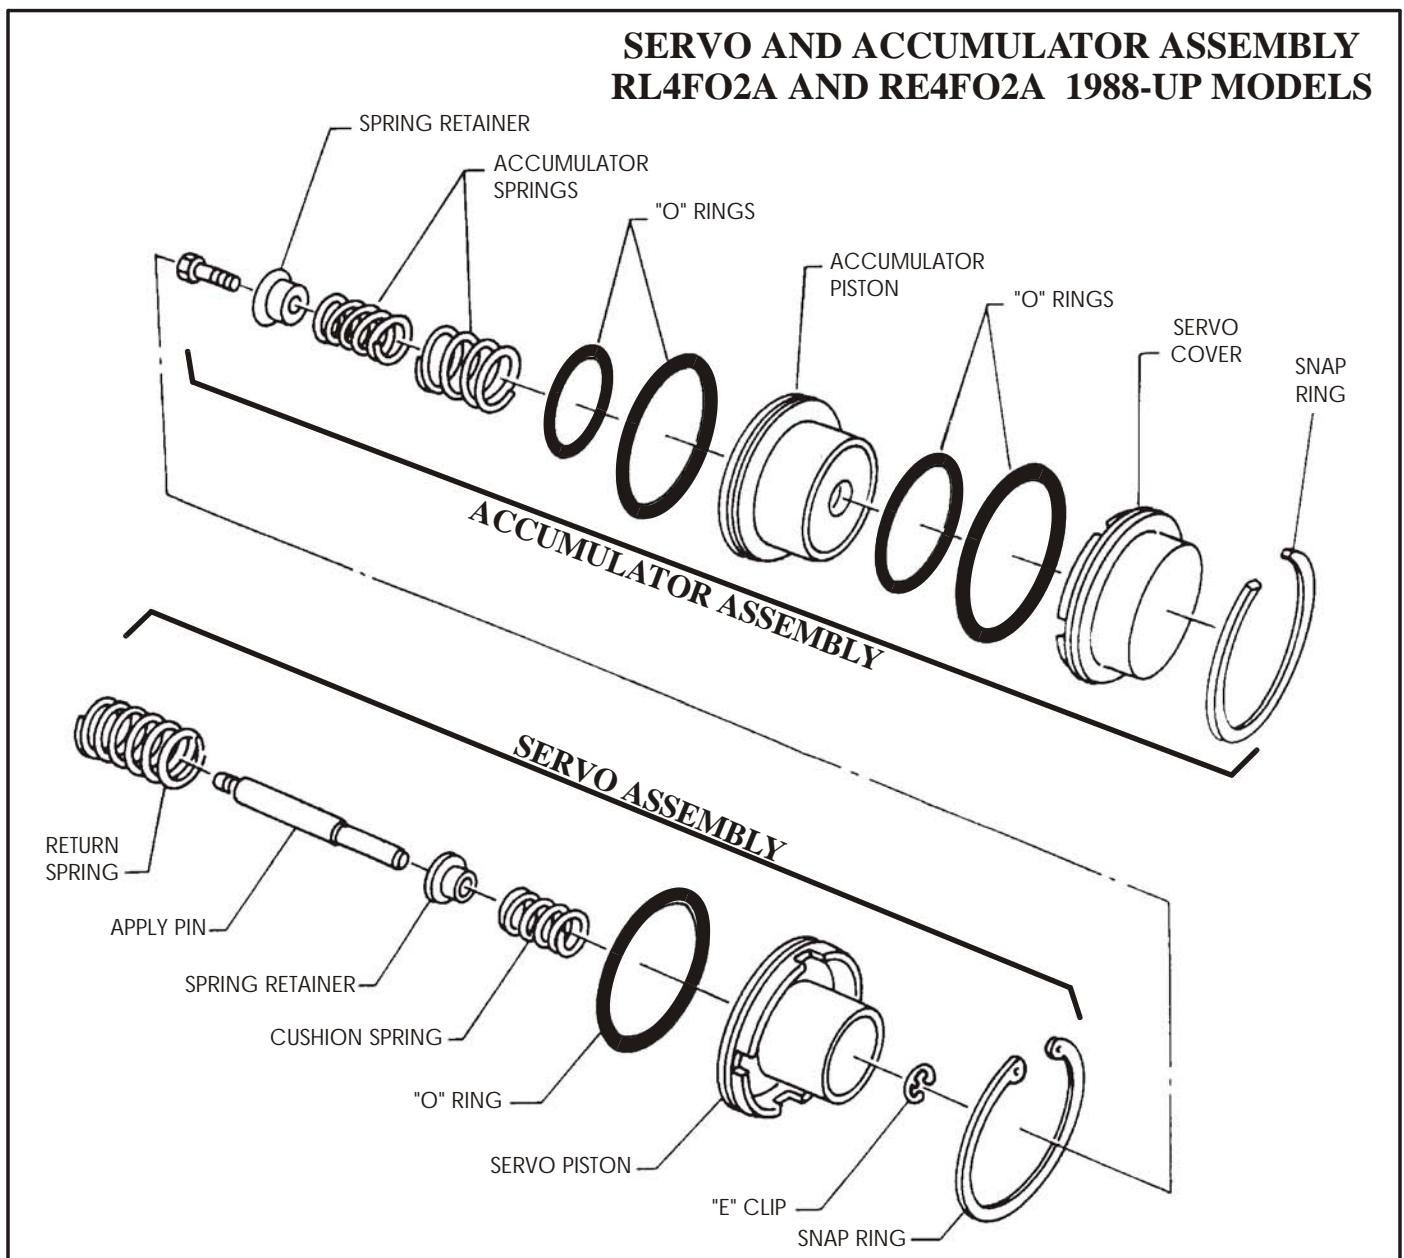
COMPLAINT: After rebuild, the transaxle exhibits a no second and no fourth condition.

CAUSE: The cause may be, a mis-assembled 2-4 servo piston.

CORRECTION: Assemble the servo piston in the proper direction, as shown in Figures 1, 2, and 3.
Refer to Figure 1 for RL4FO2A and RE4FO2A, 1988-Up models.
Refer to Figure 2 for RL4FO2A, 1986 models only.
Refer to Figure 3 for RL4FO2A, 1987 models only.

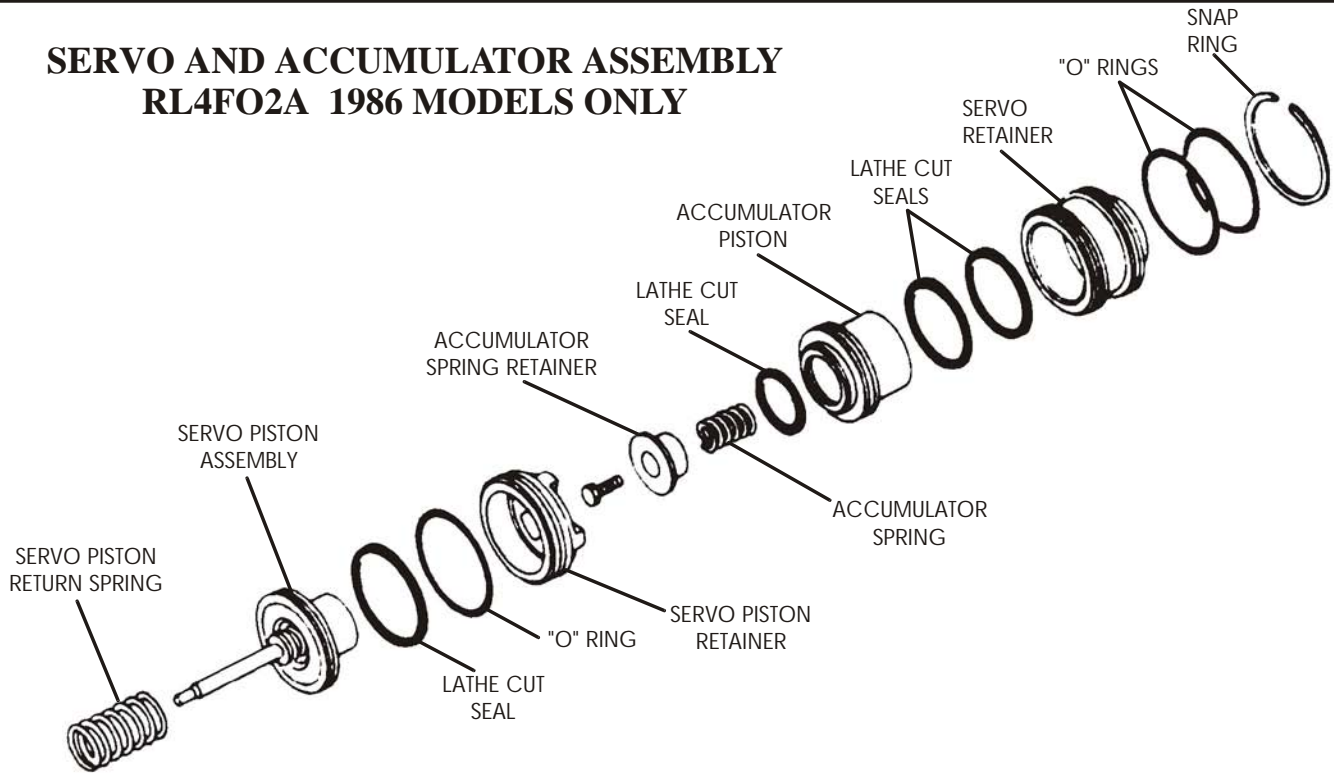
Figure 2

SERVO AND ACCUMULATOR ASSEMBLY RL4FO2A 1986 MODELS ONLY

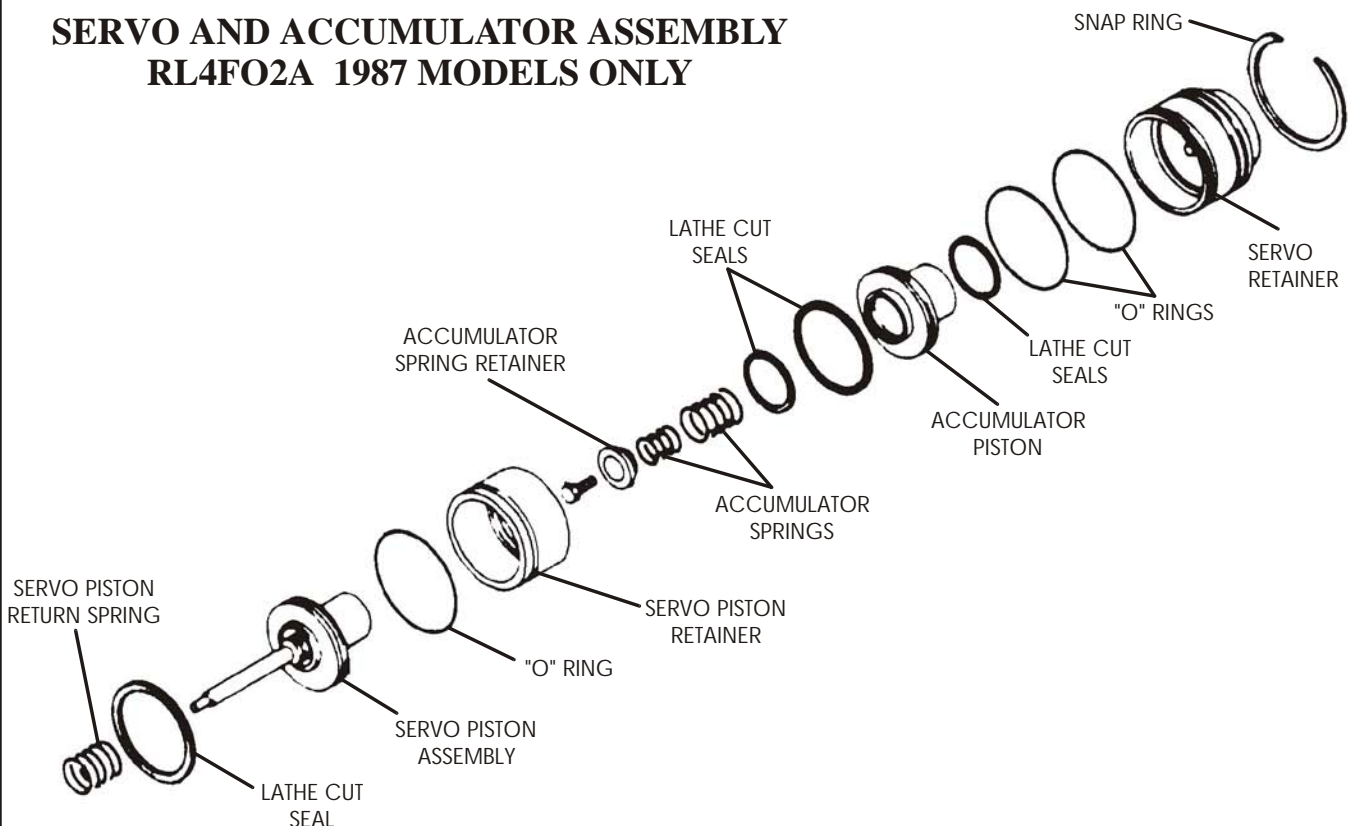
Figure 3

SERVO AND ACCUMULATOR ASSEMBLY RL4FO2A 1987 MODELS ONLY
